**GAS MAINS REPLACEMENT, ALDBOROUGH,  
NORTH YORKSHIRE**

**WATCHING BRIEF REPORT**

**REPORT NUMBER 2013/08**

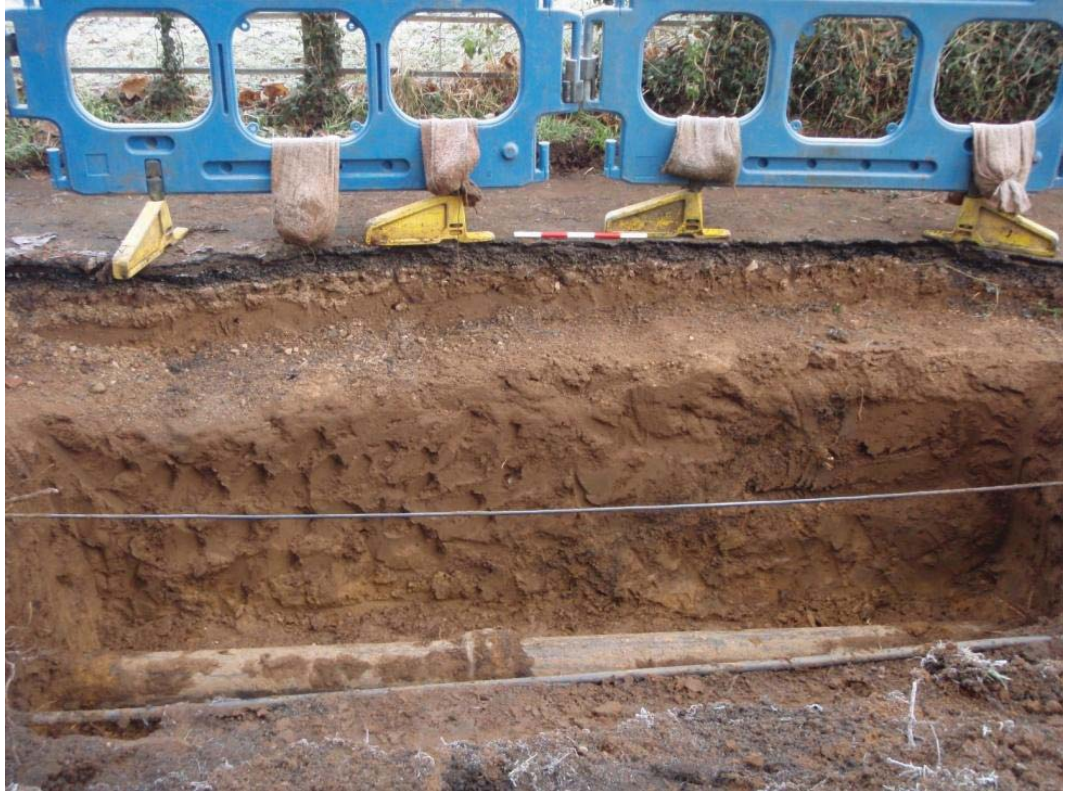
Clean soils of 'rural', rather than 'urban' appearance and character were observed in trenches 88, 89, 90, 91 and 92 (Plates 22, 23). All these soils were relatively stone free brown sandy silts virtually devoid of human derived material. The distribution of these trenches is quite striking, all occurring outside of the area of the walled town. These have the appearance of soils that were ultimately derived from processes of natural formation, though may well have subject to human working – perhaps predominantly though agriculture. Such may explain the banding within some of the soils best evidenced by that apparent in Trench 91 (see Plate 23). All these soils were fairly compact, a factor perhaps owed to their location beneath a roadway. Where clean relatively stone free soils were observed within the area of the walled town these were darker, occurred at a higher level in the stratigraphic sequence and are likely to be of medieval or later date. These have been considered in Sections 5.2.4 and 5.2.5 above.

Plate 22 Soils in Trench 90, Looking NNE.

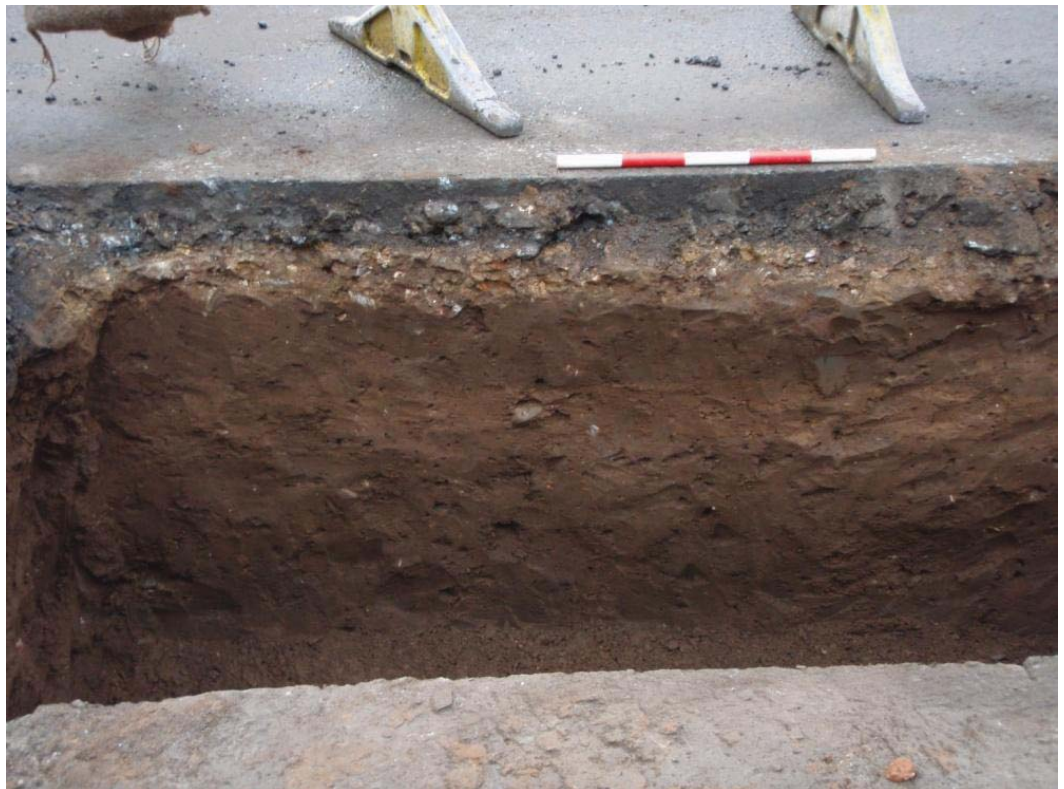
Plate 23 Soils in Trench 91, Looking SSW.

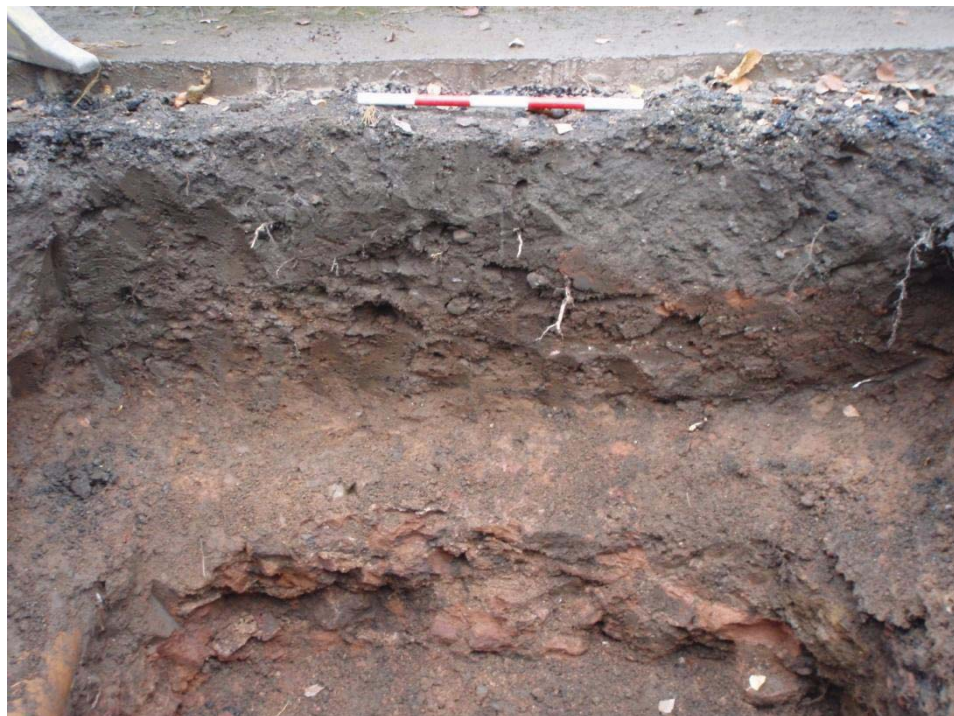
*Plate 24 Rubbly deposits of red sandstone in Trench 38, Looking SE.  
The silty deposit above contained post-medieval material.*

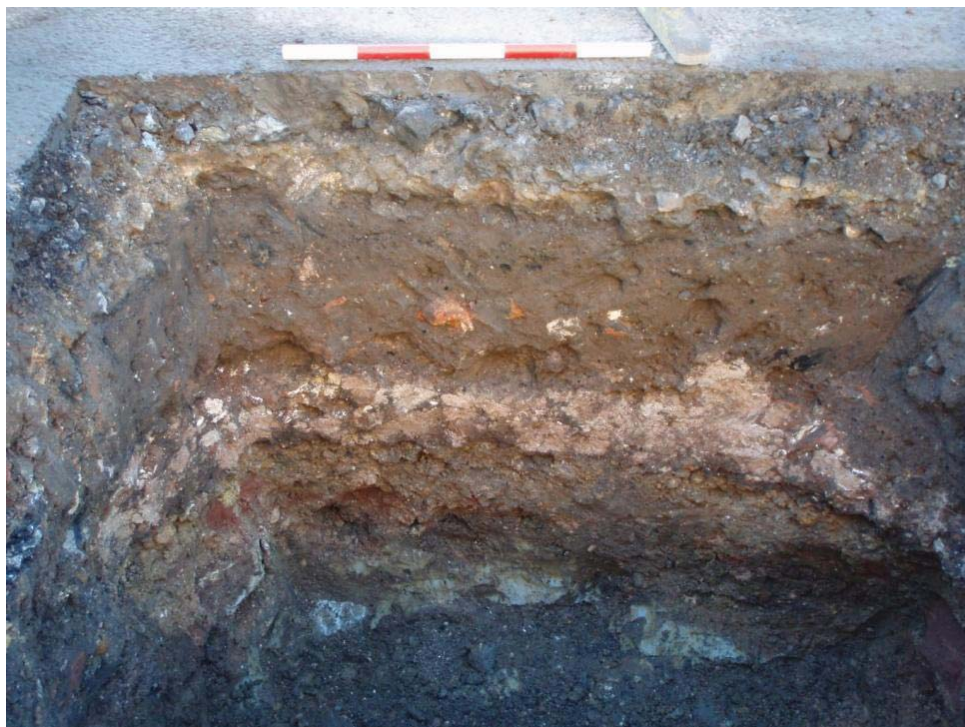
*Plate 25 Mixed rubble deposits in Trench 55, Looking S. Note the creamy white band around 1/3 rd up the section which is comprised predominantly of wall plaster. The thick soily deposit above contained post-medieval finds.*

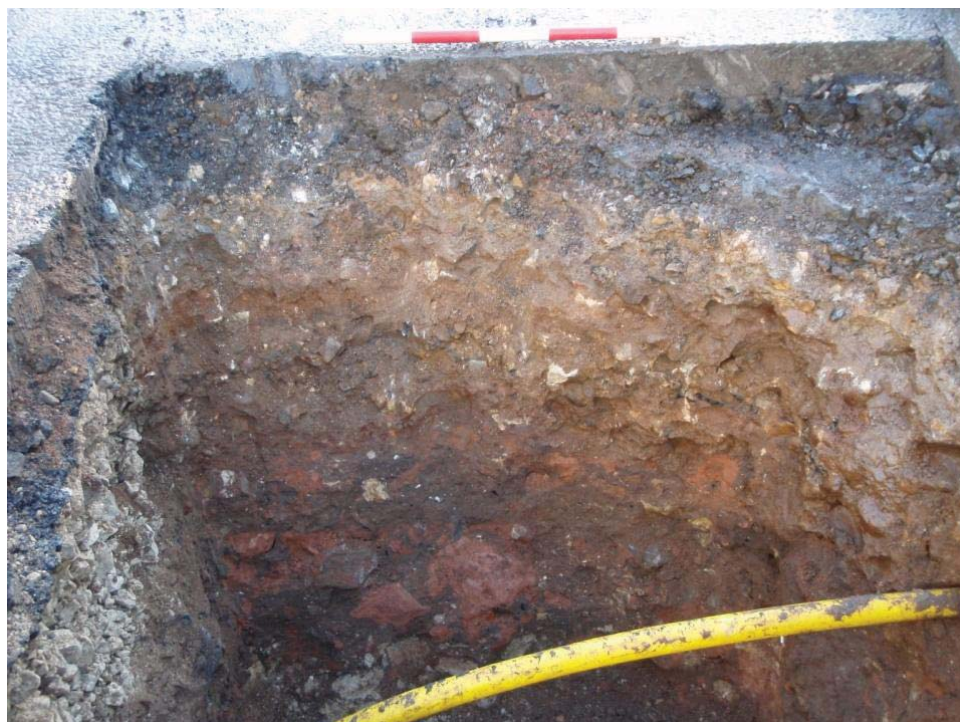
*Plate 26 Rubble deposits comprised largely of red sandstone in the lower part of Trench 80, Looking SSW. The date of the paler coloured stoney deposits above is uncertain.*

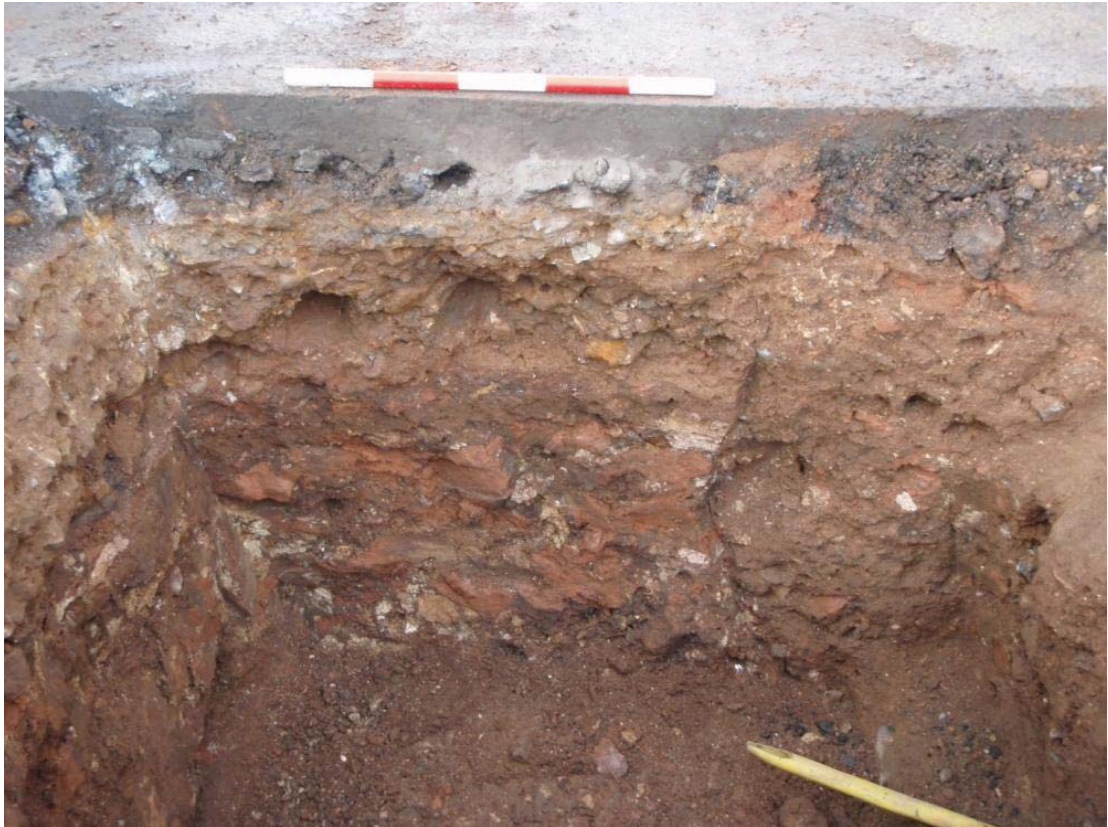
*Plate 27 Mixed rubble deposits comprised largely of red sandstone, mortar and plaster in the lower part of Trench 93, Looking WNW.*

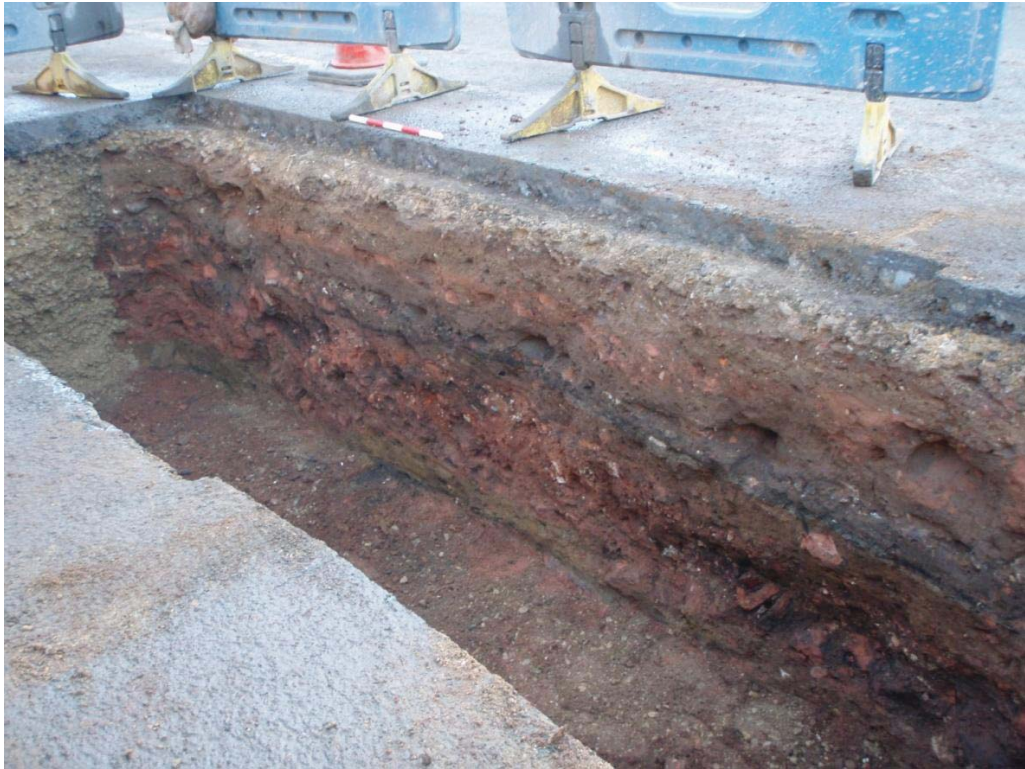
What may be characterised as 'softer' deposits, of a type more likely to relate to accumulations, deposition and dumping rather than to structures in the form of collapse, demolition or robbing, were identified in Trenches 50, 54, 56, 76 and 78. (Plates 28, 29, 30). In all cases these extended beyond the basal limits of the trenches and although the precise upper limits of the Roman material in these sequences could not readily be determined they are clearly of some depth. In all these instances rubble material of stone, mortar and plaster was present, but this was often interleaved with other materials and was at much lesser densities than those trenches with sequences predominantly of rubble. The 'softer' materials were principally comprised of layers of silts and sandy silts, occasional clayey layers - or layers with a clay content and charcoal rich layers. Often the colour range of these was quite considerable. The thickness of the soft deposits varied considerably from thin layers of charcoal rich materials only a few mm thick to thicker bands in excess of 0.20m. For the most part these deposits lay fairly horizontally though in the western part of trench 56 and the north-western end of Trench 78 they were inclined, or dipped (see Plates 26, 27). In the case of Trench 78, and possibly so in Trench 56, this appears to be related to the presence of a pit, that to 78 being particularly clear.

Plate 28 Mixture of rubble and soft deposits in the eastern part of Trench 56, Looking SE

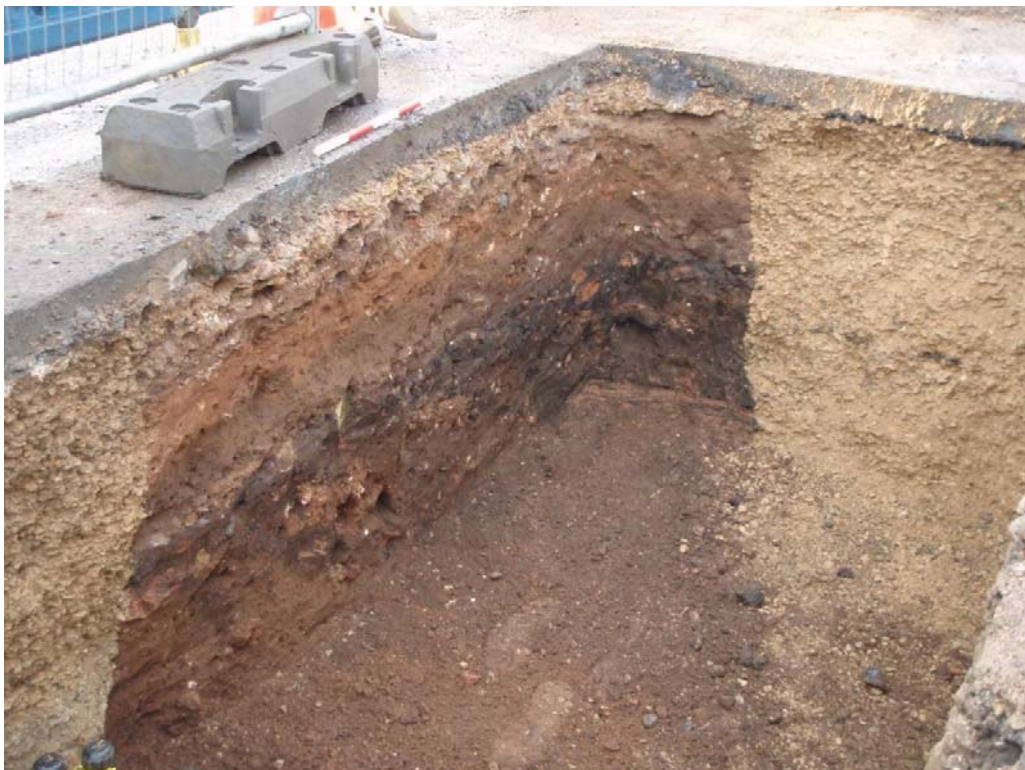
Plate 29 Predominantly soft deposits surviving between service cuts in the western part of Trench 56, Looking SW. Note that deposits towards the corner area are dipping down.

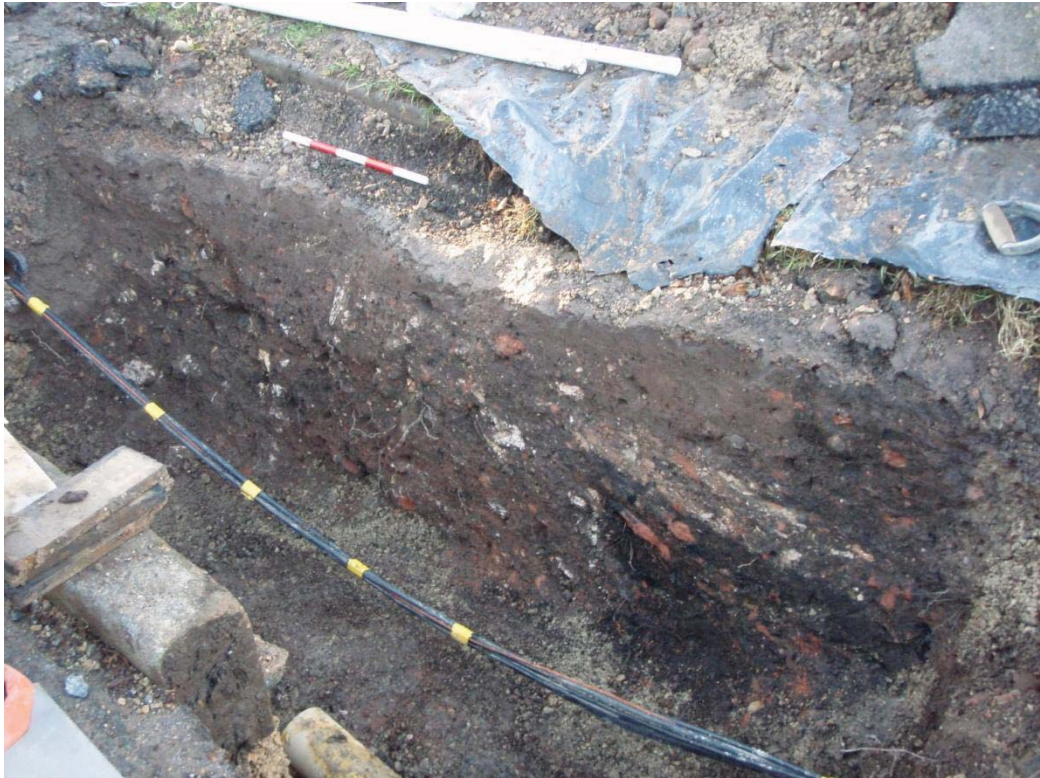
*Plate 30 Predominantly soft deposits within Trench 78, Looking S. Note the presence of what may be a pit-like feature to the right.*
