**NEW WATER PIPELINE, NORTON BACON FACTORY
NEAR MALTON, NORTH YORKSHIRE**

**GEOPHYSICAL SURVEY AND
ARCHAEOLOGICAL MONITORING**

**prepared for
LAING O'ROURKE
on behalf of
YORKSHIRE WATER SERVICES LTD**

NAA 06/123

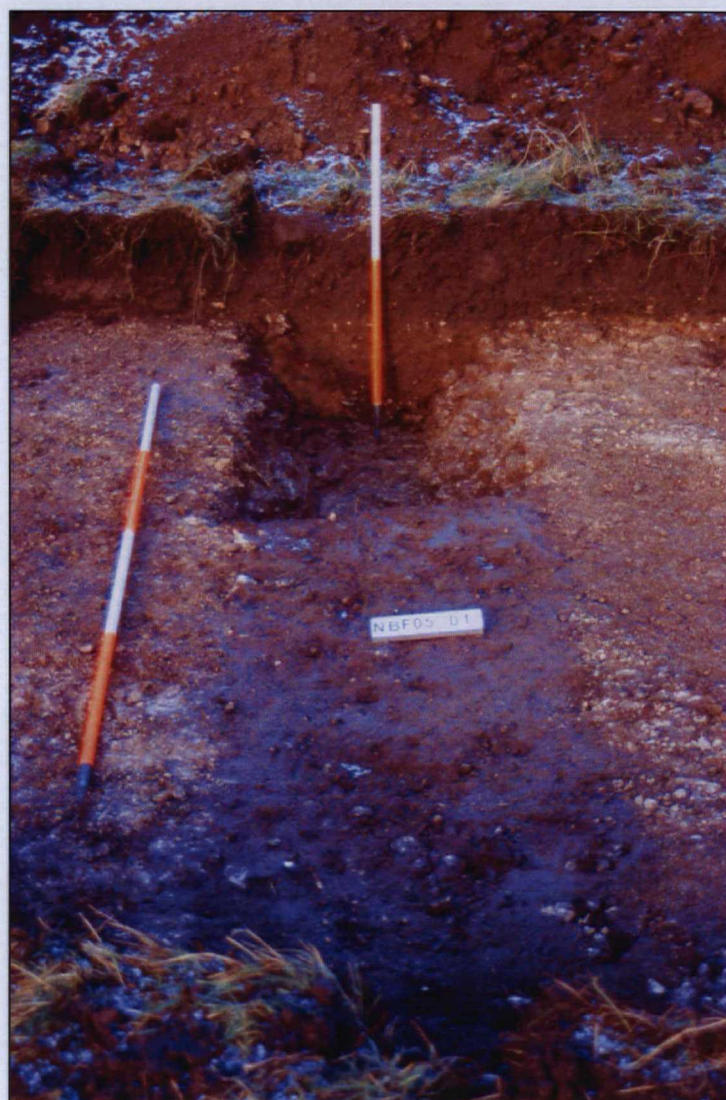
Plate 2 Norton Bacon Factory: rock-cut ditch (01)

- 6.4 At the southern end of field 1 the limestone bedrock was cut by a ditch (01) on an east to west alignment, running along the crest of the ridge (Figure 4). Ditch 01 was 0.82m wide and 0.47m deep (Plate 2). Downslope and 5m to the north of the ditch was a gully (02), 0.67m wide and 0.13m deep and cut into layer 12. The two features were filled with a mid-brown sandy soil (06) which contained no artefacts. No date could be attributed to these features.

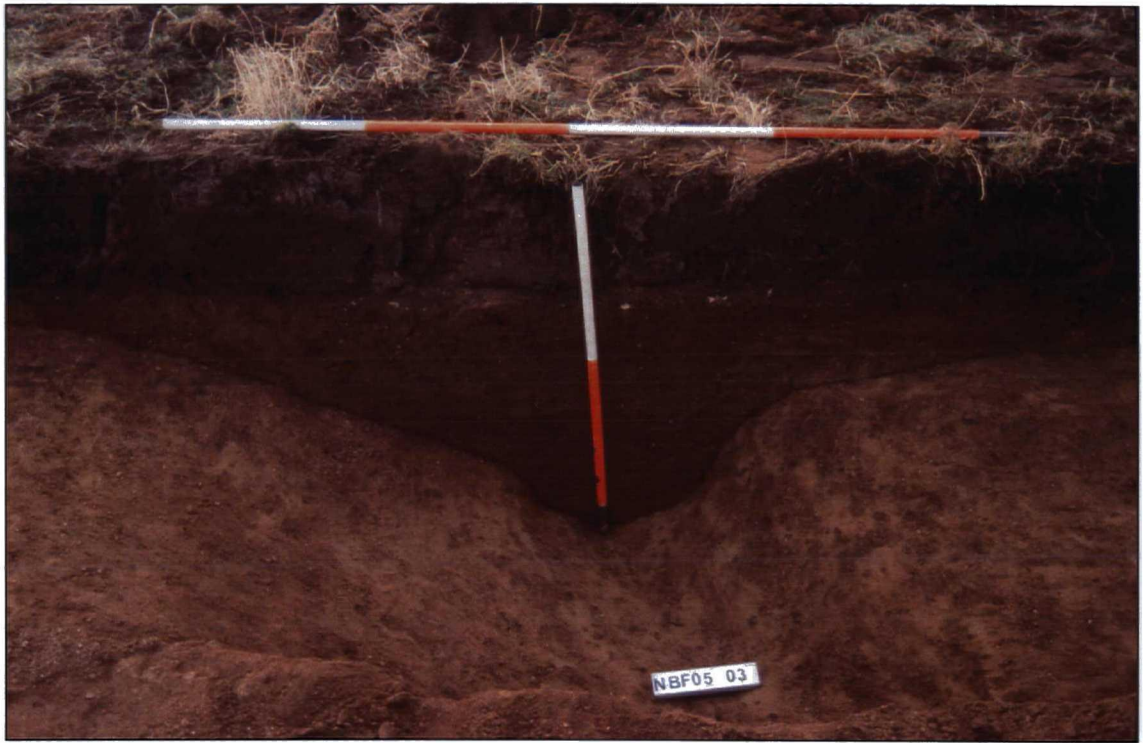
Plate 3 Norton Bacon Factory: Romano-British ditch (03)

- 6.5 Approximately 70m downslope from ditch 01 was a second ditch (03), aligned north-east to south-west and up to 3.8m wide and 0.68m deep with shallow-sloping sides and a rounded base (Plate 3; Figure 4). The brown clay lower fill (09) contained Romano-British pottery including calcite-gritted ware dating from the 2nd- to 4th-centuries, and pre-mid 3rd-century greyware. The upper fill (13) was virtually indistinguishable from subsoil 11 although this also contained calcite-gritted Romano-British pottery.

- 7.3 Topsoil stripping along the line of the new water main within field 1 revealed a number of archaeological features. The only feature which might reasonably be dated was a large ditch running approximately east to west at the foot of the slope of Howe Hill. The ditch was relatively shallow-sided, suggesting that it had not served any defensive purpose. The two layers of ditch fill yielded Romano-British pottery, while Roman coins and other metal artefacts were recovered from the adjacent topsoil and spoil heaps using a metal detector. Along the crest of the ridge continuing eastwards from Howe Hill were a ditch and gully running approximately

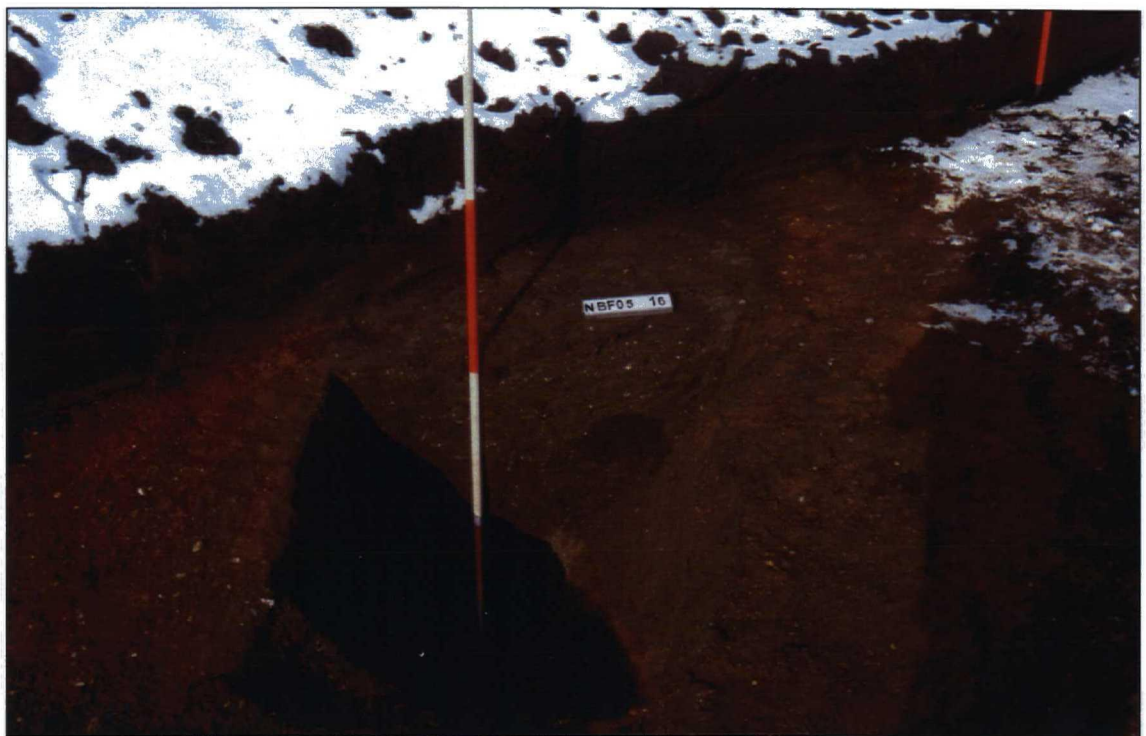
Plate 4 Norton Bacon Factory: former parish boundary ditch (16)

- 6.10 The largest ditch (16) was aligned north-west to south-east and corresponded with a former parish boundary (Site h) indicated on historic mapping (Robinson 1978, 39). Ditch 16 was up to 1.18m wide with a depth of 1.05m (Plate 4). This was filled with mixed, yellowish-brown clay sand (18) contained fragments of clay 'horse shoe' field drain. To the north of ditch 16 a second, smaller, ditch (19) was aligned north-east to south-west and corresponded with a surviving length of hedgerow to the north-east. This probably represented a removed section of the field boundary. Ditch 19 was 1.35m wide and 0.40m deep.

- 7.7 To the north of Beverley Road topsoil stripping exposed a ditch associated with the parish boundary and a second ditch marking the line of a now-removed field boundary. Topsoil stripping also exposed two separate field drainage systems constructed of 'horse-shoe' and cylindrical clay land-drains respectively.
