## LINTON TO KILNSEY WITH CONISTONE WATER PIPELINE

### ARCHAEOLOGICAL MONITORING

NAA 97/19

April 1997

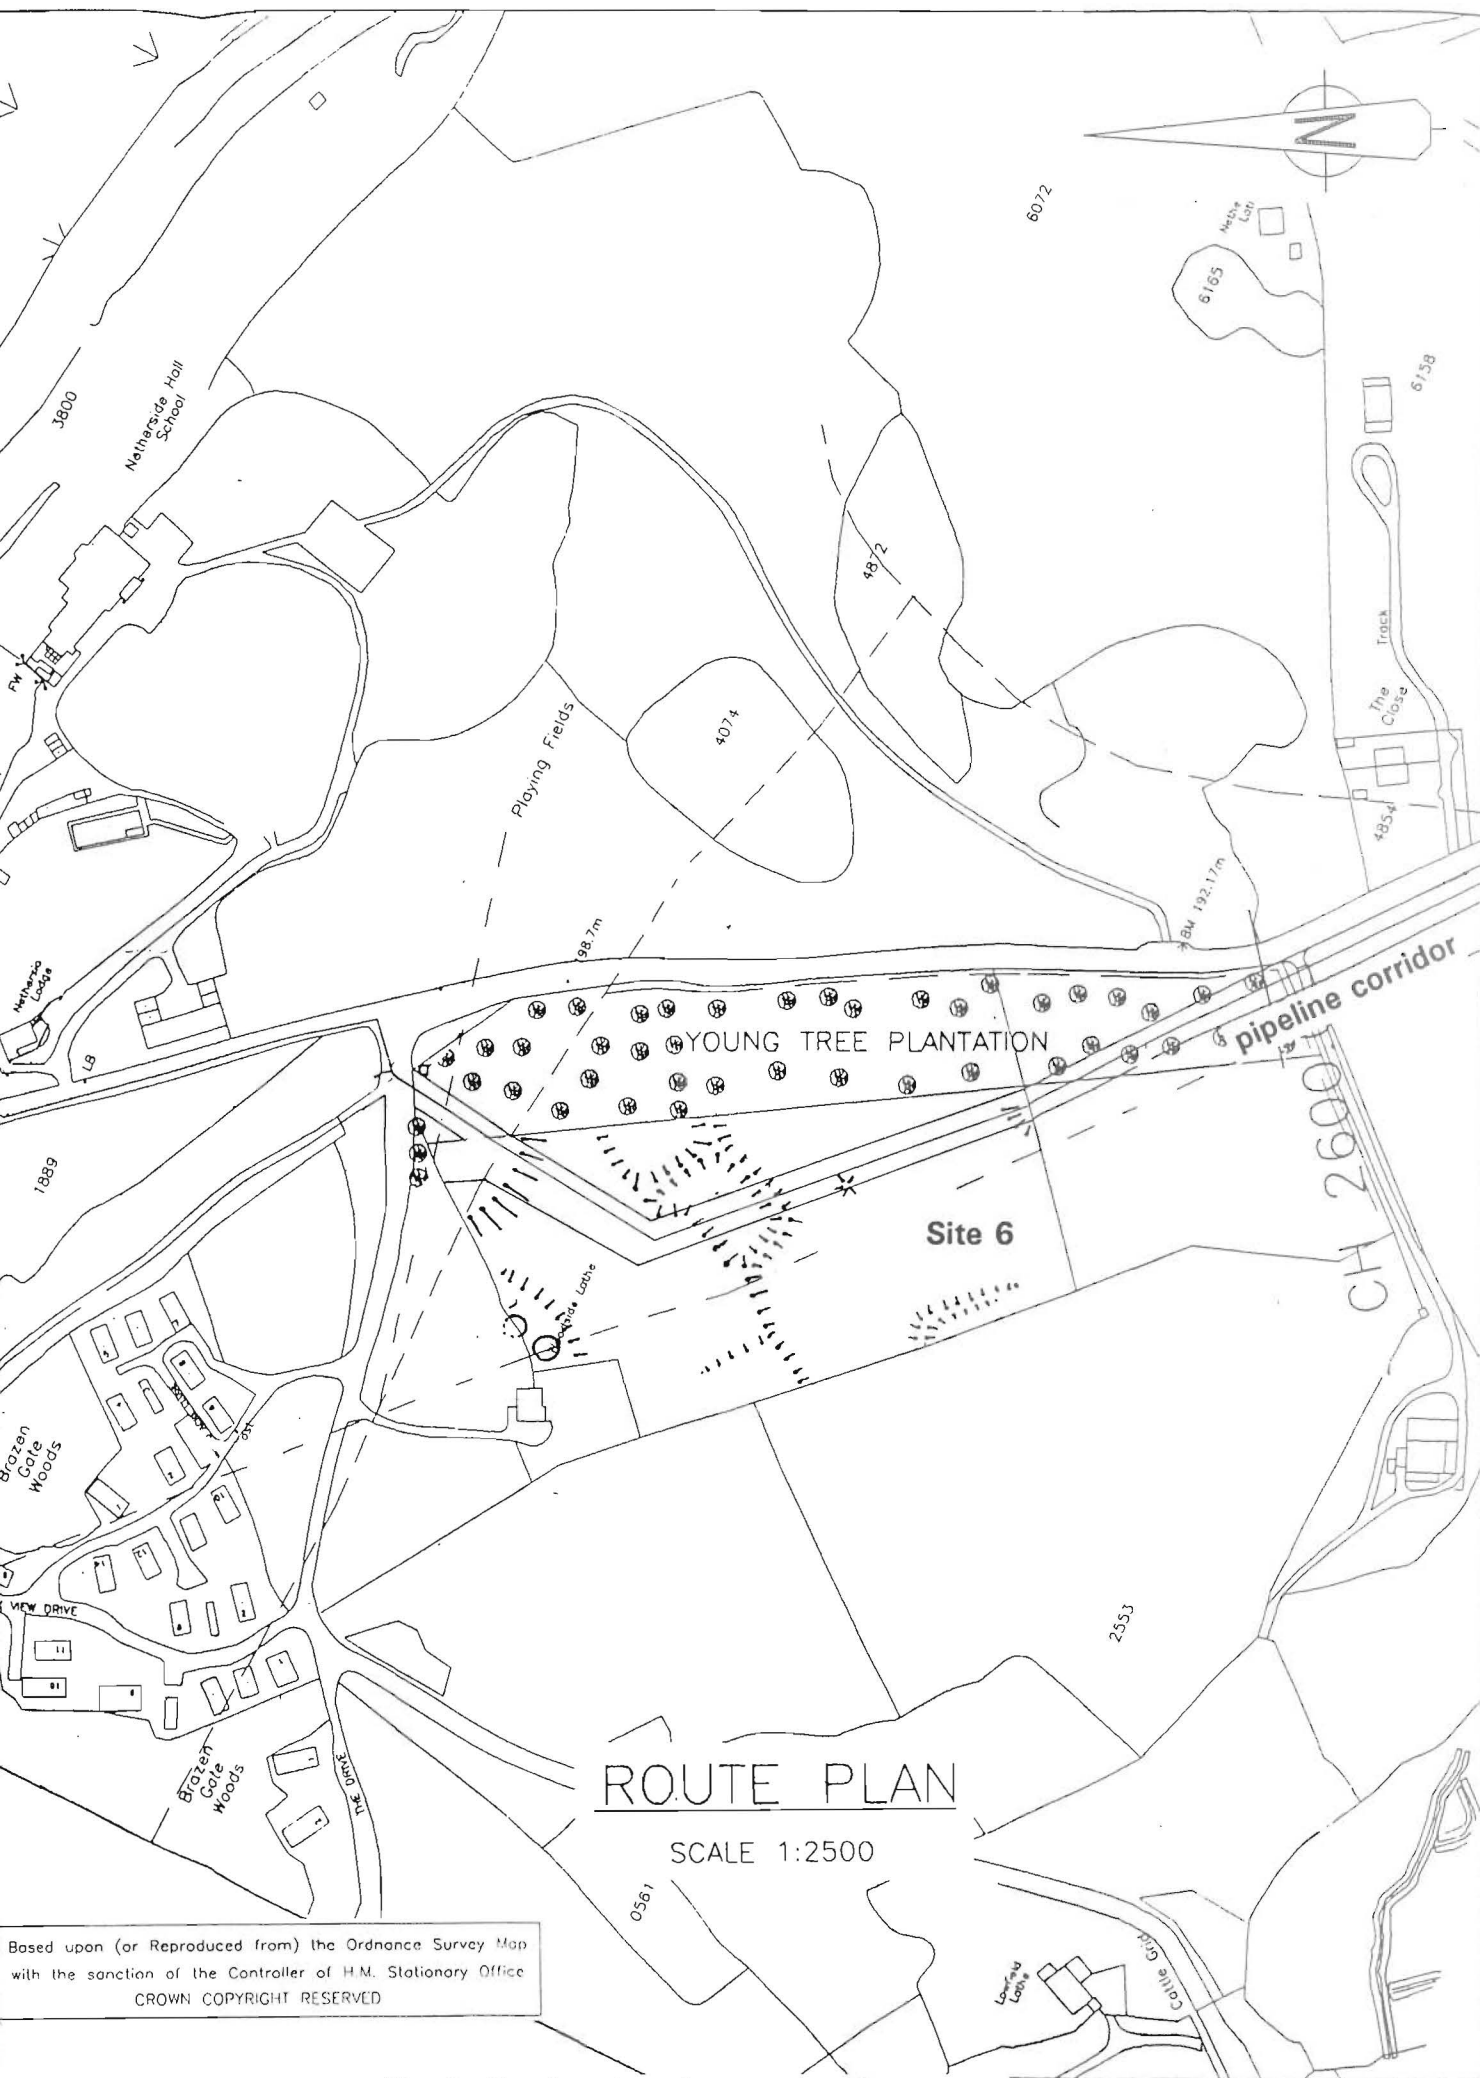
Fig. 2 Site 6 earthwork survey location

A group of earthworks comprising several rectilinear enclosures, probable hut circles, a cairn and wall lines was visible in a pasture field to the west of a young plantation and east of Long Ashes Caravan Park. At the north-east corner of the site a prominent limestone outcrop formed a raised terrace, the upper lip of which was surmounted by a low linear earthwork ('A'). This ran from the northern field wall around the curve of the terrace and then north-eastwards across the northern end of the roadside plantation to the B6160. On the other side of the road its line could be observed extending north-eastwards in a line across the football pitches.

In the north-western corner of the field, a field barn converted into a house (Woodside Lathe), stands within a walled garden upon another terrace of probable natural origin. On the north-eastern part of the terrace, outside the garden, were two low circular earthworks and possibly part of a third (earthworks H). One of the rings was bisected by the north-western field boundary and clearly predated the modern field layout, already in place by 1848 (1st Edition 6" OS map, 1853).

To the south of Woodside Lathe, a raised terrace ('F') was located below the south-western field boundary. From its eastern corner a slight bank or terrace ('B') ran north-eastwards to form the north-western side of a line of small embanked enclosures extending from near the centre of the field north-eastwards. One full enclosure, the south-eastern side of which was formed by bank 'C', lay within the field, with part of another to the north-east which continued into the roadside plantation, where part of a third was also observed.

Near the southern end of the field were the north-eastern and part of the north-western sides of a large embanked enclosure ('G') which could be observed continuing as a badly plough-degraded, but still substantial, earthwork in the field to the west.

An isolated small low mound ('D') was identified on the lower level ground near the centre of the field. A probable small quarry hollow ('E') was located at the south-eastern corner of the field, extending into the plantation to the north-east but not observed to the south-east of the field wall, probably as a result of deliberate infilling (the field to the south-east having clearly been extensively improved).

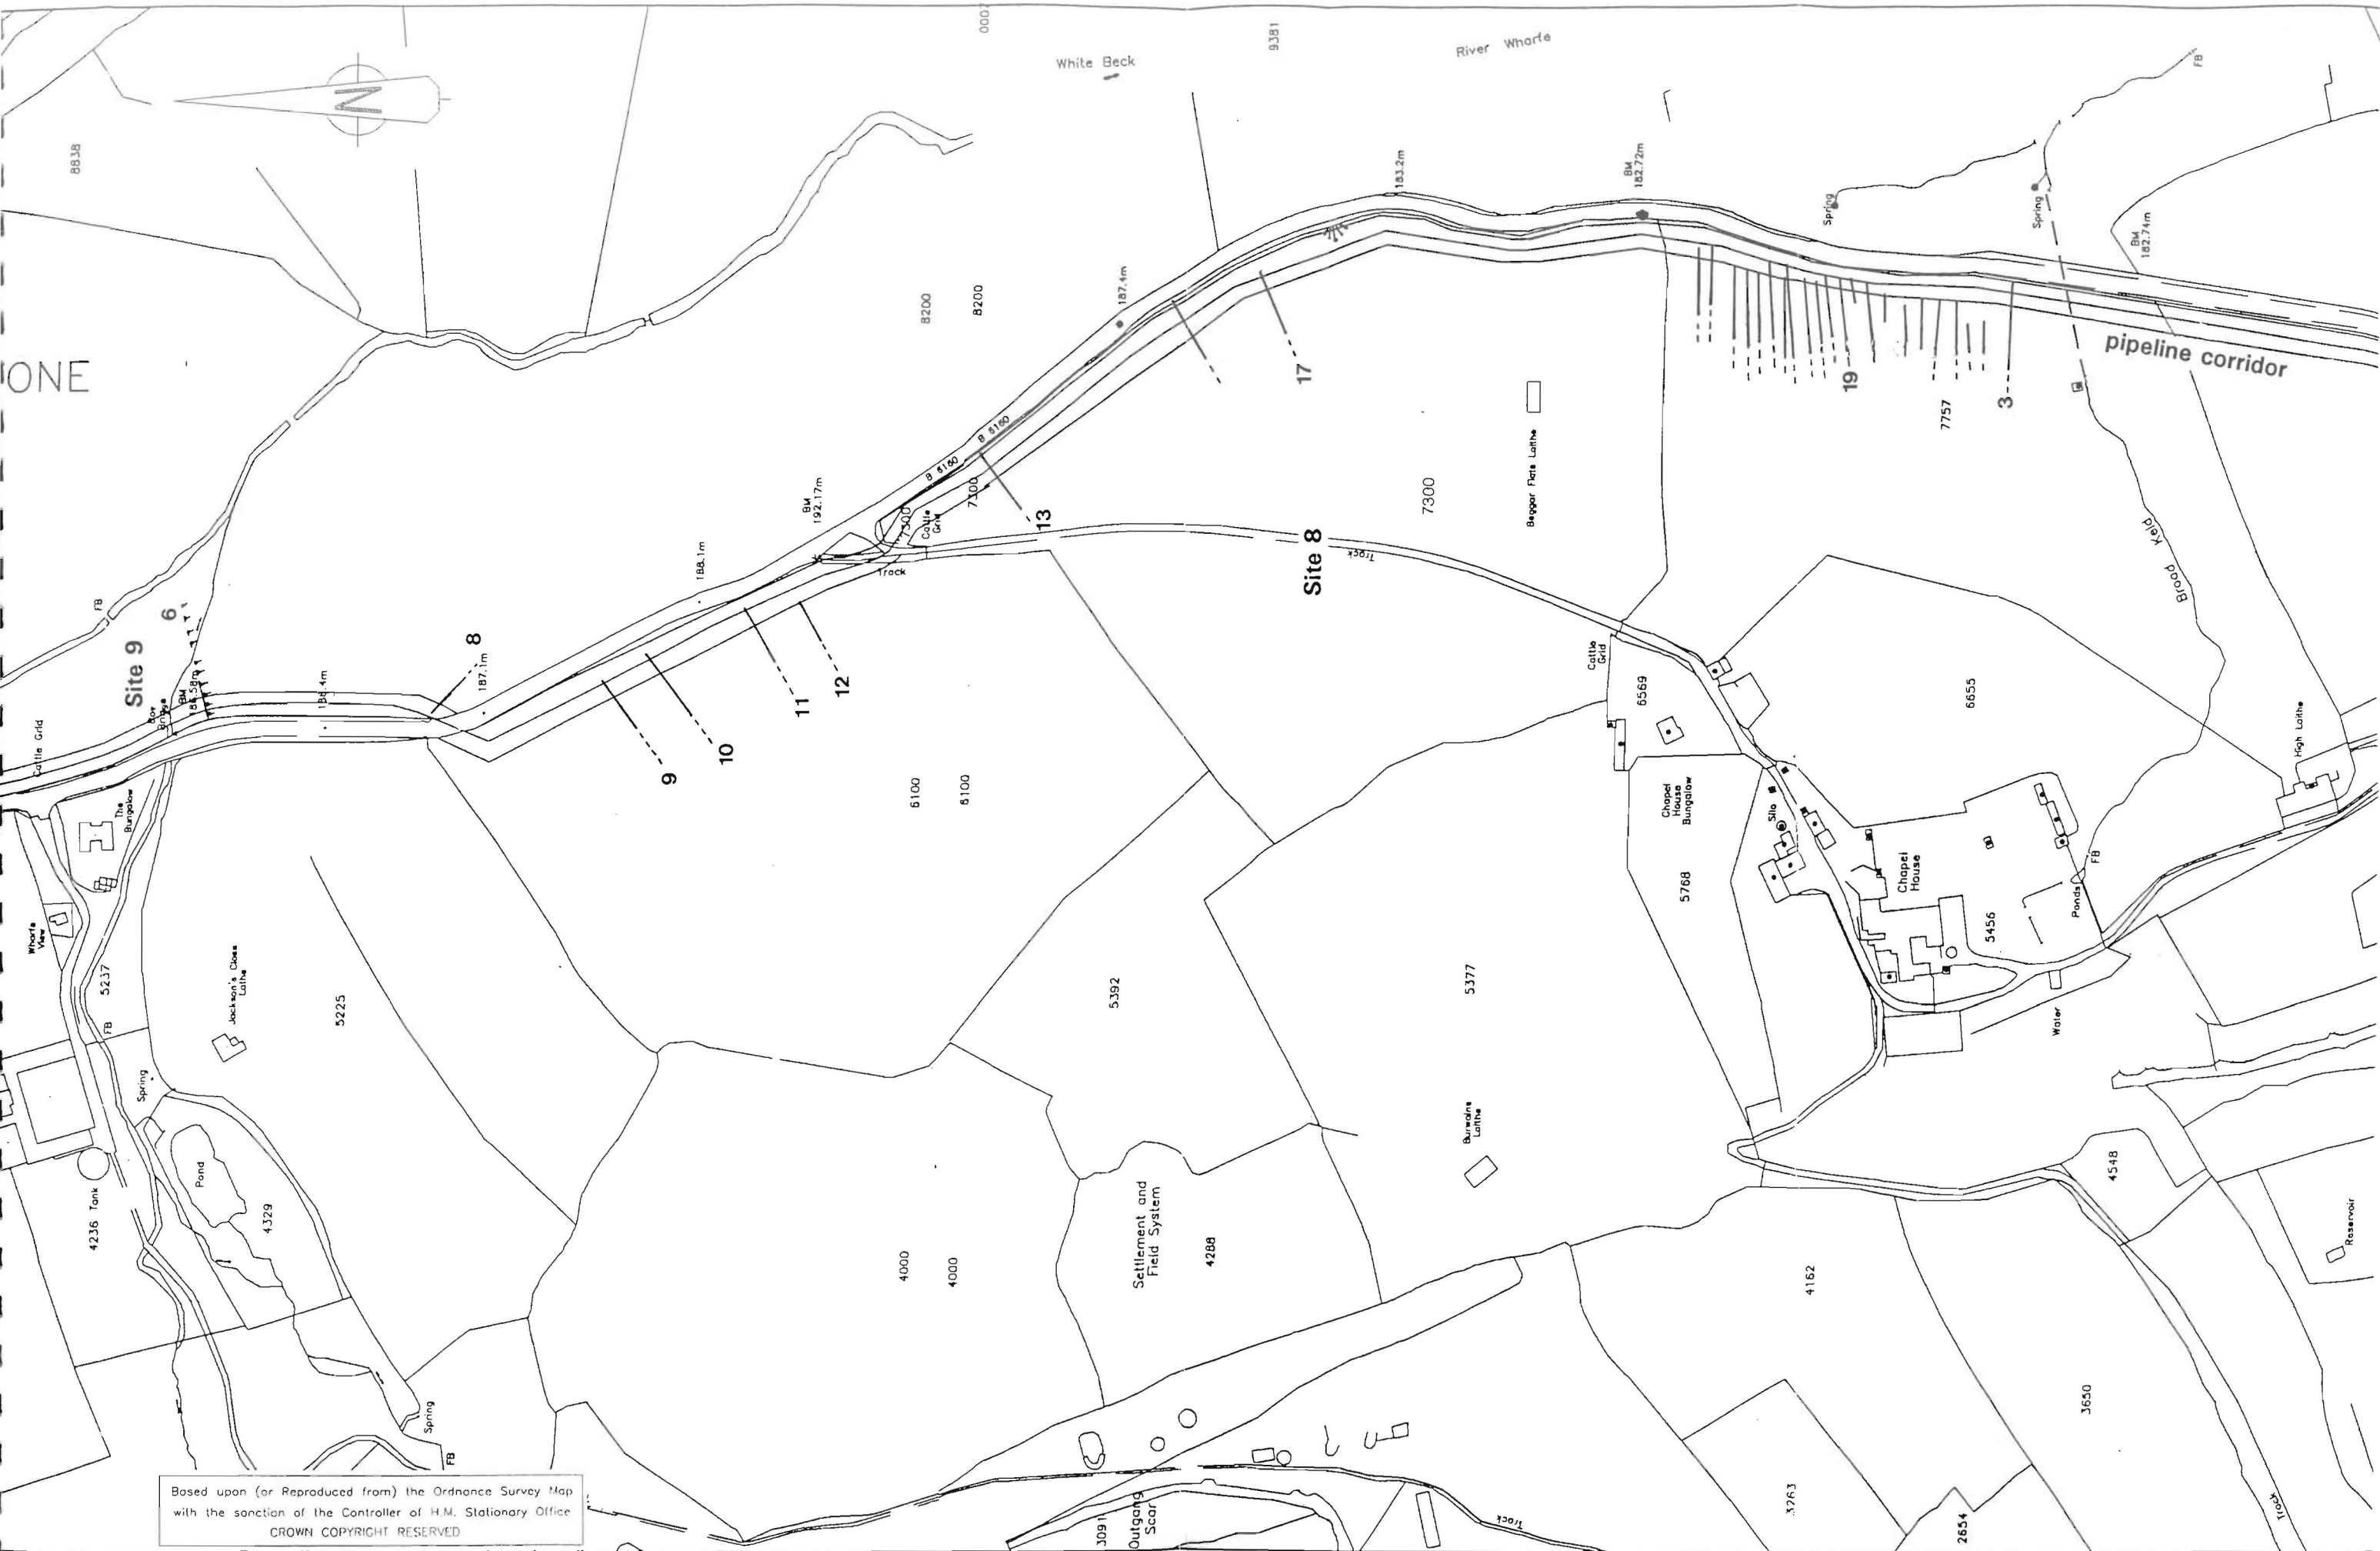
Fig. 3 Sites 8 & 9 feature locations

In OS Field 7757 no earthworks were noted to the south of the Broad Keld stream (culverted at its eastern end in the area of the survey). To the north of the stream a series of parallel undulations were present orientated roughly east to west and probably representing the remnant of ridge and furrow agriculture corresponding to the aerial photographic record. Several slightly more substantial, and possibly infilled, ditches were observed extending to the west up the hillside across the field.

To the north, in OS Field 7300 a possible quarry hollow was recorded against the eastern field boundary. This was subsequently avoided by the stripped pipeline corridor. Further north, three widely separated, small linear earthworks were recorded crossing the corridor aligned roughly from east to west. The northern feature had several large stones projecting through the turf to the west of the pipeline corridor. No evidence for ridge and furrow agriculture recorded from aerial photographs could be identified on the ground.

In OS Field 6100 four small parallel linear banks crossed the pipeline corridor running from south-west to north-east roughly at right angles to the north-eastern field boundary. One bank had a slight possible ditch at its southern side. No evidence was visible on the surface for the more extensive ridge and furrow agriculture recorded from aerial photographs.

Site 8 consisted of OS Fields 7757, 7300 and 6100 on the western side of the B6160 to the north of Chapel House Lodge. Slight earthworks, probably relating to ridge and furrow agriculture and former field systems, had previously been detected in these fields from aerial photographs. A survey of those earthworks visible on the ground in the immediate vicinity of the pipeline corridor was undertaken prior to topsoil stripping (see section 5.2), and topsoil stripping was continuously monitored. Intermittent monitoring of the pipe trench excavation also took place.

Site 9, was situated within OS Field 8200 to the east of the B6160 immediately south of Middle Bridge. The area was identified as being in the vicinity of a postulated roadway leading to a medieval bridged crossing of the River Wharfe. In addition, a prominent gravel knoll adjacent to the B6160 overlooking the river and flood plain was considered to be of potential significance, with particular respect to Mesolithic occupation. A watching brief was therefore conducted throughout topsoil stripping in this part of the corridor.

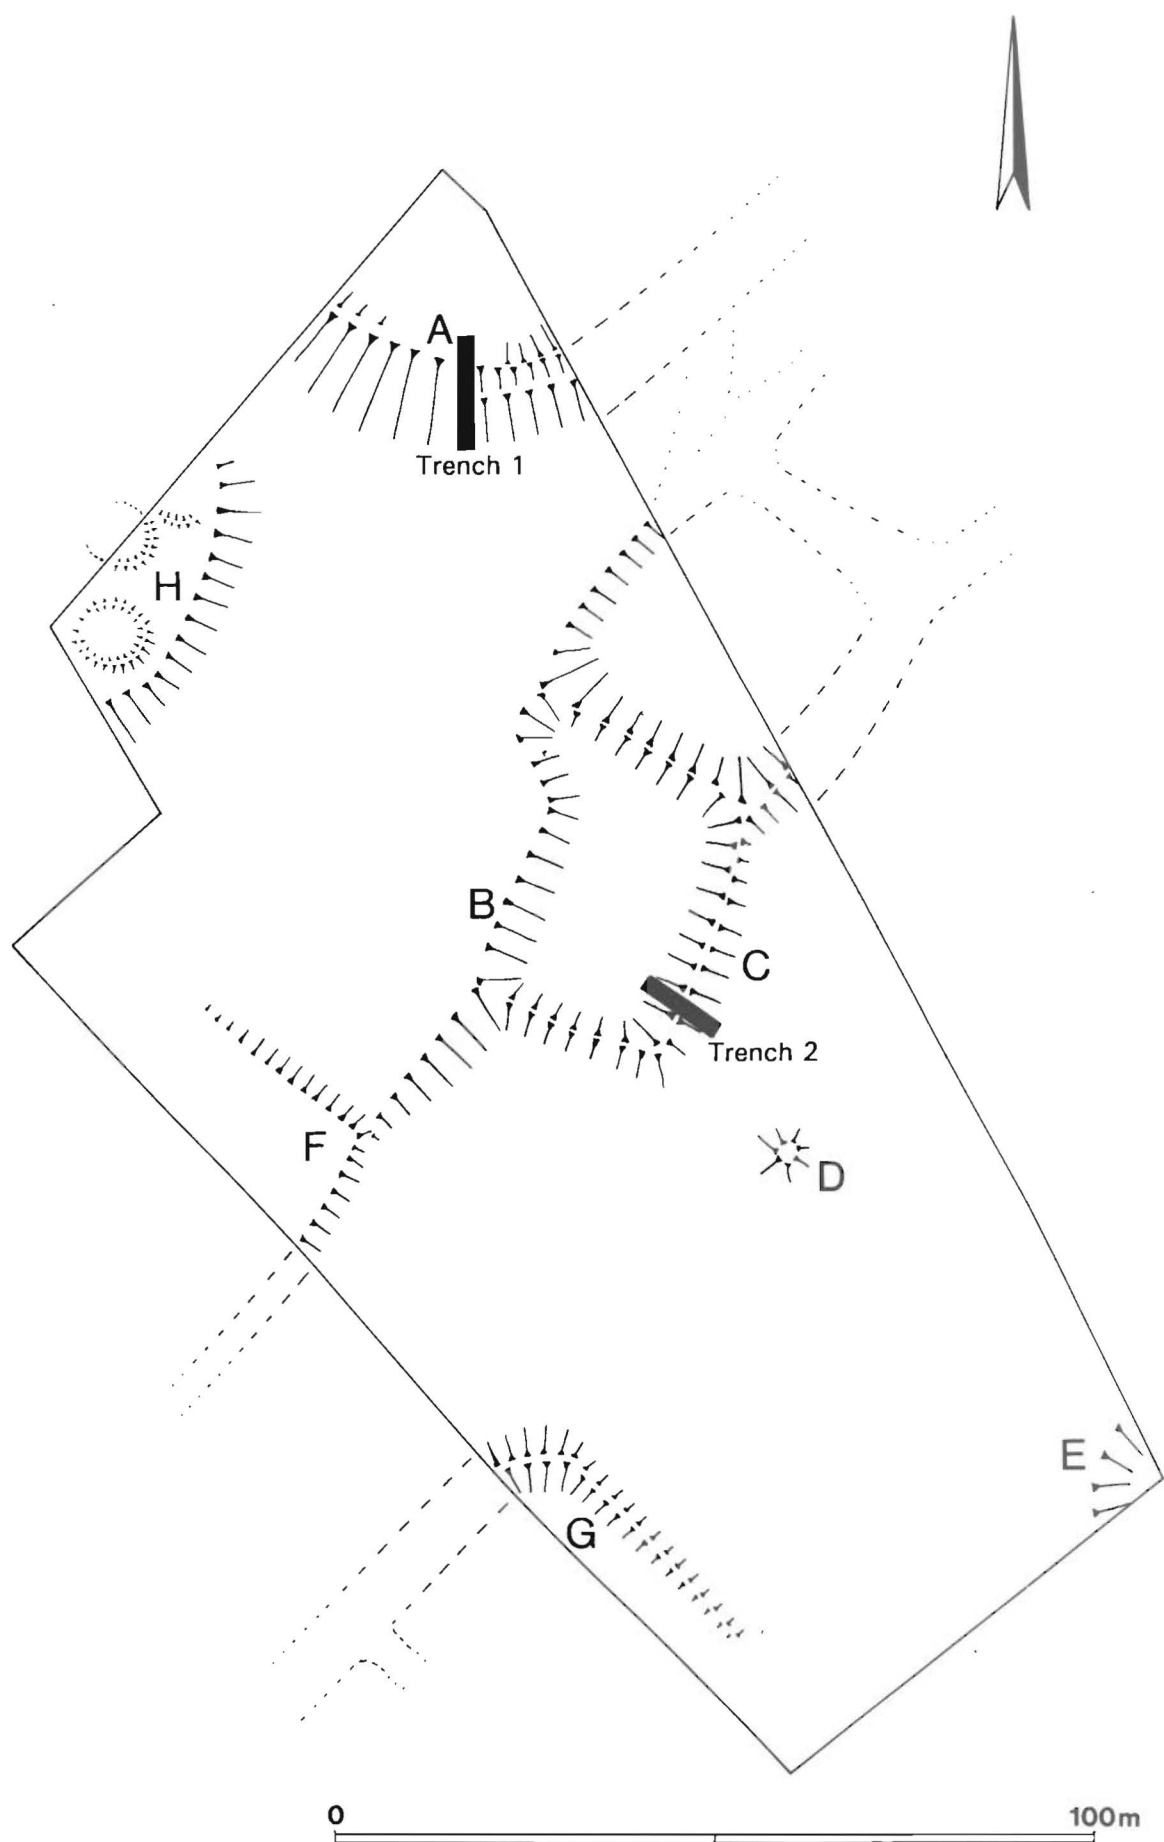
Fig. 4 Site 6 feature and trench locations

Six trenches were machine and hand excavated in advance of topsoil stripping in order to examine several of the earthworks; the topsoil stripping was continuously monitored with scanning of the spoil heaps for finds, and parts of the pipe-trench cutting were monitored.

Trench 1, measuring 22m long by 2m wide and orientated north to south, was excavated by machine across the top of the northern terrace, across earthwork A and down the south-facing slope of the terrace (Fig. 5, Section 4). The terrace was shown to be an outcrop of greyish white limestone with an apparently naturally weathered surface. Earthwork bank 'A' running around the upper margin of the terrace was shown to be a tumbled bank [32] of weathered limestone blocks measuring up to 0.25m. It was 1.25m wide and up to 0.45m high, and stood on the limestone bedrock. It was covered by 0.15m of topsoil, and up to 0.25m of subsoil or colluvium had collected against its upslope side. Immediately downslope of this feature to the south was a parallel drystone wall footing [31], 1.6m wide and formed of two faces of limestone blocks measuring up to 0.4m with a smaller rubble infill. It survived to a height of 0.5m, constructed on the bedrock, with some tumbled stones running downhill to the south. No stratigraphic relationship between the walls survived and no dating evidence was recovered.

Trench 2, measuring 15.5m by 1.5m, was positioned to cross earthwork 'C' from northwest to southeast. The earthwork consisted of a bank of limestone rubble [34] 2.1m wide and 0.3m high, and stood upon degraded limestone bedrock (Fig. 5, Section 5). It was almost entirely buried by a 0.2m thick deposit of probably colluviated reddish brown subsoil and 0.15m of topsoil. A solution hollow cutting into the top of the bedrock was also recorded.

Trench 3, measuring 7m by 1m, was machine excavated southwards from the centre of small earthwork mound 'D'. This showed that the mound incorporated a stone cairn sealed by a soil deposit. Three further small trenches, 4, 5 and 6, were hand excavated in order to further define the form and nature of this feature (Fig. 5, Plan 1).

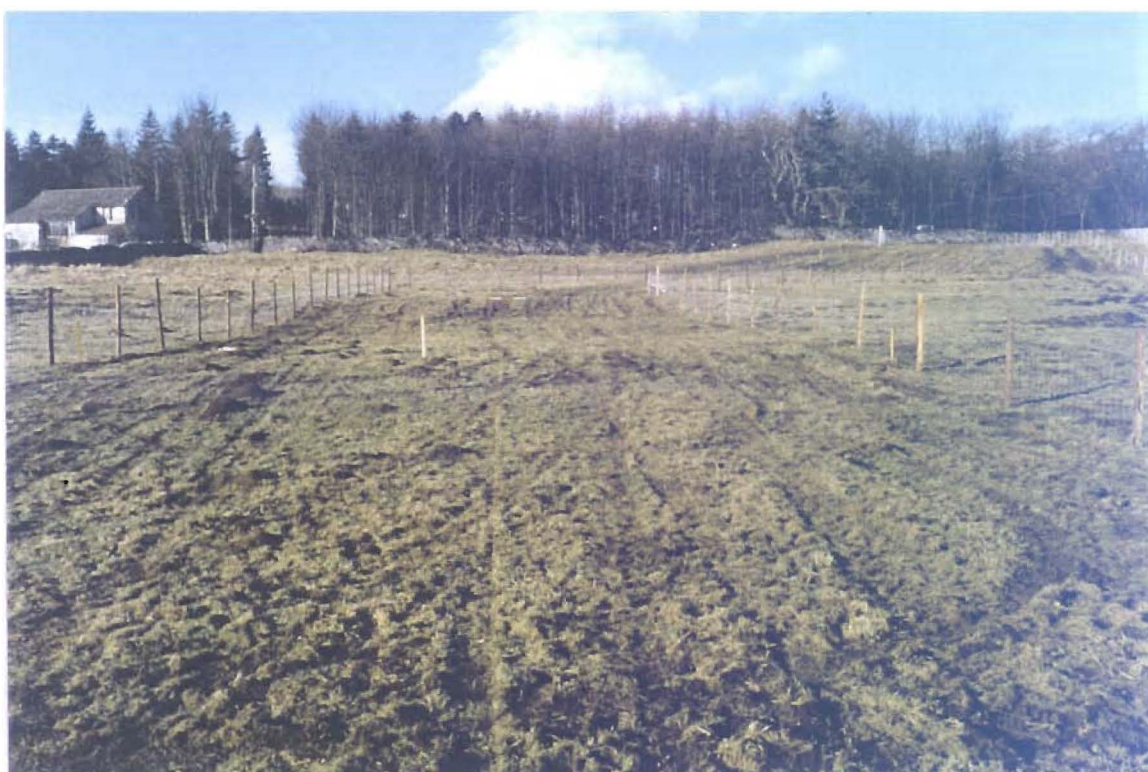
Plate 1: Enclosure earthworks at site 6. Platforms at the north-west and north-east corner of the field visible in the far distance

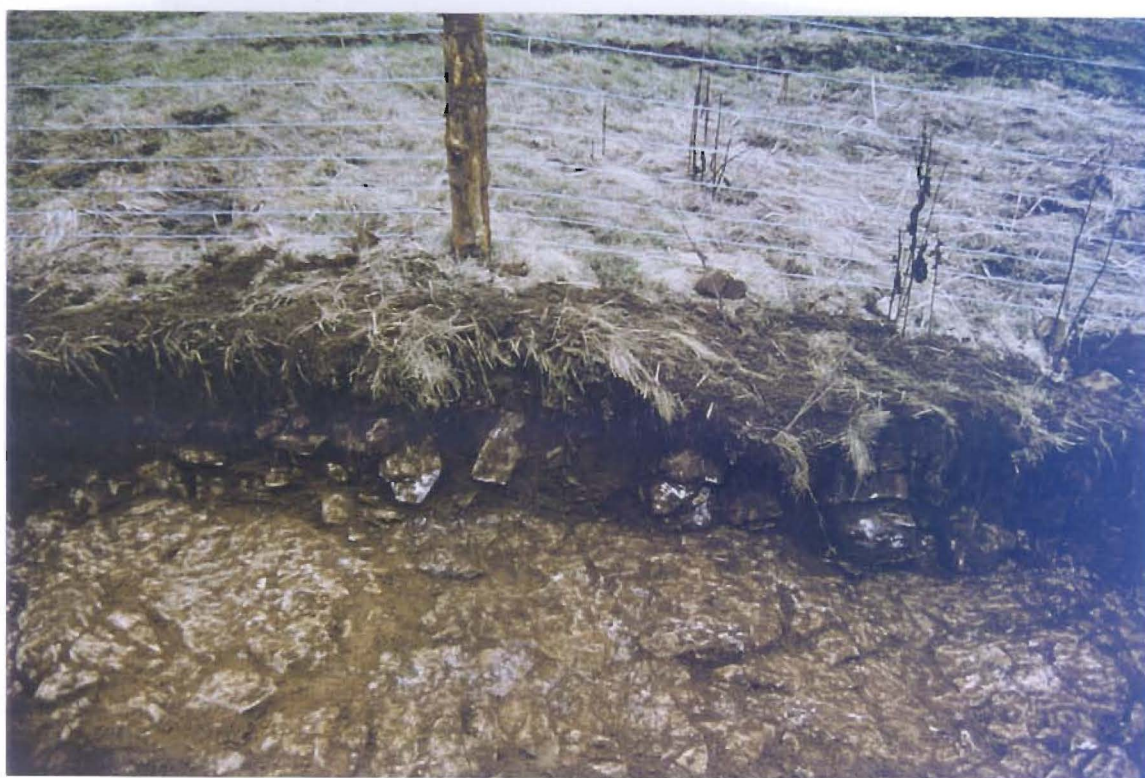
Plate 2: Section across Bank 'C' of the enclosure at site 6

Earthwork C consisted of a bank orientated northeast-southwest of limestone rubble measuring up to 0.2m. The feature was 2.1m wide and 0.3m high, and stood upon degraded limestone bedrock. It was almost entirely buried by a 0.2m thick deposit of probably colluviated reddish brown subsoil and 0.15m of topsoil.

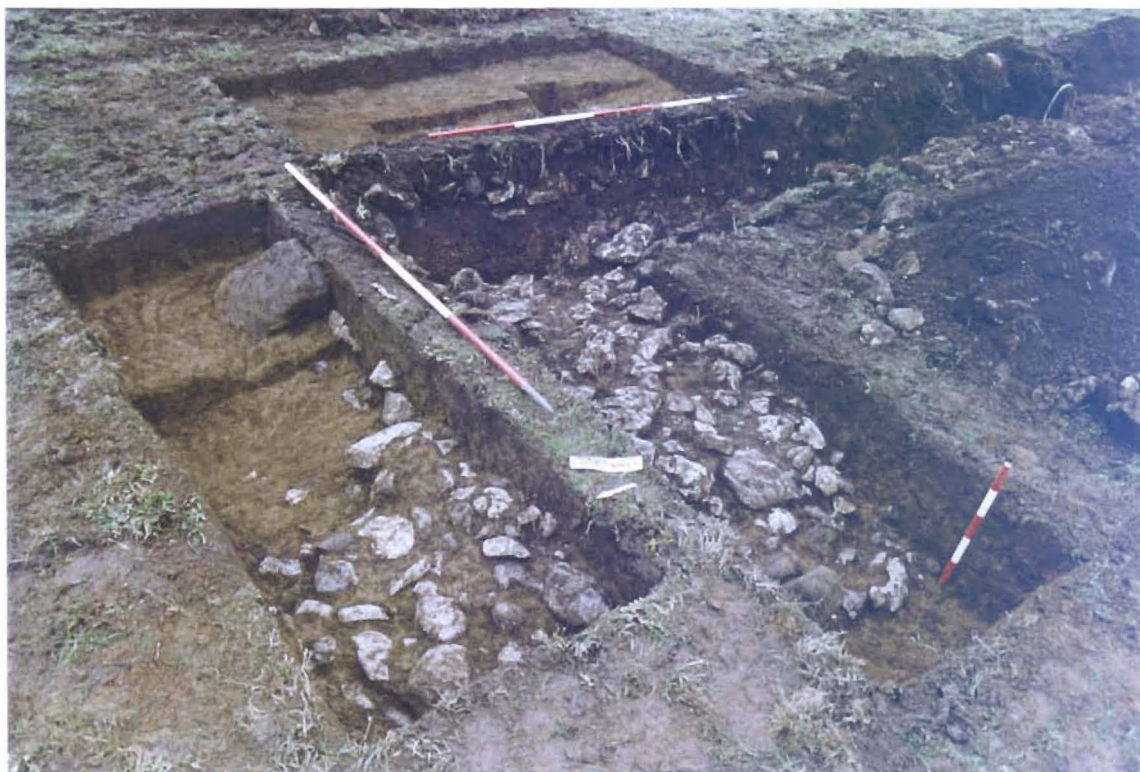
The cairn at D was likely to have been built as a result of field clearance rather than burial activity. It was buried by a significant depth of colluviated subsoil, which had apparently collected against its upslope (northern) side, resulting in the asymmetry of the mound. Its date was not ascertained but it was probably contemporary with the nearby enclosures.

Plate 3: The cairn at site 6

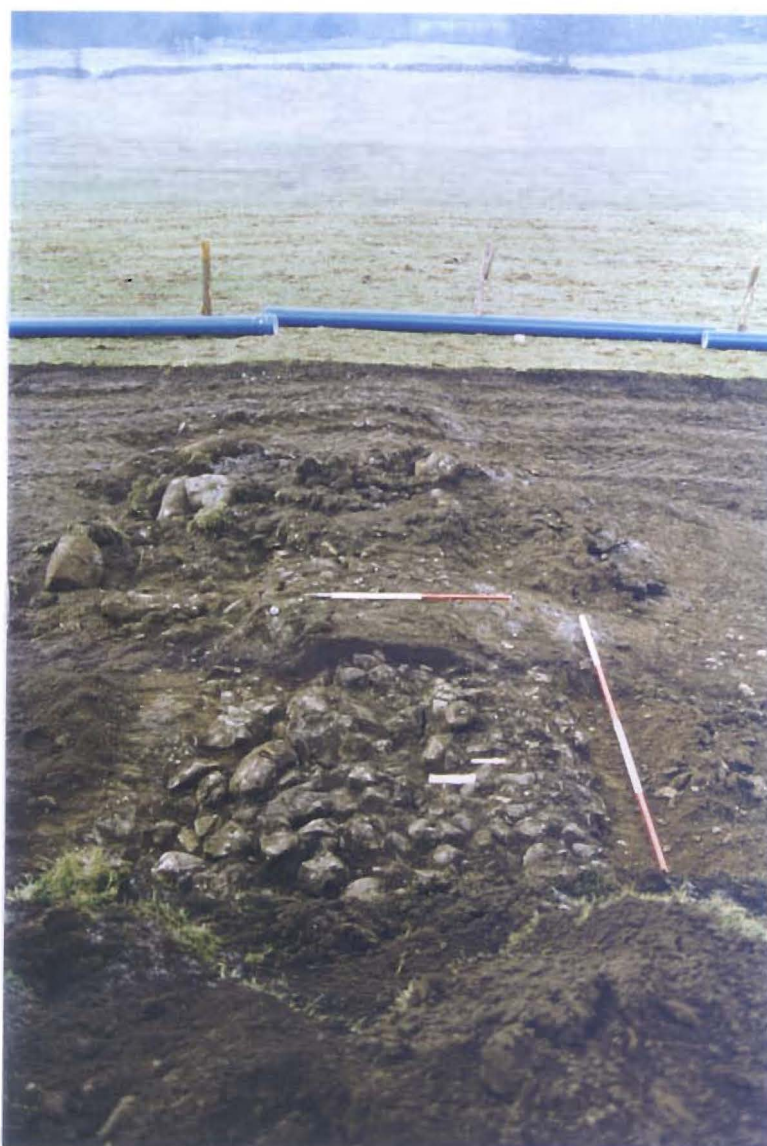
A stone wall footing [3] was recorded crossing the corridor 73m from the southern end of the field. It consisted of unshaped rounded limestone boulders and cobbles, measuring up to 0.5m, in a matrix of dark brown sandy silt. It was up to 2.0m wide and 0.3m high. Although rather machine-disturbed it appeared that the northern 1.0m of the stone spread consisted of two lines of larger facing stones with a smaller stone infill, forming the wall footing, with the southern 1.0m comprising more random stone tumble. The footing had been cut through a subsoil layer down to gravel. A quantity of animal bone fragments were recovered from over and between the stones, but no dating evidence was recovered. The feature was observed for a length of 9m crossing

Plate 4: Wall footing 03 at site 8

Observed before topsoil stripping as a slight earthwork aligned east-west and running right across the field. Within the stripped corridor it was 9m long, and where cleaned was 2.0m wide and 0.30m high. It consisted of unshaped limestone boulders and cobbles, both angular and rounded, measuring up to 0.50m, mostly 0.25m. A 1m segment was hand-excavated against the eastern edge of the stripped corridor, and showed that the feature, although very denuded and machine-disturbed, probably consisted of a wall footing, with two lines of facing stones and smaller rubble infill, forming the northern c.1m of the feature, with tumble to the south. No evidence survived for a construction cut, although the distribution of tumbled stones over the subsoil suggested that the footing had been cut through it. A quantity of animal bone fragments was recovered from between and immediately over the stones of this feature.

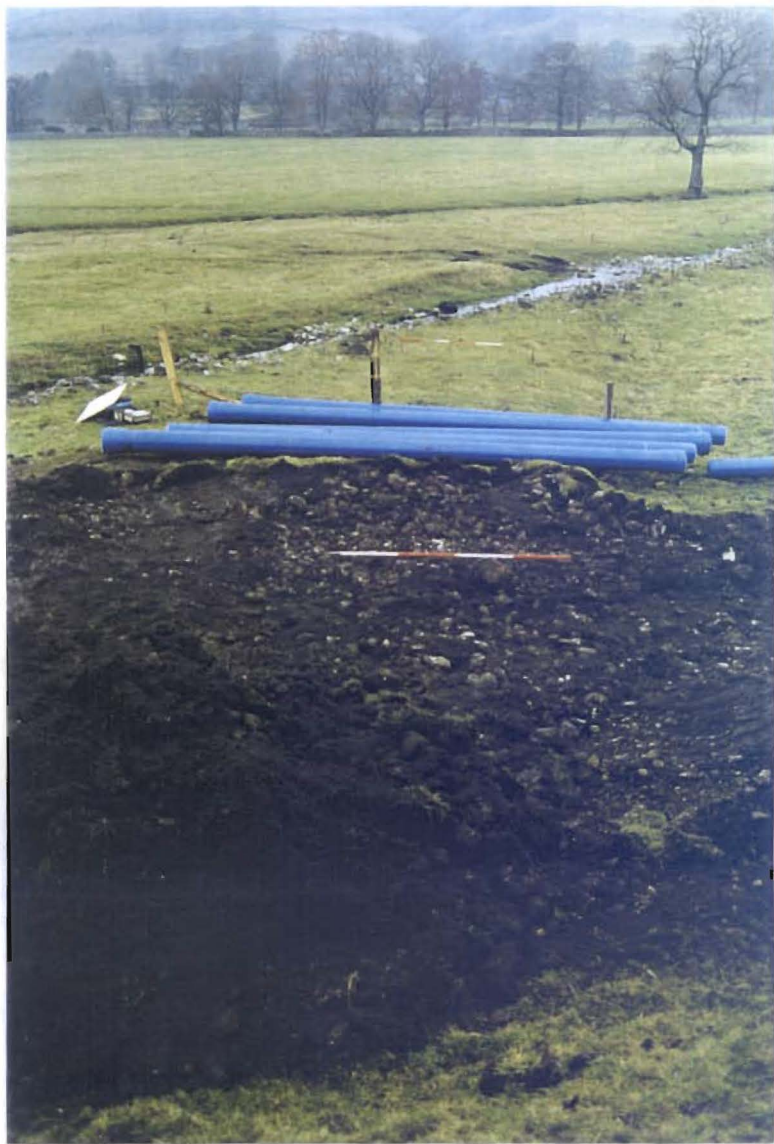
Immediately to the south of Bow Bridge, on the north-facing side of the gravel knoll, was a substantial cobble bank [6] up to c.10m wide and c.0.6m high. It ran downslope eastwards from the roadside wall levelling out slightly before being cut by the stream, beyond which the line was continued by a low embanked terrace to the western bank of the White Beck. The bank was formed of cobbles, generally measuring c.150mm, in a matrix of brown silty sand. A line of larger boulders measuring c.0.5m were dislodged from the southern edge of the bank during stripping.

Plate 5: 'Causeway' 06 at site 9

Located immediately to the south of Bow Bridge, on the north-facing side of the gravel knoll. 06 was a substantial cobble bank up to c.10m wide and where machine-damaged c.0.6m high. It sloped steeply down eastwards from the roadside wall, levelling out slightly before being cut by the stream, beyond which the line was continued by a low embanked terrace to the western bank of the White Beck. The bank was formed of cobbles, generally measuring c.150mm, in a matrix of brown silty sand. A line of larger boulders measuring c.0.5m were dislodged from the southern edge of the bank during stripping. At the western end of the bank, adjacent to the roadside wall and outside the stripped corridor, a line of four earthfast boulders [7] measuring up to 0.5m ran along the southern edge of the feature and possibly represented part of the same line of stones. The western stone was sealed beneath the roadside wall.

The stone bank which ran towards the stream at site 9 may have been a causeway and the possible kerbing [7] at its upper end was certainly a constructed feature. No dating evidence was associated with the feature but it remains possible that it formed part of an earlier route across the valley.
