**HARVEY AVENUE,
CODDINGTON,
NEWARK**

An Archaeological Watching Brief

*by
Leon Hunt
and Richard Sheppard*

OS Grid Ref. SK824547-824552
TPAT Project Code: HAC.1
File Name: HAC-report.doc
July 2003

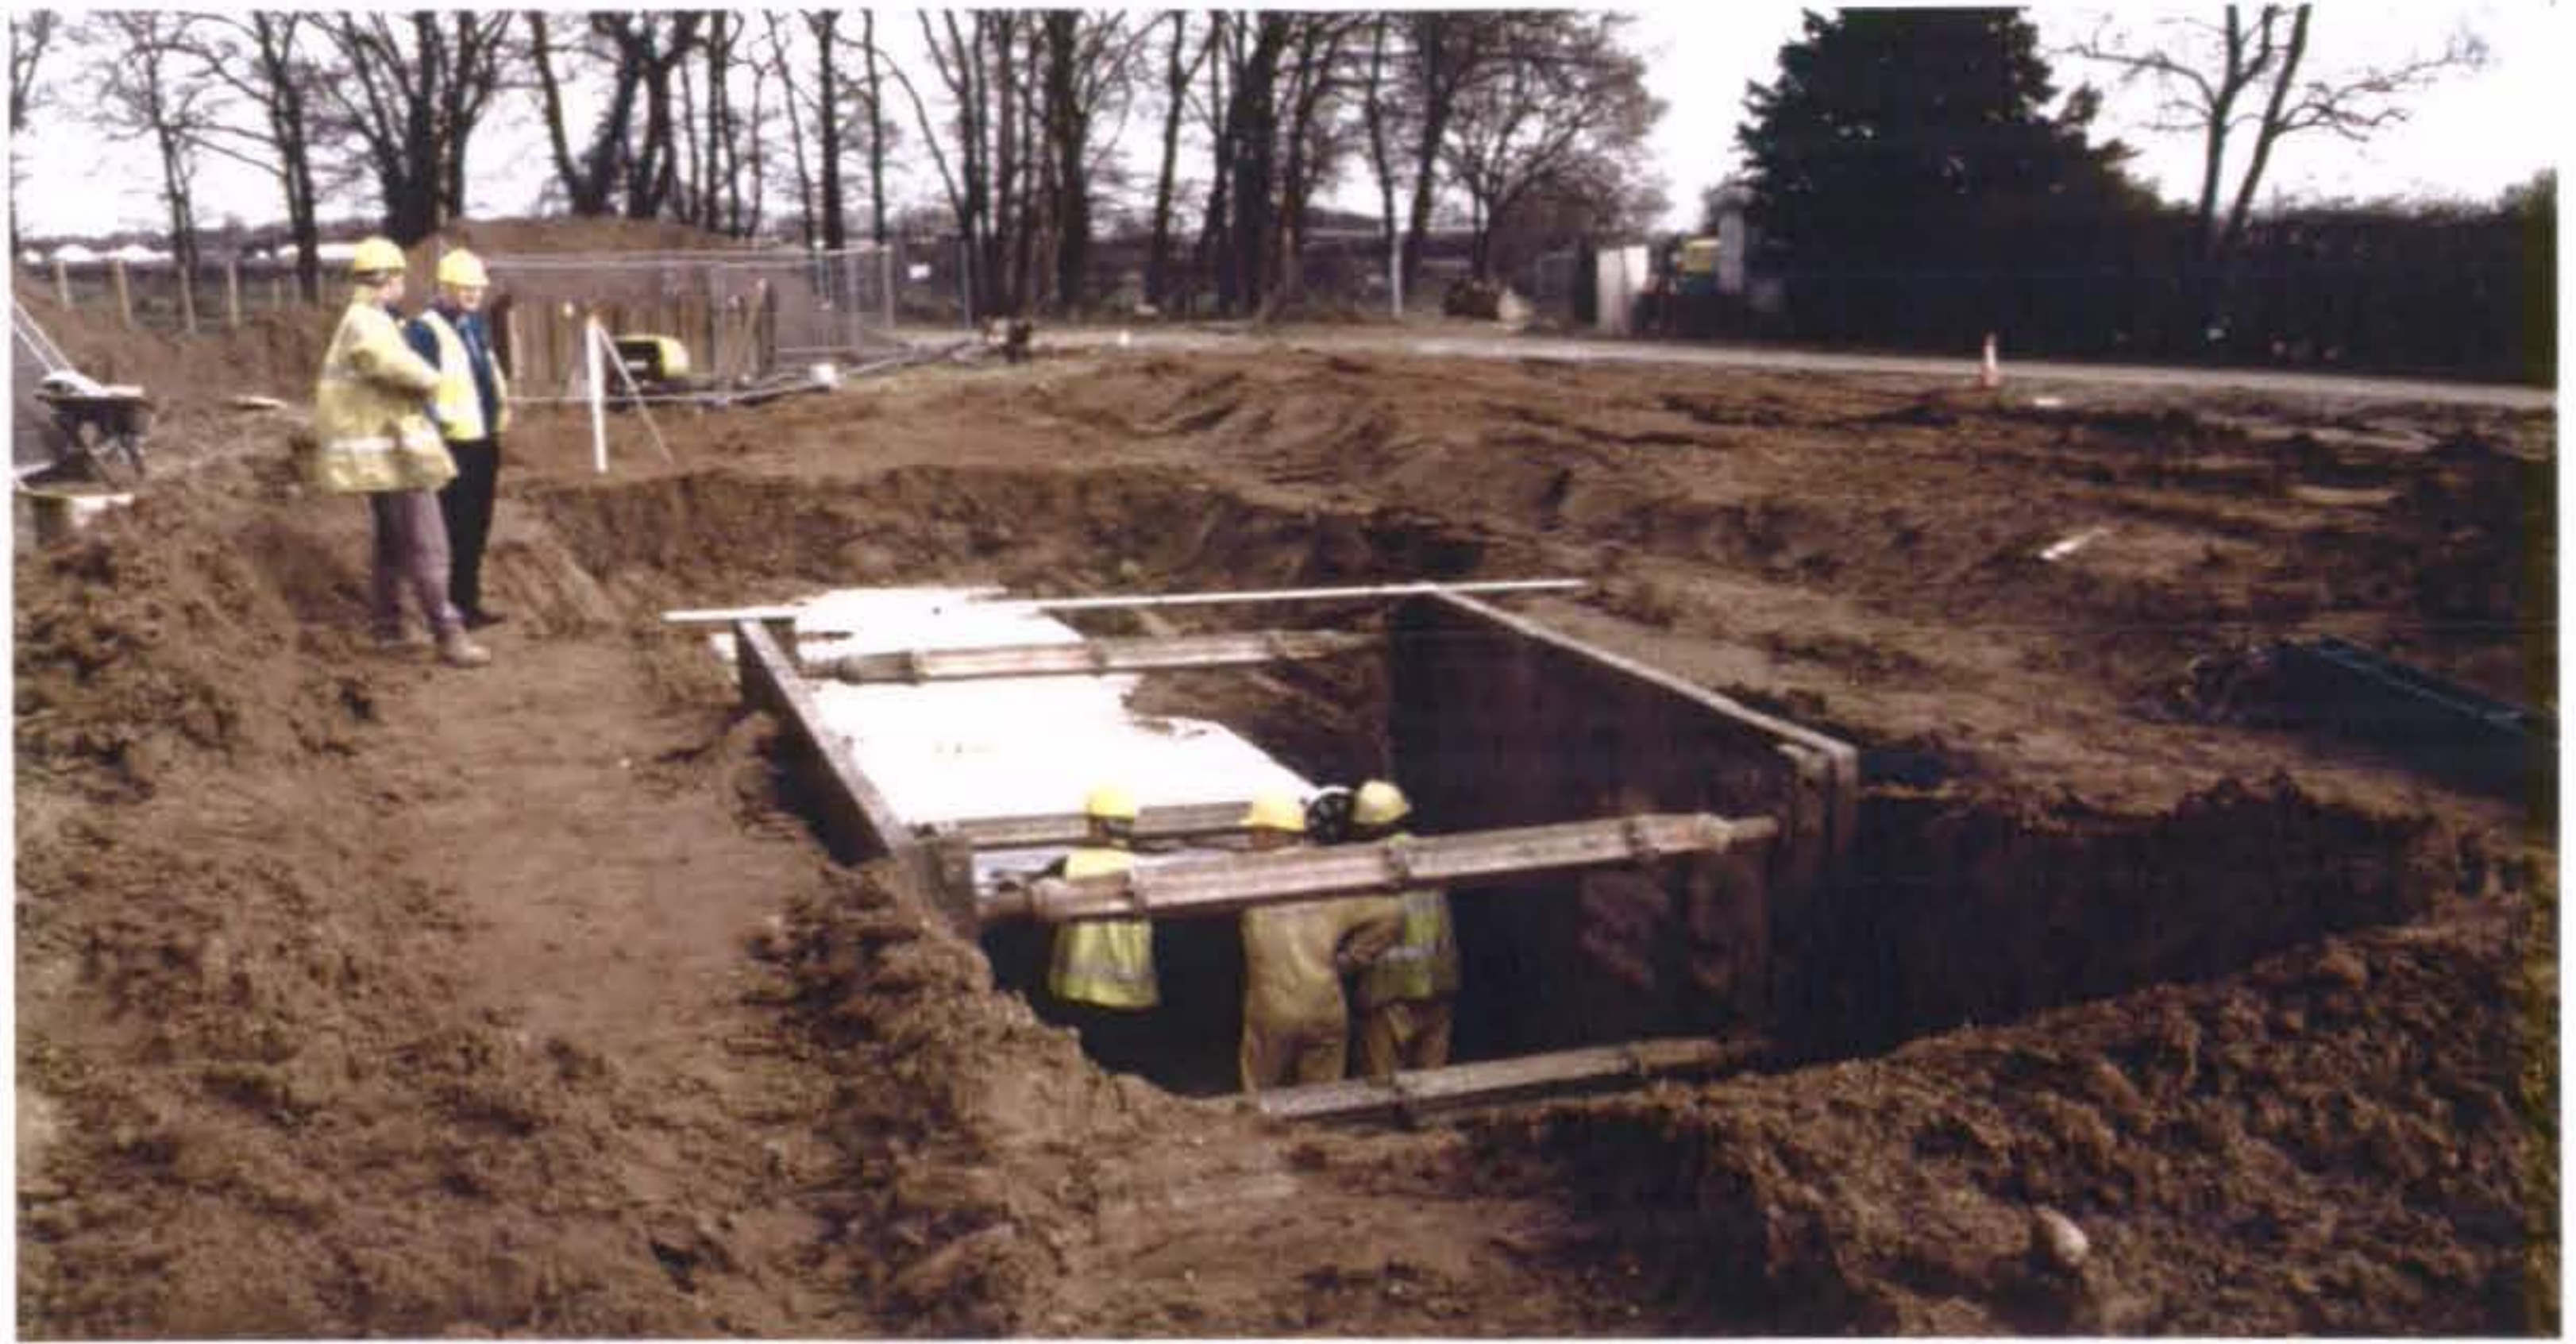
Plates 1-3. 1: Manhole 1 in the course of construction; 2: Feature 0002 in Area 03; 3: Feature 0004 in Area 03.

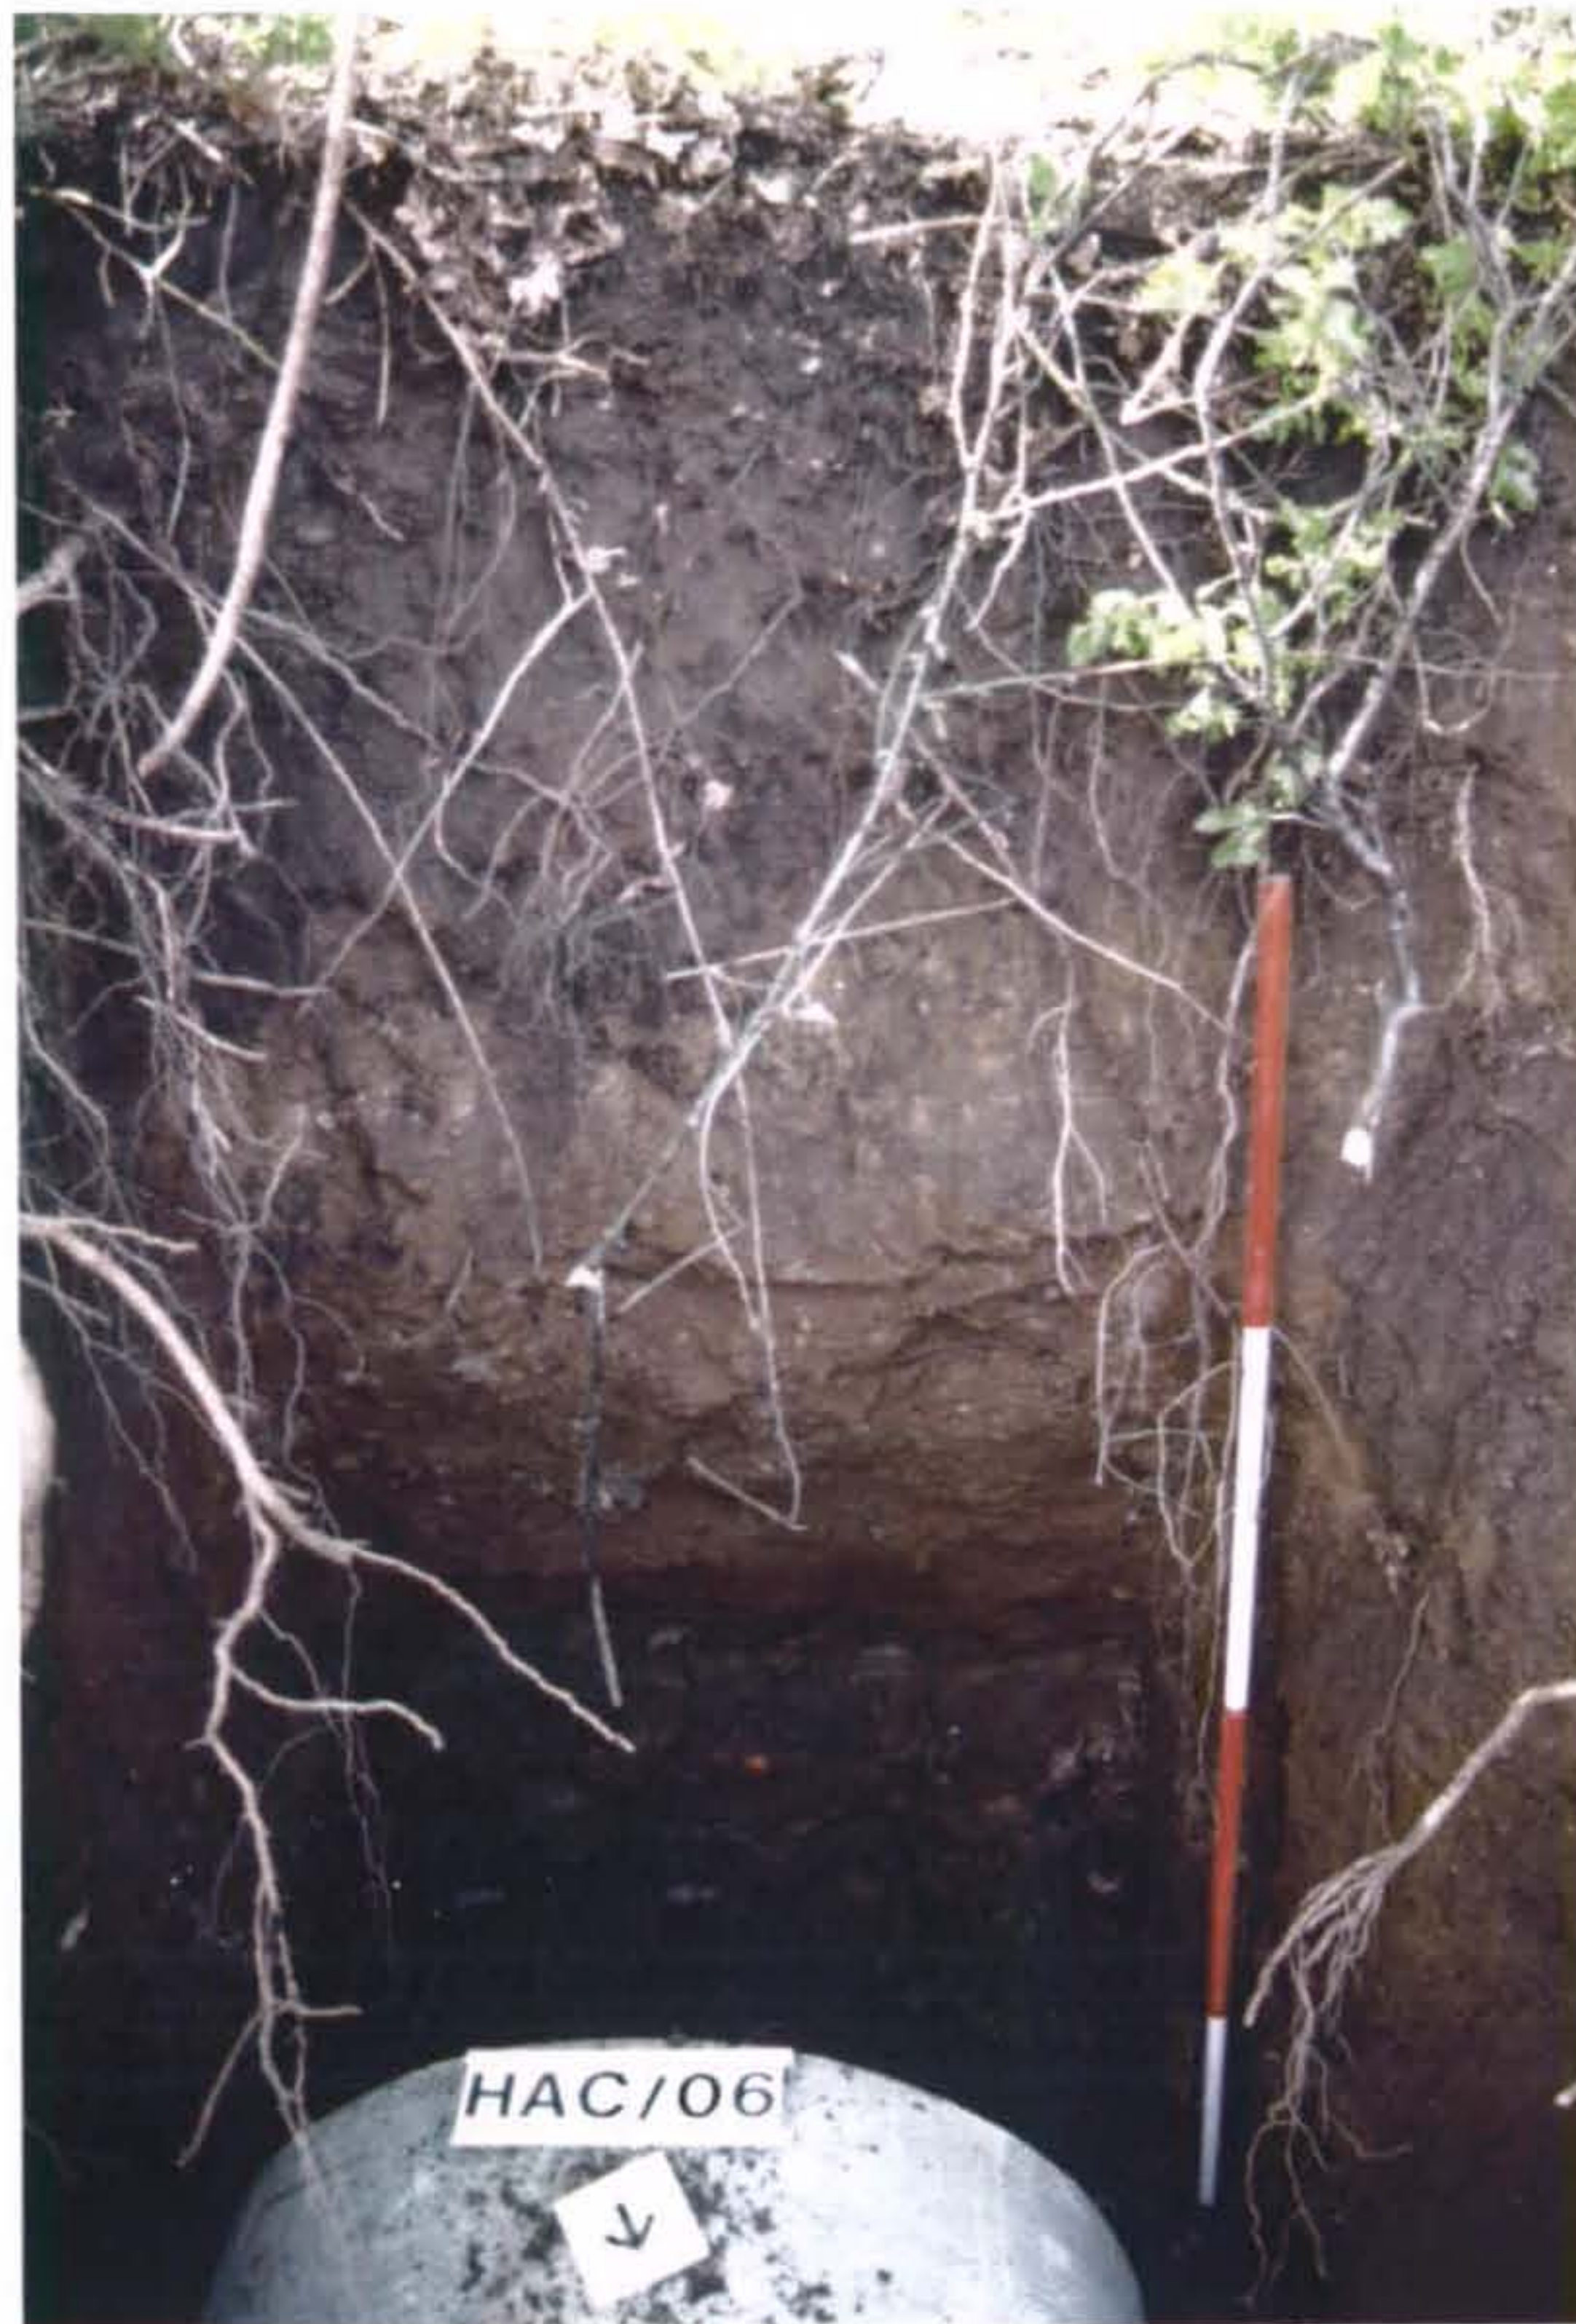
4

In the arable field (Area 03) the topsoil was noticeably different. Consisting of a much darker brown sandy silt loam or sandy clay loam it varied in depth between 0.5-0.9 metres. Where it could be determined, the subsoil was a reddish brown sandy loam, around 0.15 and 0.2 metres deep with some stone inclusions. As the trench approached Area 07 the subsoil deepened to around 0.4 metres. The rest of the trench fill was typical of the natural deposits of the area, consisting of reddish brown Mercia mudstone with layers or lenses of grey clay. The general matrix of topsoil, subsoil and bedrock is shown in Plate 4.

Plates 4, 5. 4: Section showing the depth of topsoil, subsoil and bedrock, close to Manhole 4, in Area 06; 5: A wartime RAF air-raid shelter that survives in the copse that forms the north boundary of the new housing development at Harvey Avenue, Coddington.

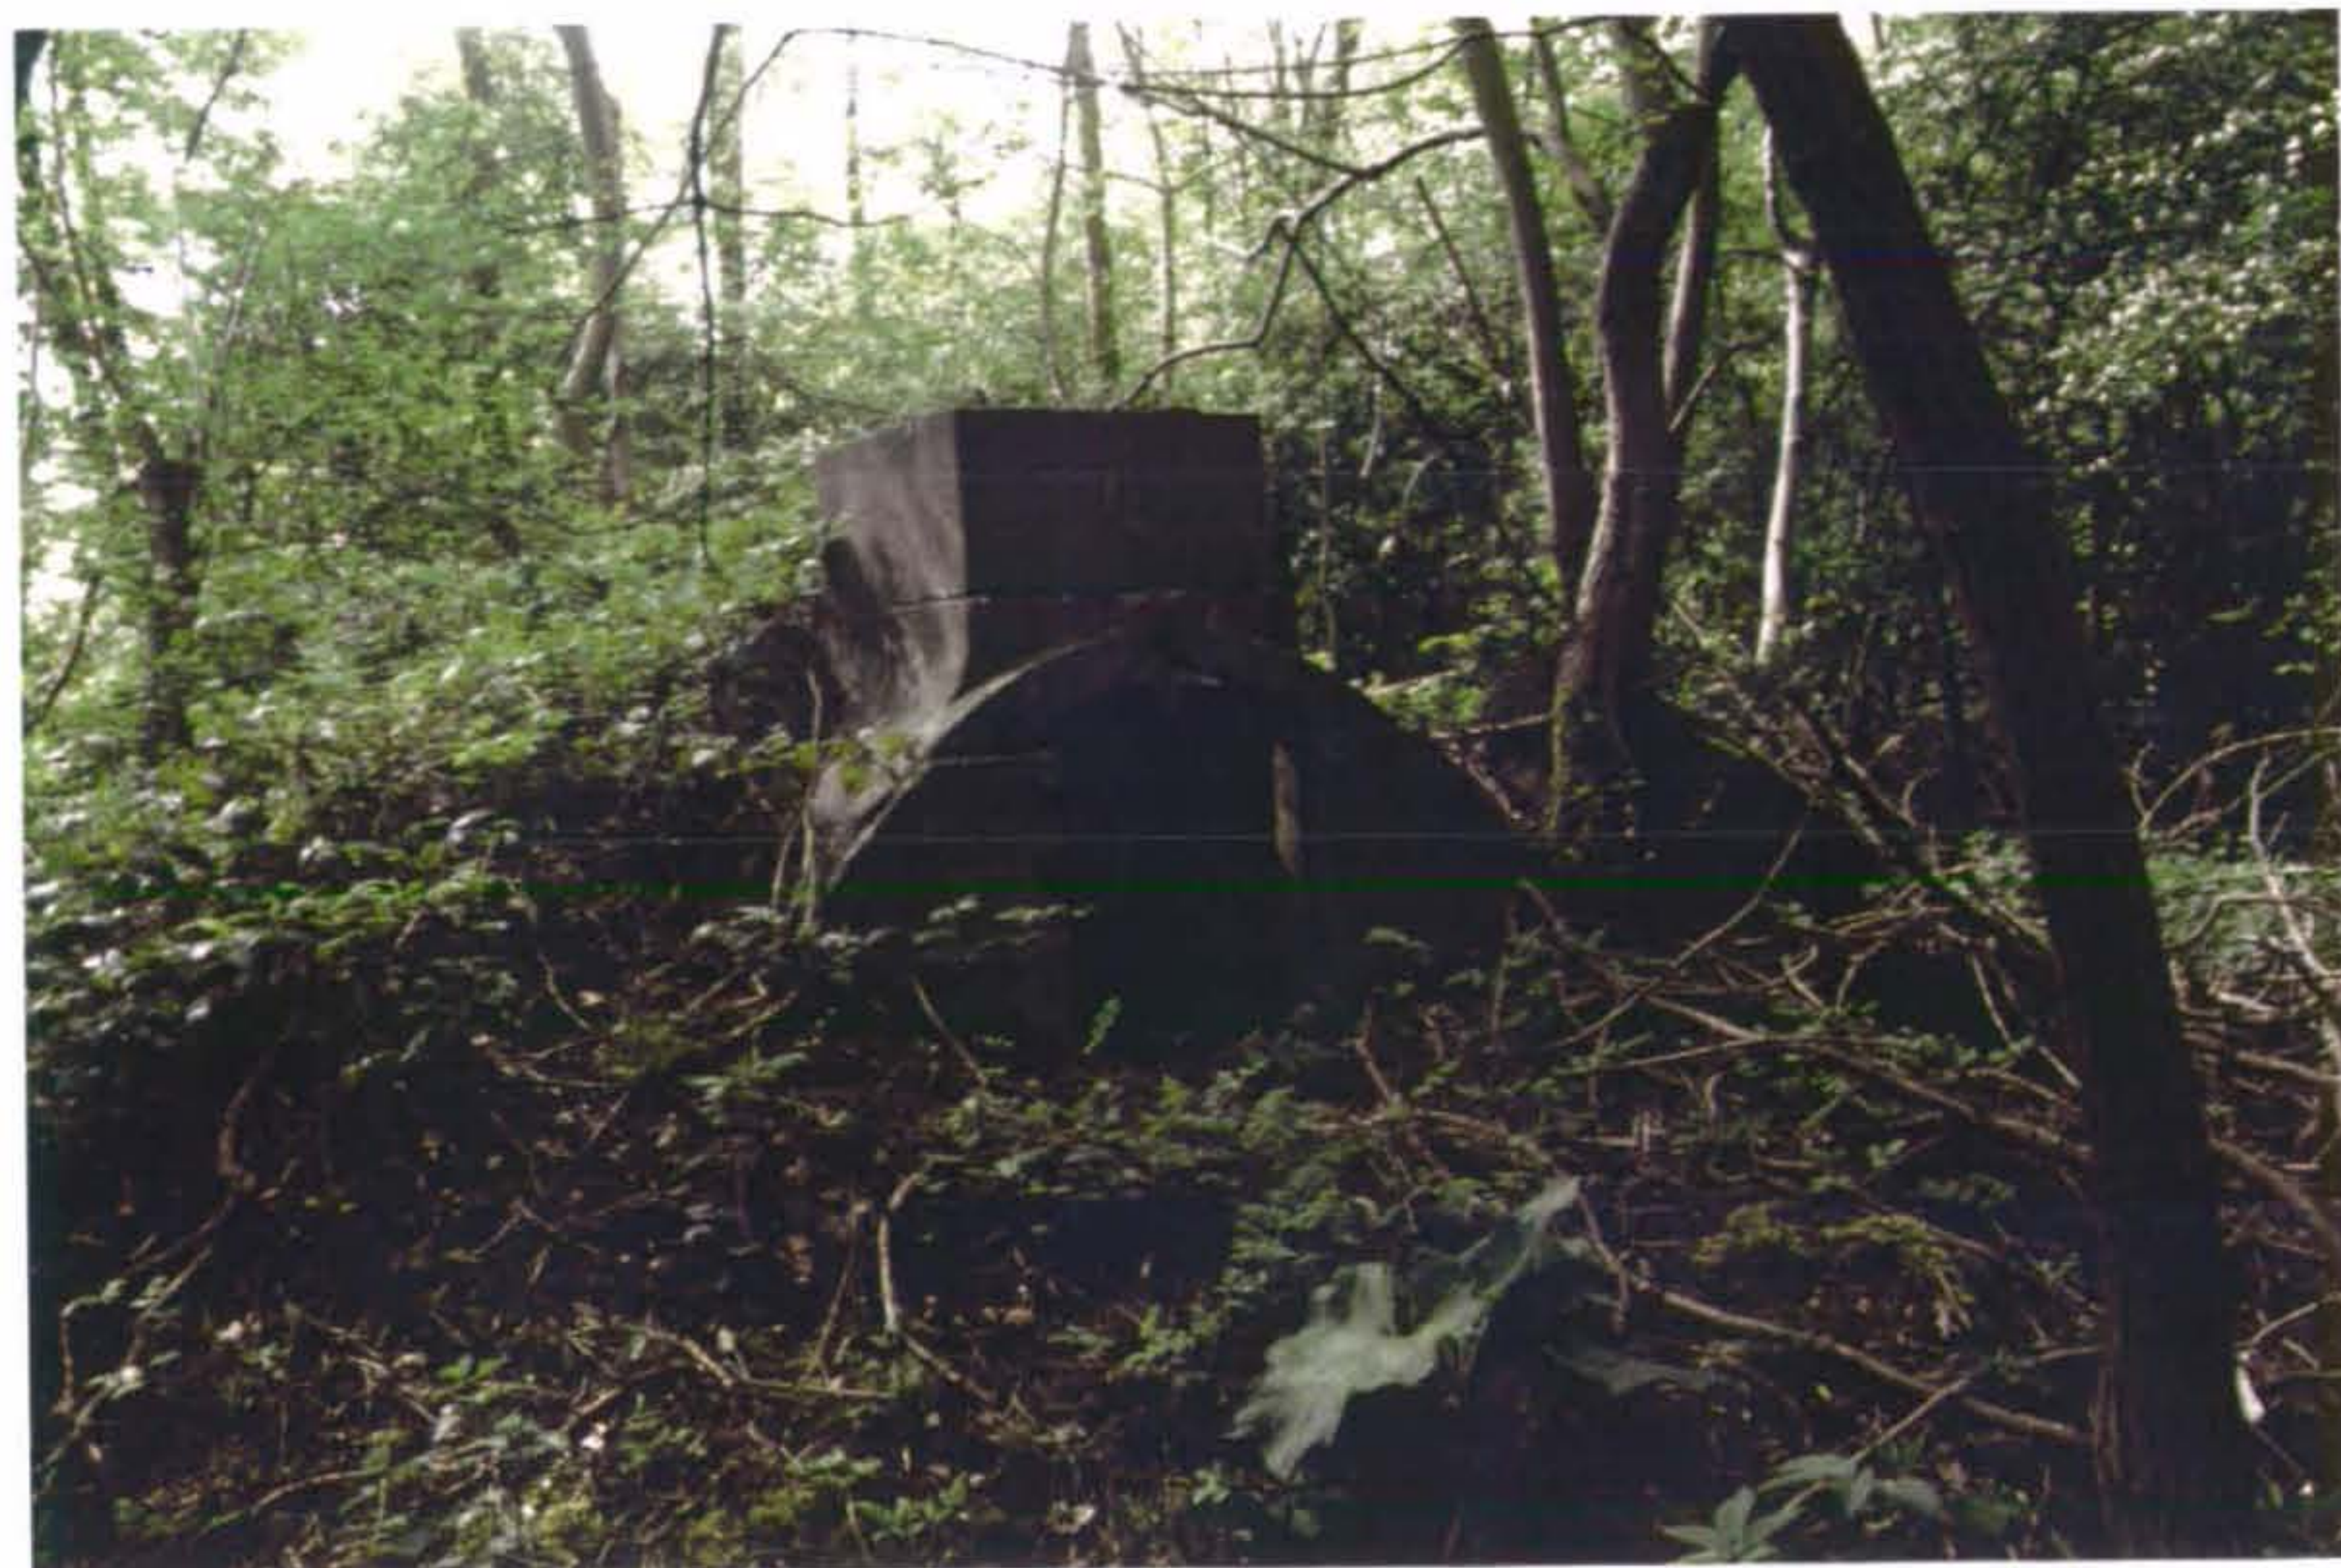
5

The sewage works appears to have been in use during this period and the remains of platforms for military buildings, such as barracks, can be seen in various places around the site. These are particularly obvious in the woods to the east of Beaconfield Lane. Two partially complete air raid shelters can be seen in amongst the trees that lie alongside the southern fence of the equestrian centre (Plate 5). Site plans held at Newark Air Museum (on what remains of the former airfield) show the layout of the airfield as it existed in July 1947 (Figs 6A, 7). These show the sewage disposal site, the sick quarters and the officer's quarters, although only the first of these was within the line of the pipe-trench. Most of the land
