Archaeological Salvage Recording

Keynsham Cemetery, Durley Hill, Keynsham,
Bath & Northeast Somerset.

(BSMR 30141/30142).

Avon Archaeological Unit

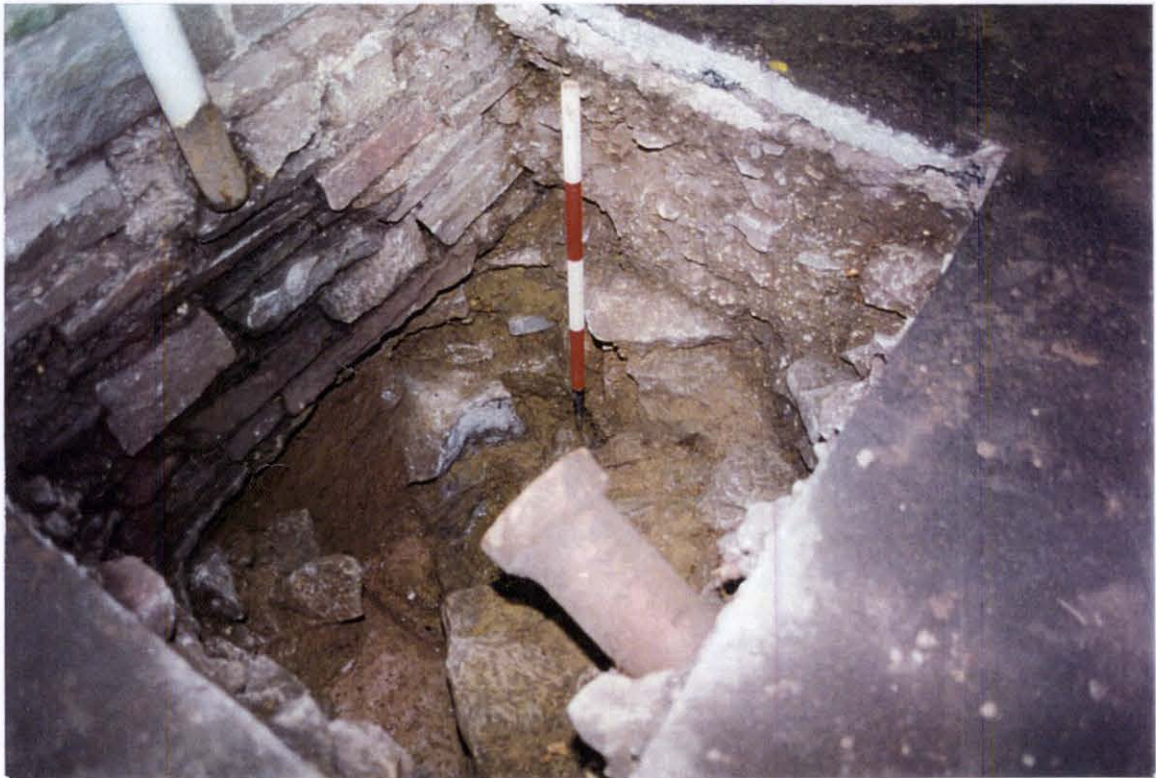
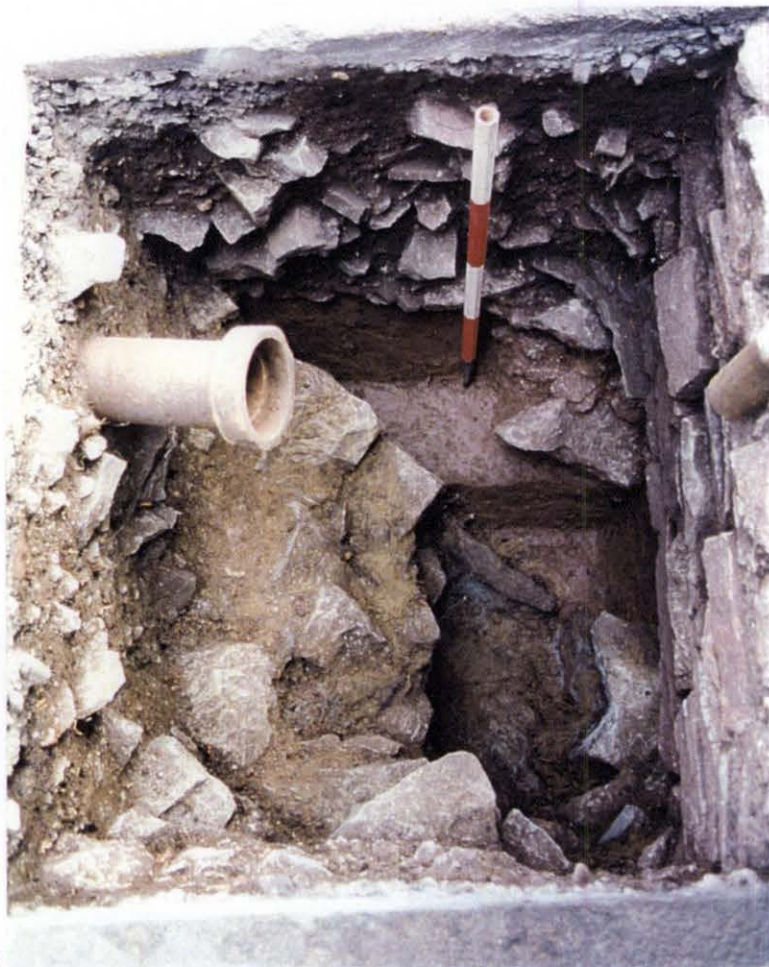
Testpit 1, Keynsham Cemetery, Keynsham, Bath SMR 30142

Testpit 1 was excavated flush with the external walls of the Victorian chapel through c. 0.12m of modern concrete and scalplings (contexts 100 and 101 respectively). The following series of subterranean features and deposits were revealed:

Wall 106 - The earliest archaeological evidence revealed comprising a stretch of well preserved coursed and faced sandstone masonry orientated west-east. The wall was 0.70m wide and primarily formed of subangular limestone blocks (< 0.20m wide) with occasional limestone rubble, bonded with a fine sandy mortar. The masonry had been destroyed and removed to a greater depth at the western end although even here the base of the wall was not revealed. Where best preserved the masonry was 0.75m high, the highest course preserved at a depth of 0.60m (c. 14.6m OD) below the present ground surface. The northern face of the wall was visible in plan but not exposed in section.

Wall 106 - the coursed limestone masonry was partly revealed in section, lying directly beneath the masonry foundations (Wall 104) of the Victorian chapel. The south face of the wall was butted by natural clay deposit 107 and no wall foundation cut (Cut 111, above) was visible. The uppermost section of Wall 106 was indicated by an increased proportion of sandy mortar and a few disturbed masonry blocks reflecting an area where the masonry appeared to have been disturbed or robbed.

This pit opened at the northeast corner of the chapel revealed a previously unknown section of Roman wall whose orientation fits into the overall rectilinear pattern recorded in the 1920's (see figures 4 and 7). The wall foundations were set in a narrow foundation trench (.0.3m deep) cut into the natural clay, the masonry itself well preserved below a level of c. 14.6m OD. but seemingly disturbed above this.

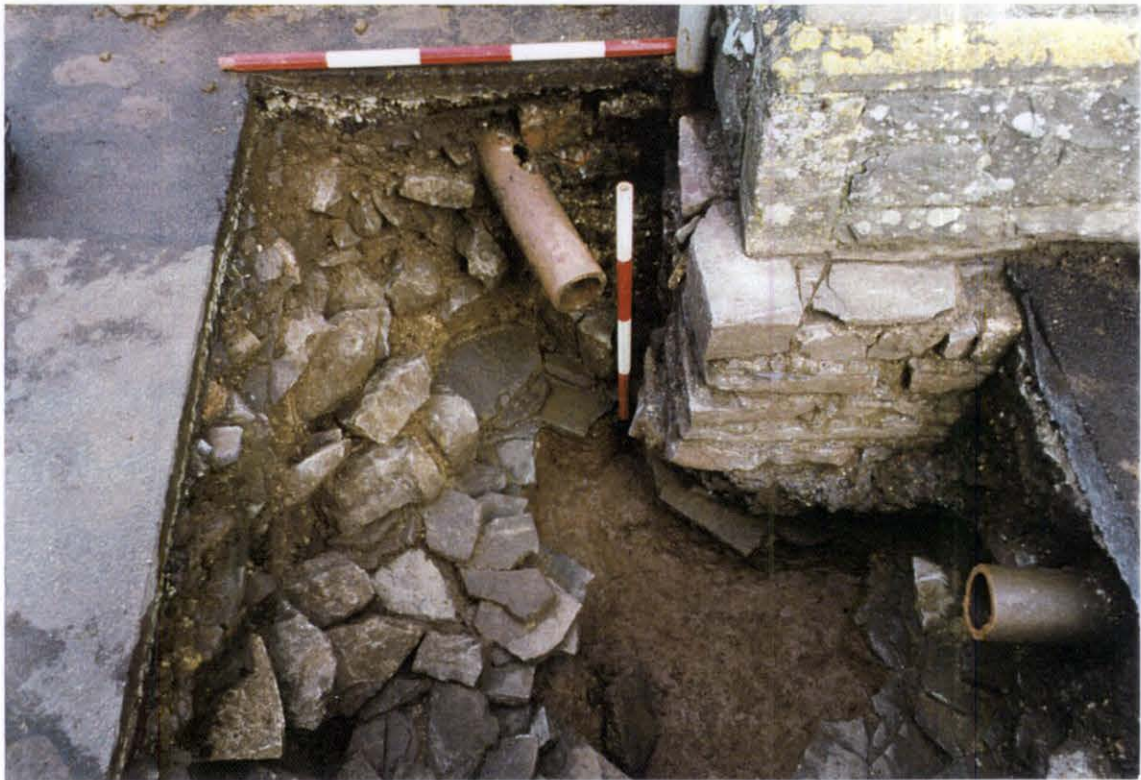
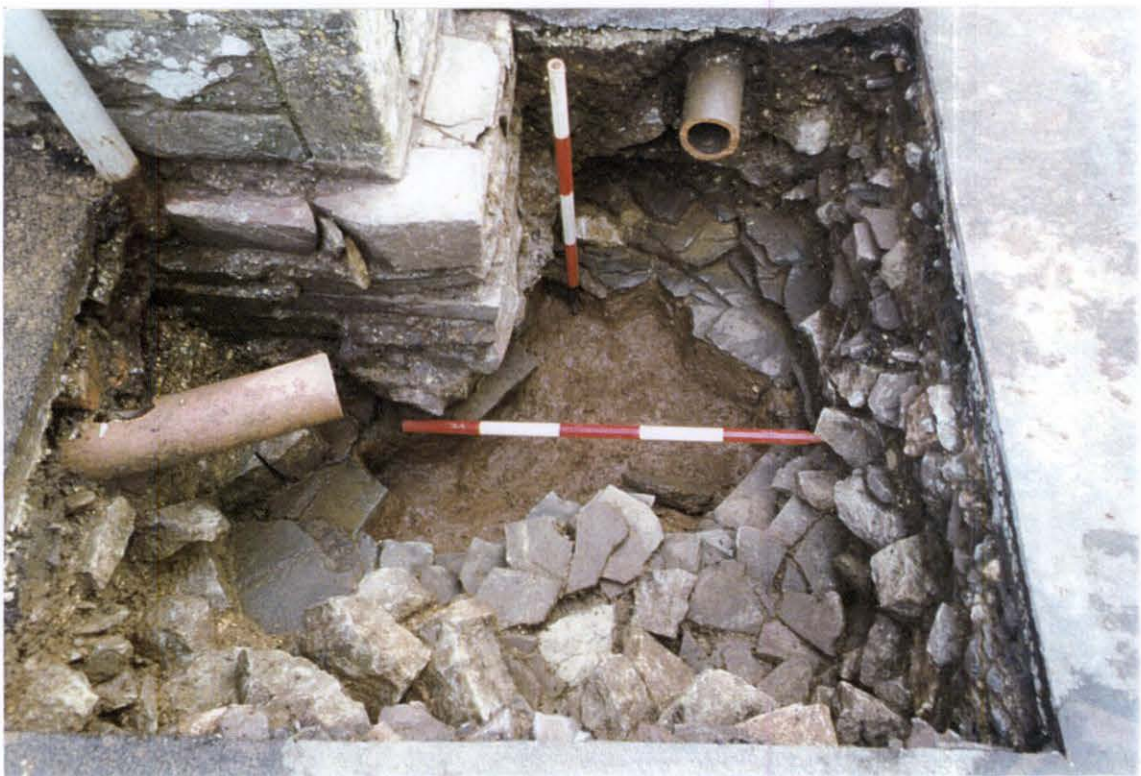
Testpit 2, Keynsham Cemetery, Keynsham, Bath SMR 30141

This pit was opened to examine foundations forming the southeastern corner of the Victorian chapel. Here the underlying archaeological deposits were more varied and complex than those revealed in Pit 1 above.

The plan view as cleaned (**SMR 30142; Plates a and b**) shows the majority of archaeological contexts revealed in this pit although they are difficult to appreciate from this aspect and are therefore described in detail below in the four recorded sections. What the plan view does highlight well is the area where archaeological remains were totally destroyed, as indicated by the central exposure of clean natural clay (203).

Floor Layer 205 - a seam of flat sandstone slabs varying from 1-3 in number. The slabs were missing in the central portion. Interpreted to represent up to three episodes of flooring.

Floor Layer(s) 205 - as above. The series of possible floor layers were best preserved in this section where each seam was separated by a bedding or mortar layer of charcoal rich orange sandy clay. The layers were truncated by deposit 206.

This pit had cut through a more complex sequence of archaeological deposits, although the majority of these appeared to reflect demolition rubble from adjacent villa structures. Of greatest interest are the sequence of well laid pennant floor slabs (Layer 205) partially preserved at the base of the sequence which were set directly above the natural clay and preserved immediately beneath the concrete foundations of the Victorian chapel. Up to five seams of thin floor slabs were indicated, those in the northern corner of the cutting separated by thin deposits of sandy clay bedding material. This evidence suggests that the floor in this area was relaid on several occasions, possibly because the thin slabs would have cracked and fragmented relatively easily.

The position of the testpit in relation to the 1920's groundplan (figure 4) indicates that the pennant layers formed the floor of the north corridor (shown as R3 on figure 7). Similar 'badly cracked pennant squares' were noted to form the floor at the western end of the same corridor (Bulleid and Horne, *ibid*; p.113).
