Gatcombe Farm, Flax Bourton,
North Somerset
An Archaeological Evaluation
on behalf of
Mr William Butler.

R. A. Broomhead BA
Field Archaeologist
RAB/08/06 SMR 47303 SAM22848

RAB/08/06
SMR 47303. National Monument 22848.
Gatcombe Farm, Flax Bourton, North Somerset
An Archaeological Evaluation
On Behalf Of
Mr William Butler
By
R. A. Broomhead BA
Field Archaeologist

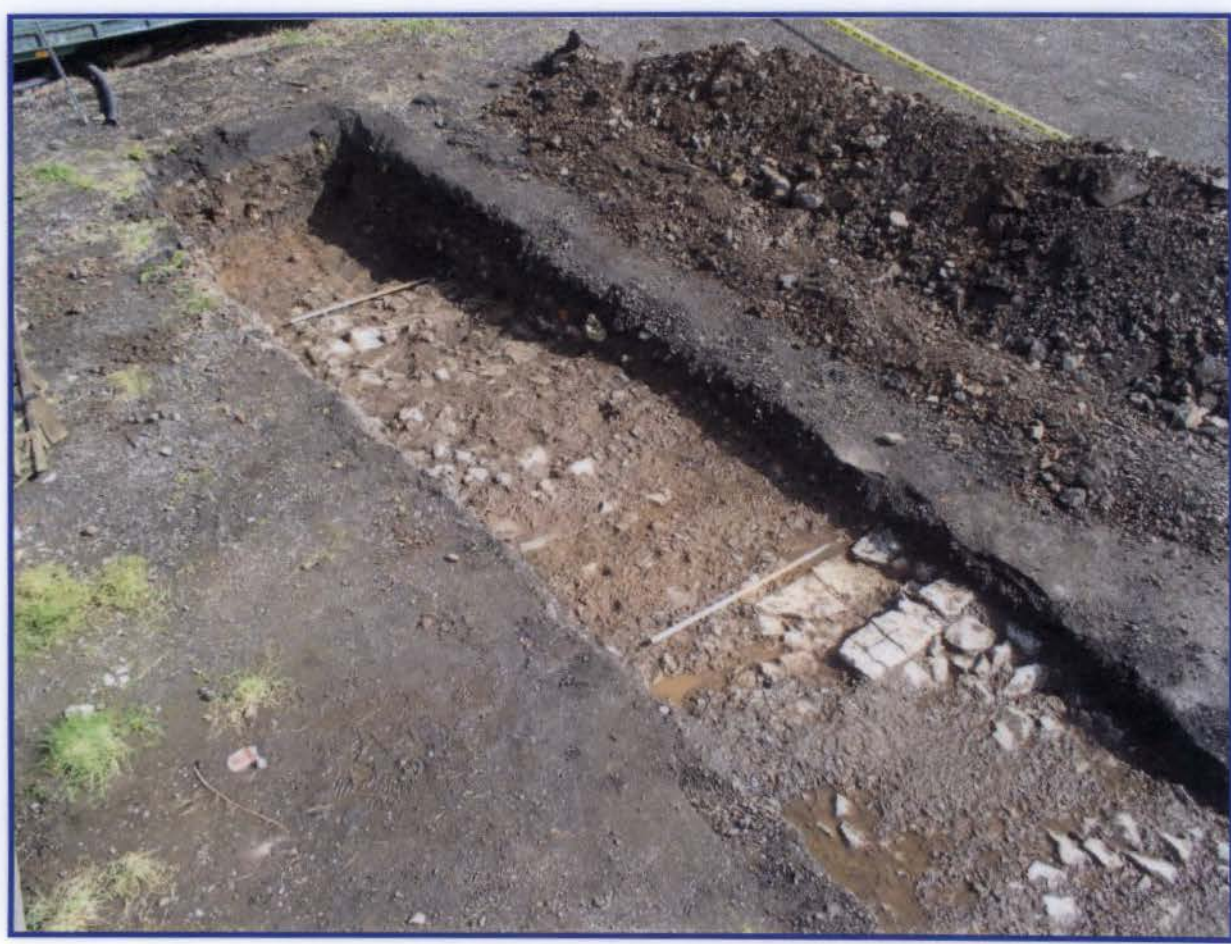
| Cover | General view of the excavated trench from the west showing [F104] to the left and [F106] on the right | |

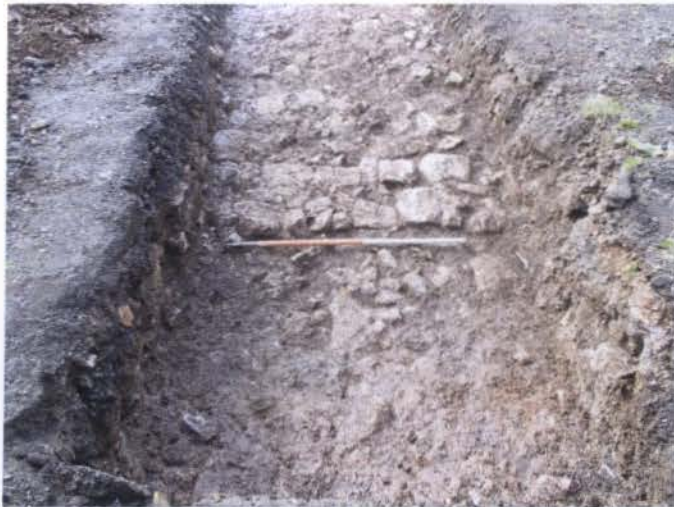
Left: [F104] from the north showing [103] in the foreground and tumble [105] to the south. Scale 1m

- [F104] Single course of walling orientated east west standing approximately 150mm and comprising faced lias blocks with core of clay bonded rubble. Sealed and abutted by [103] butted by [105]

- [105] Rubble spread comprising lias and limestone blocks 50mm – 300mm with significant quantities of pennant tile fragments. Sealed and abutted by [103]. Abuts [F104]

- 7.1.1** There is little doubt that all the recovered archaeology is Romano-British although virtually all vertical stratigraphy has been lost and there were no clearly stratified finds. Neither is the relationship between the previously excavated archaeology and that exposed by the evaluation totally clear although contexts [101] and [102] may be seen as material redeposited following prior excavation. Certainly the plotted location of the trench would suggest this and tends to support the hypothesis that the more northerly of the two exposed walls [F104], represents the previously unexcavated southern wall of Branigan's Building 16. The presence of tumble with frequent pennant roof tile [105] to the south of [F104] lends weight to the suggestion that this area is external to that building.

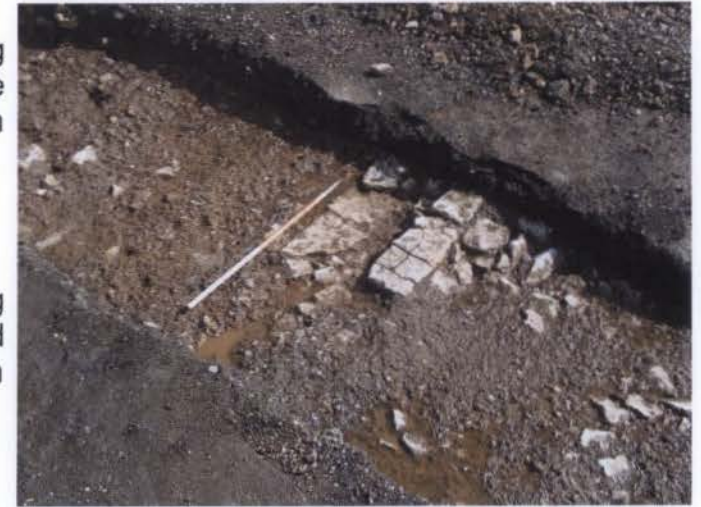
Right: [F106] from the west showing robber cut [106], cobbling [108] and tarmac bonded clays [109]. Scale 1m

- [F106] Single course of walling orientated east west comprising faced lias blocks with core of clay bonded rubble. Robbed to west. Sealed by [100] abutted by [103] to the north and cobbling [108] to the south

- [107] shallow cut (<50mm) continuing line of northern face of wall [F106].
- [108] Limestone cobbling, irregular, well worn and partially eroded. Butts against [F106] to the north. Sealed by [100] and [109]

- [109] Hard clay fused with tarmac sealing much of [108]

- 7.1.2** Wall [F105] survived for only a short length and would appear to have been robbed to the west. Discontinuous limestone cobbling [108] interspersed with tarmac hardened clay [109] suggests an internal floor similar to that described as the phase 2 floor in room 1 of building 12 (Branigan *op. cit.* p 20). [F105] may therefore be considered the northern wall of a previously unknown building, number 25 in sequence.
