Archaeological recording on the
Severn Trent Water
Stratford Strategic Supply water main
1995-1996

Stuart Palmer and James Meek

Report 0307
March 2003

Warwickshire Museum Field Services
The Butts
Warwick
CV34 4SS

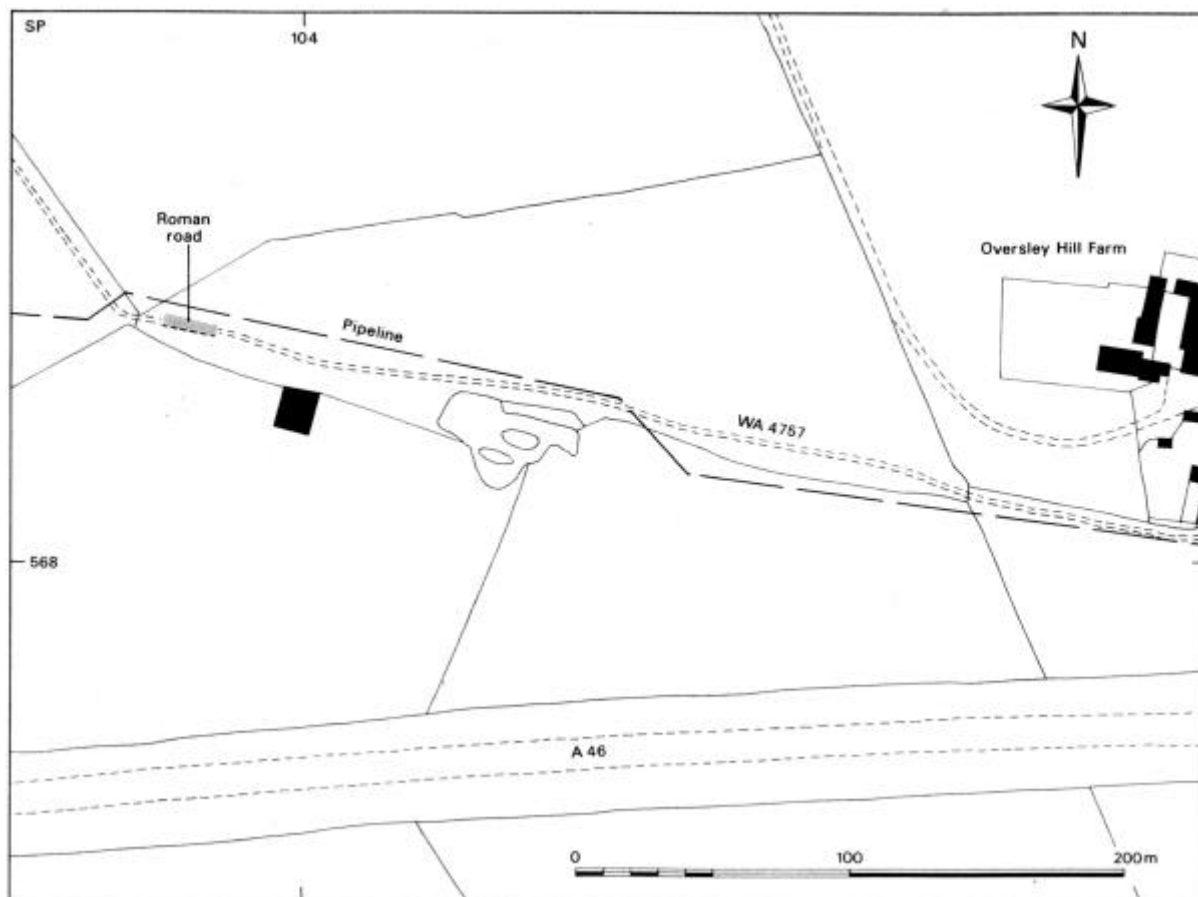
Fig 2: Site 1: Roman road (WA 4757) west of Oversley Hill Farm, Alcester

5.1 A c 1350m length of the pipeline easement was likely to impinge upon the projected route of the Alcester to Stratford Roman road (SMR WA 446/WA 4757) between Oversley Green and Oversley Hill Farm. The road was likely to have been disturbed by the existing water main, but otherwise could be relatively well preserved.

5.2 The possible remains of the Roman road were visible in one area of the easement of the pipeline at grid reference SP 10355689. The area contained a c7m long spread of gravel, bounded on the southern side with a line of possible kerb stones aligned almost east-west. To the south of the kerb stones there may have been a roadside ditch. No kerb stones were visible on the northern edge. To the east and west of the visible spread, the gravel had either been removed or was hidden beneath subsoil. No associated features were recorded and no finds were recovered from the area of the possible road.

5.3 Observation of the easement after topsoil stripping revealed no other remains of the Roman road in the areas where the two coincided.

6.2 The Stratford to Alcester Roman Road (Site 1) was only revealed in a single area of the pipeline easement, though the line of the road should have been uncovered within the pipeline easement over a much longer area. Evidence for the road had presumably been destroyed through ploughing and possibly quarrying of the road surface material for use elsewhere.

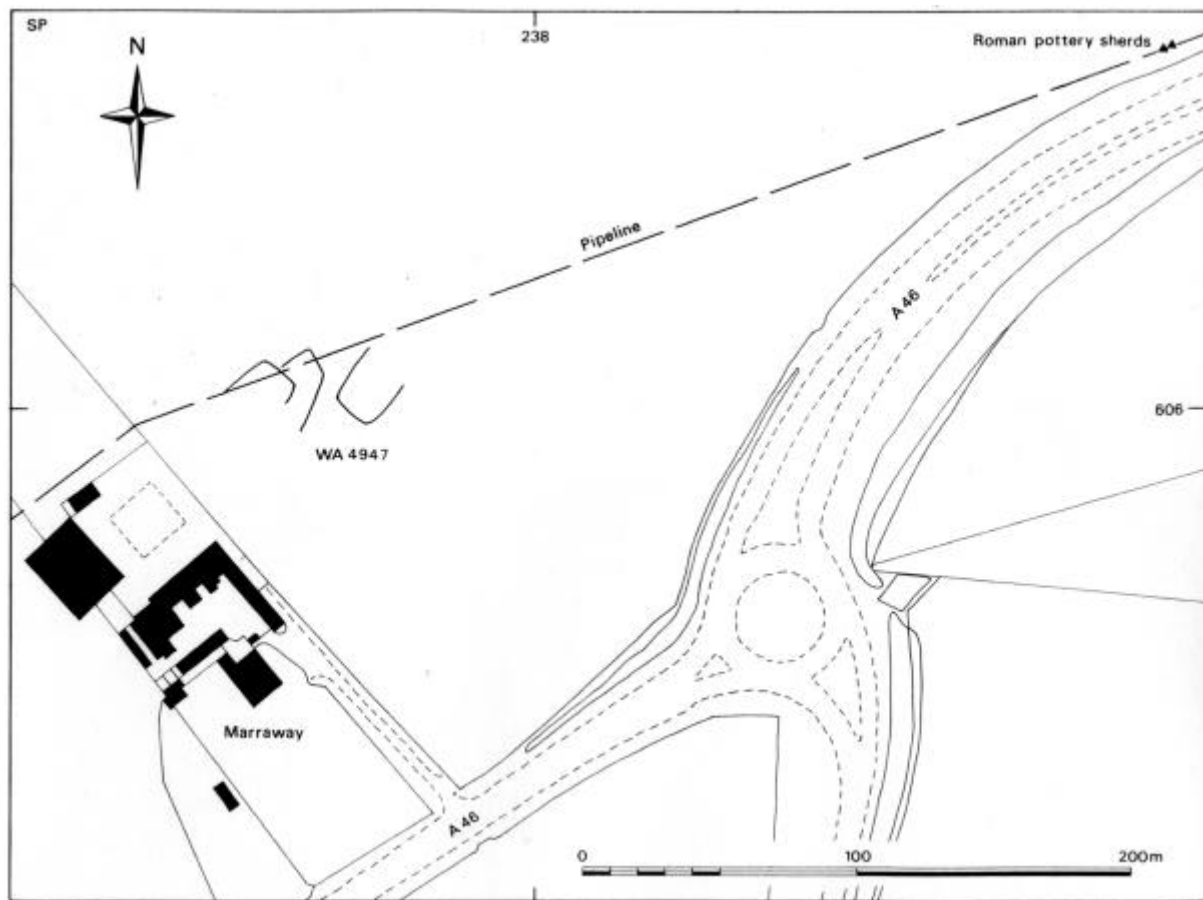
Fig 5: Site 6, Cropmark enclosures (WA 4947) north east of Marraway Farm, Snitterfield

5.12 Just to the east of Marraway Farm, Snitterfield the pipeline easement passed close to a series of cropmark enclosures, photographed by A Baker in July 1969 (SMR AP Ref SP2360/A-B) and possibly representing prehistoric or Romano-British settlement (SMR WA 4947). The proximity of the pipeline easement to the cropmarks was such that topsoil stripping of this area was intended to be archaeologically observed. Unfortunately, due to a 'communications difficulty' with the site engineers this was not possible.

5.13 The area was examined after the removal of the topsoil which revealed a subsoil (old plough soil) layer which masked the geological natural. Although no archaeological features were observed within the area adjacent to the cropmarks and no finds were recovered, it remains possible that the cropmarks relate to features which remain preserved beneath the layer of subsoil in this area.
