FOSS ISLANDS ROAD, YORK.

REPORT ON AN ARCHAEOLOGICAL WATCHING BRIEF.
OSA REPORT No: OSA03WB01.

AUGUST 2003.

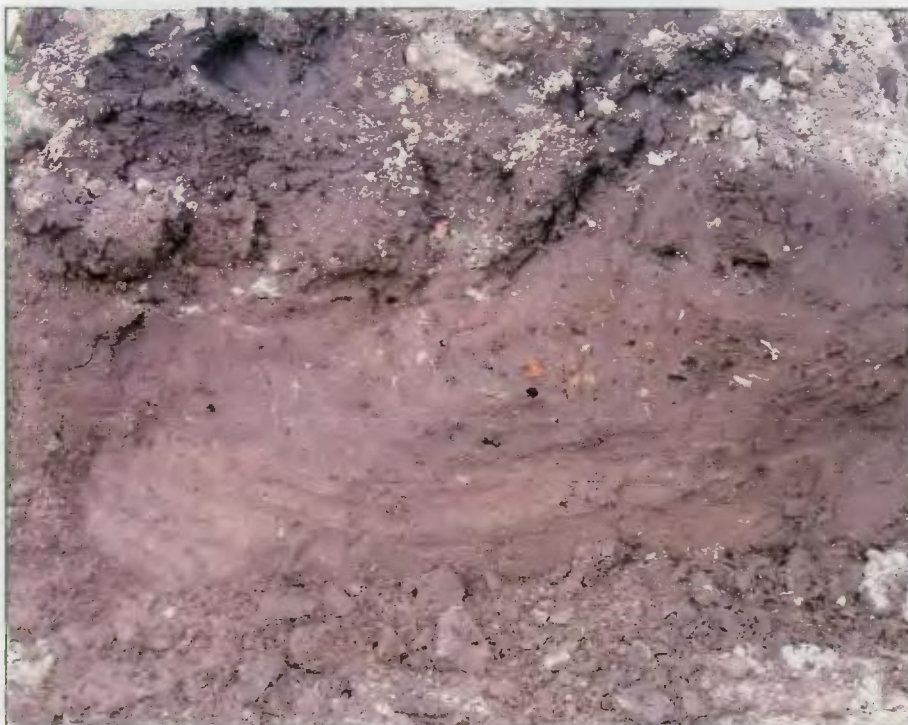
refuse pit. This flat bottomed and steep sided pit contained a single fill (1025) of loose dark grey silty sand. The pottery recovered from the fill represented a range of dates from the later 11th to mid 15th centuries. Therefore, it is likely that this pit dates from the later medieval period. It is to be noted however, that as this pit cuts through the possible agricultural layer (1024), the material recovered from the pit fill provides at least a relative date for this horizon. Pit [1016] cut through two medieval occupation layers, (1021) and (1022). This vertical sided, flat-bottomed pit was filled by a loose greyish brown silty sand (1015), from which four sherds of later 11th to mid 12th century York gritty ware were recovered. Finally, pit [1009], filled by a firm silty clay (1008), profited no dating evidence. As the feature cut a layer of natural looking material (1007), it seems likely that it too dates from a period of antiquity.

Plate 2. Trench 1, showing context (1026).

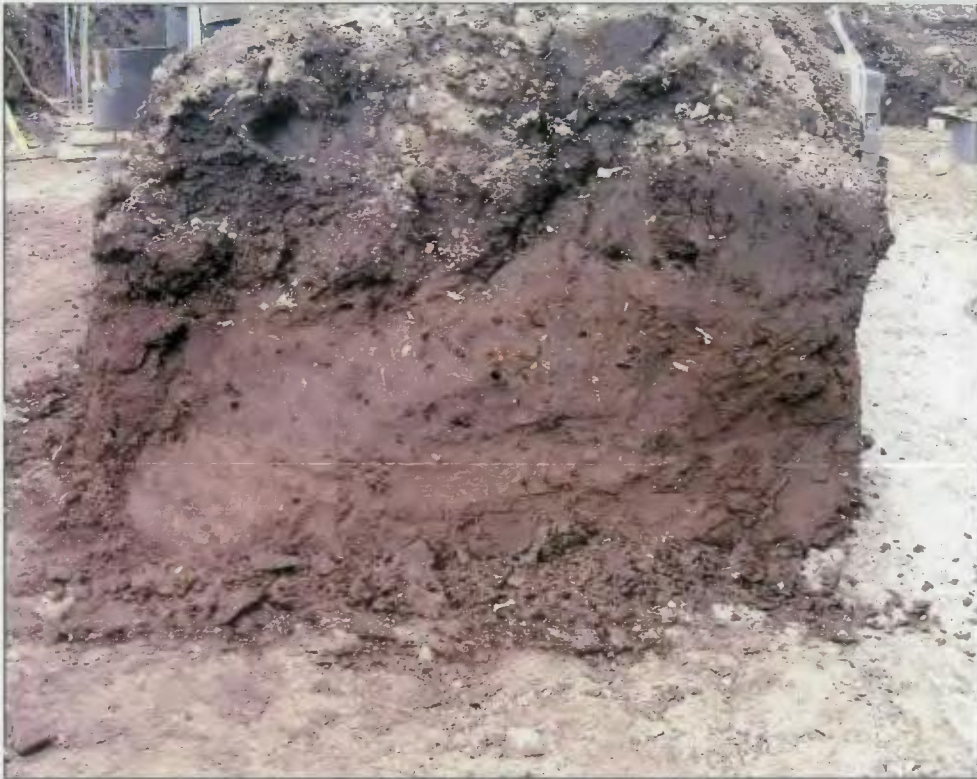
Both pits [1013] and [1028] contained late 12th to mid 13th century pot. As these features cut earlier horizons, (1020) and (1014) respectively, they provide a relative date for these earlier occupation horizons. The nature of the fills of these pits, (1012) and (1027), suggests that the features may be the remains of cesspits. Feature [1026] however, is thought to represent a

Plate 3. Trench 1, showing context (1028).

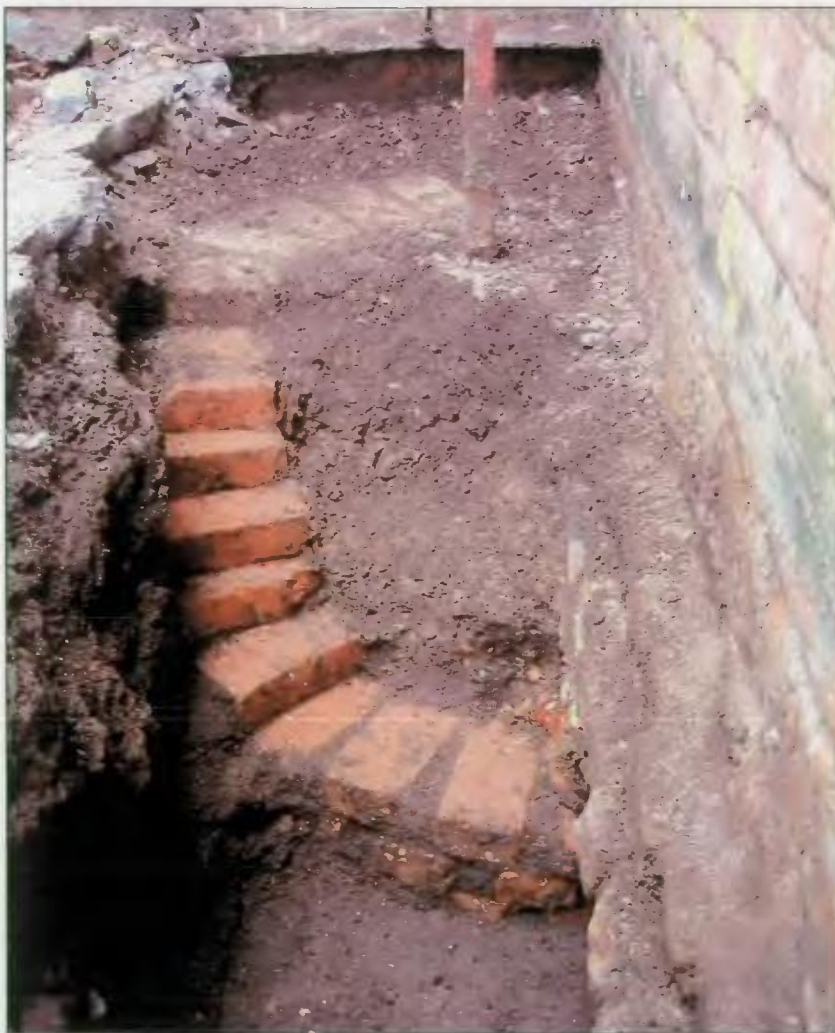
Horizon (7006) was cut by a structure in the extreme northwest corner of the building that was to be underpinned. A circular red brick well (7002) measuring 1.2m x 0.8m, and dry bonded was observed in plan. Though this feature is likely to be fairly recent in date, the same could not be readily said of the second cut feature seen in the south eastern most underpinning pit. During the hand digging of this pit a sudden slump revealed a backfilled circular pit or well dug into the clayey (7010). This cut [7009] was some 0.80m in diameter, the loose fill observed at the base following the collapse of the feature consisted of a compact green grey silty clay with moderate brick, tile, c.b.m, and charcoal, with occasional pebbles and cobbles (7008). Unlike (7002), which was only a matter of a few centimetres below the existing floor surface, [7009] was not encountered until a depth of almost 1m. As a result, it was not possible to observe the feature, other than in plan. The fact however, that it cuts the lower (7010) and is located at such a depth suggest that the feature dates from an earlier archaeological period than the post medieval (7002). Perhaps it represents the remains of an earlier robbed out well, or it may relate to some domestic or industrial usage.

Plate 4. Trench 7, showing well [7002].

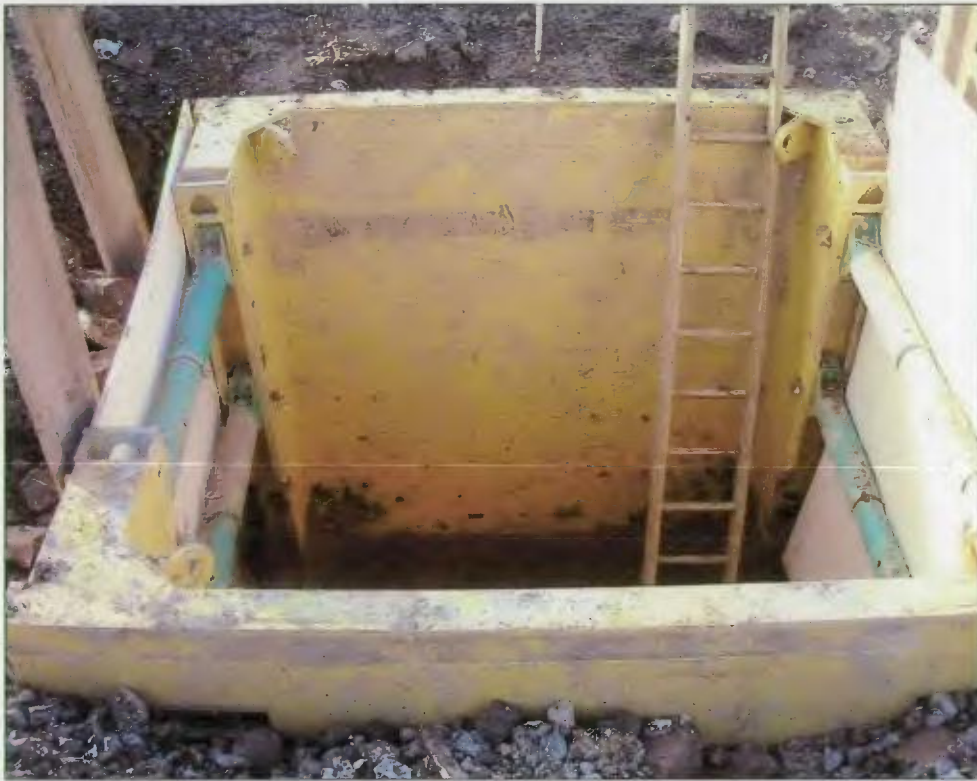
This drain represented the deepest of all intrusions on the site and its construction required the excavation of a single pipe length at a time. This resulted in the machining of individual bays measuring 5m by 4m by 2.5m+. Such dimensions naturally increased the potential for disturbance to the archaeological resource, and as such, thirty-six context numbers were assigned to this trench (4000 to 4035). There were two main concentrations of archaeological features along its length, and the simplest way to present the data is to look at each in turn.

Plate 5. Trench 4 box shoring.

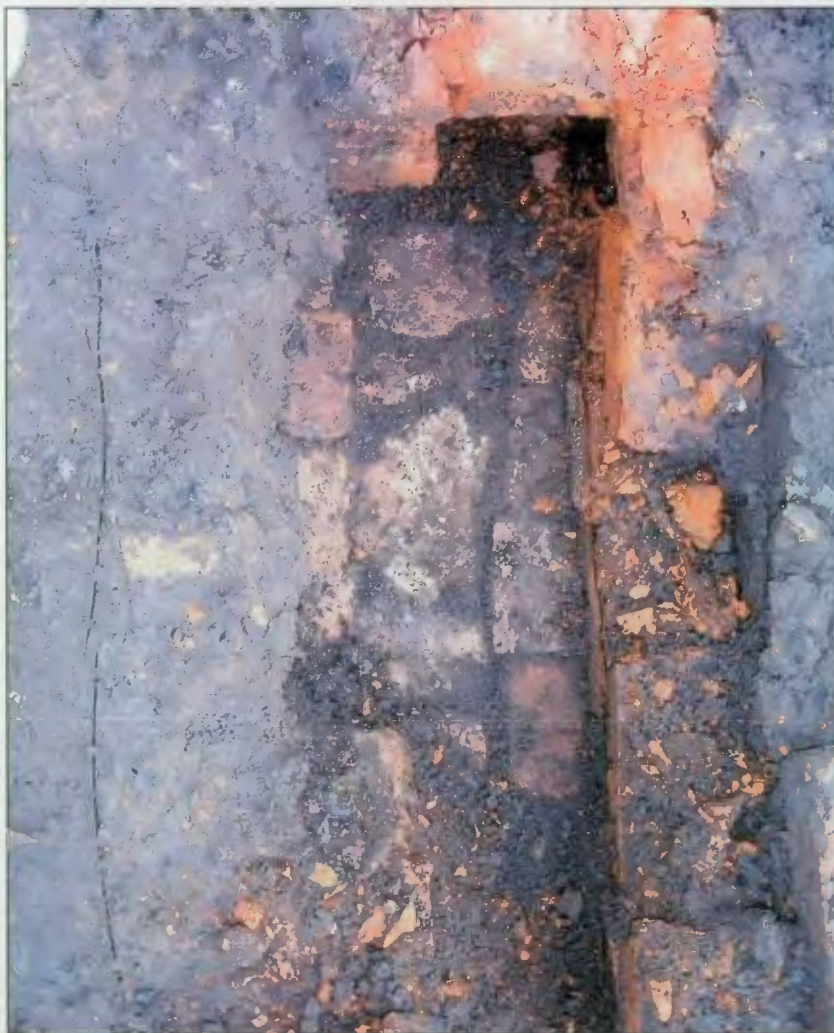
These features were sealed by (4002) a loose mid brown silty sand with moderate charcoal and c.b.m fragments, into which a further feature was cut. Running on roughly the same alignment as the pipe trench was a brick built drain or culvert (4004). The bricks were all two inches thick and hand made, the sides were each three courses deep and the top was formed by a single course of capping bricks set at ninety degrees to the sides. Measuring 0.24m in width the structure sat in a regular cut [4005] which was 0.50m in width and backfilled with a loose mid brown clayey sand with occasional smears of charcoal (4003). The interior of the drain contained only a fine build up of silt suggesting that the structure had been fast flowing and in use up until quite recently. This feature was visible in some of the later western bays, but the angle at which it cut the trench was distorted due to the dogleg in the pipe trench.

Plate 6. Trench 4, showing culvert [4004].

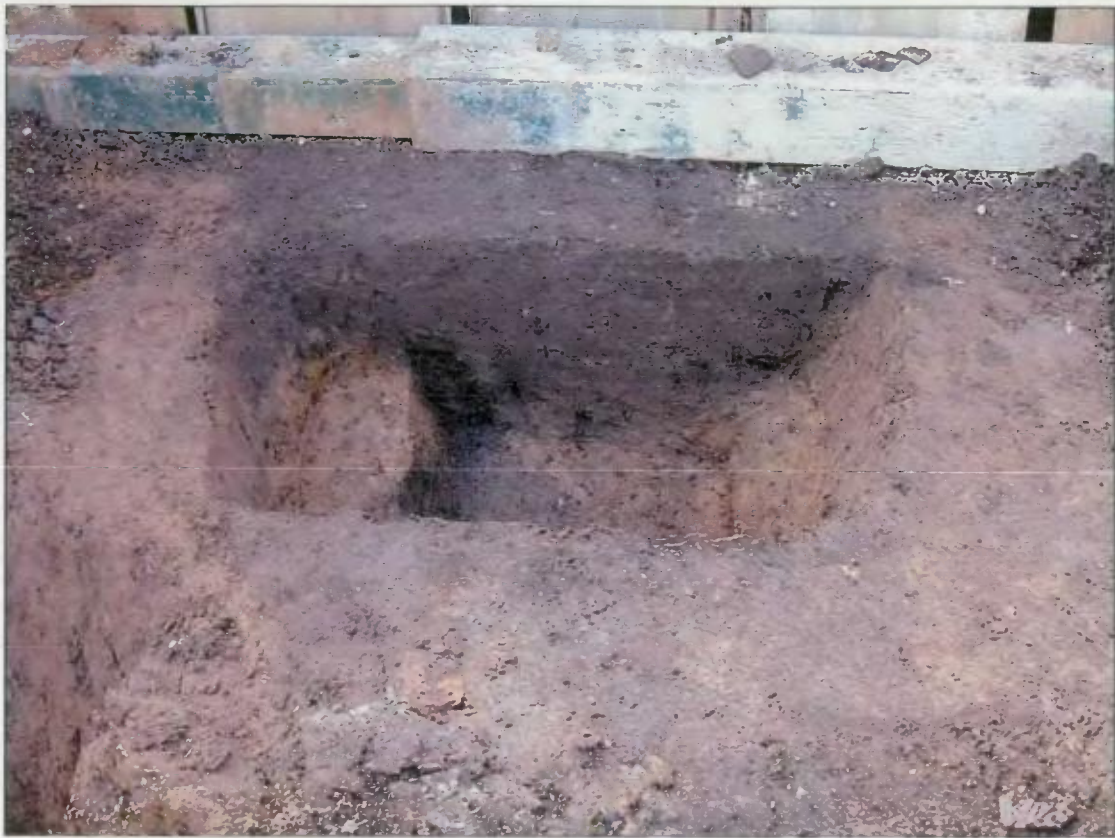
The linear feature in this bay was unusual, as it seemed to represent a later linear situated atop an earlier one. The earlier of the two [4018] was the narrower of the two at 0.46 and contained both a primary (4016) and secondary (4013) fill. Above this was the wider of the two [4014] at 0.90m and this contained only a single fill (4013). This may relate to the palisade as seen by Y.A.T in the “behind jimmy’s fish bar” excavation. Dating from fills (4013) and (4017) however, in the form of Stamford ware pottery, show that both cuts date from the mid to late 12th century. Either the cuts represent a single event and the linear was deliberately cut with a stepped profile, or the feature was widened at a later date within the same mid to late 12th century period.

Plate 7. Trench 4, showing contexts (4114) & (4018).
