# Bridge House Badby Northamptonshire

## ARCHAEOLOGICAL EVALUATION

Archaeology Warwickshire Report No 1847

June 2018

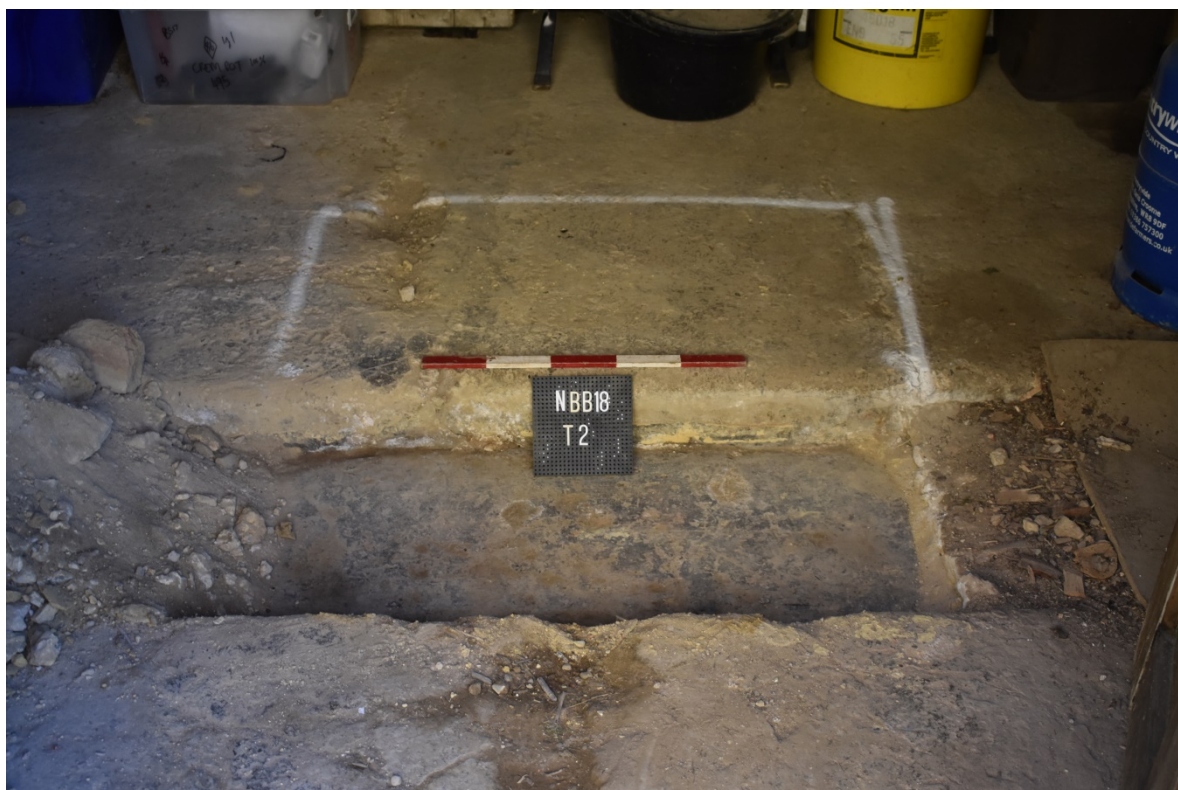
1. Trial pit 2 before excavation, showing concrete and concrete drainage channel

- 4.1 The main aim of the evaluation was to determine if there is a significant floor layer below the concrete in the barn in order to inform planning decisions relating to the redevelopment of the barn.
- 4.2 The results from the test pitting were to be presented in a report.
- 4.3 Two 1m<sup>2</sup> test pits were cut through the concrete floor using a hand held pneumatic chisel in the locations agreed with the planning authority. Excavation then proceeded by hand.
- 4.4 Both test pits were located over a preformed concrete drainage channel and and the concrete floor (Photo 1).

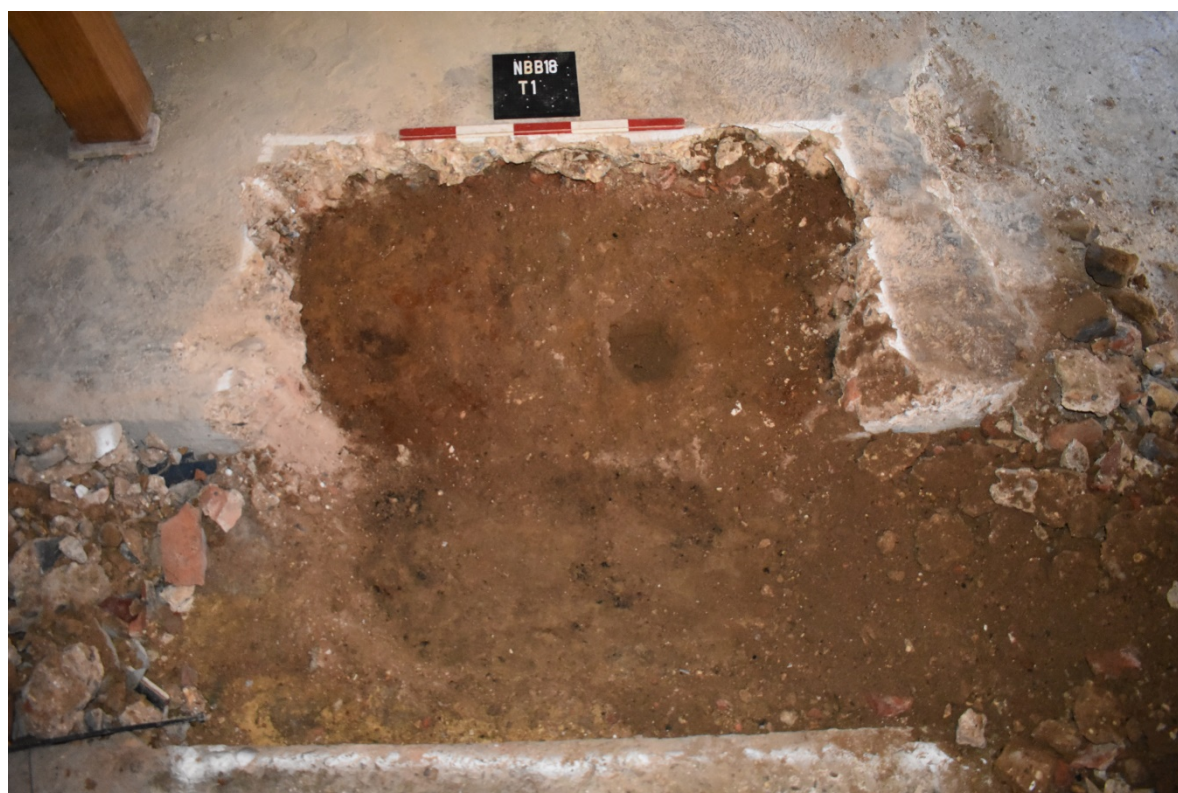
- 5.1 Removal of the modern concrete (up to 0.14m thick, 100/102) revealed a brown, yellow clay floor (101). This was cut by a NW-SE 0.30m wide slot (103) filled with red, brown sandy loam (104), which was probably for an internal partition for animal stalls within the barn (Fig 2; Photograph 2).

2. Trial pit 1, showing the clay floor and partition cut

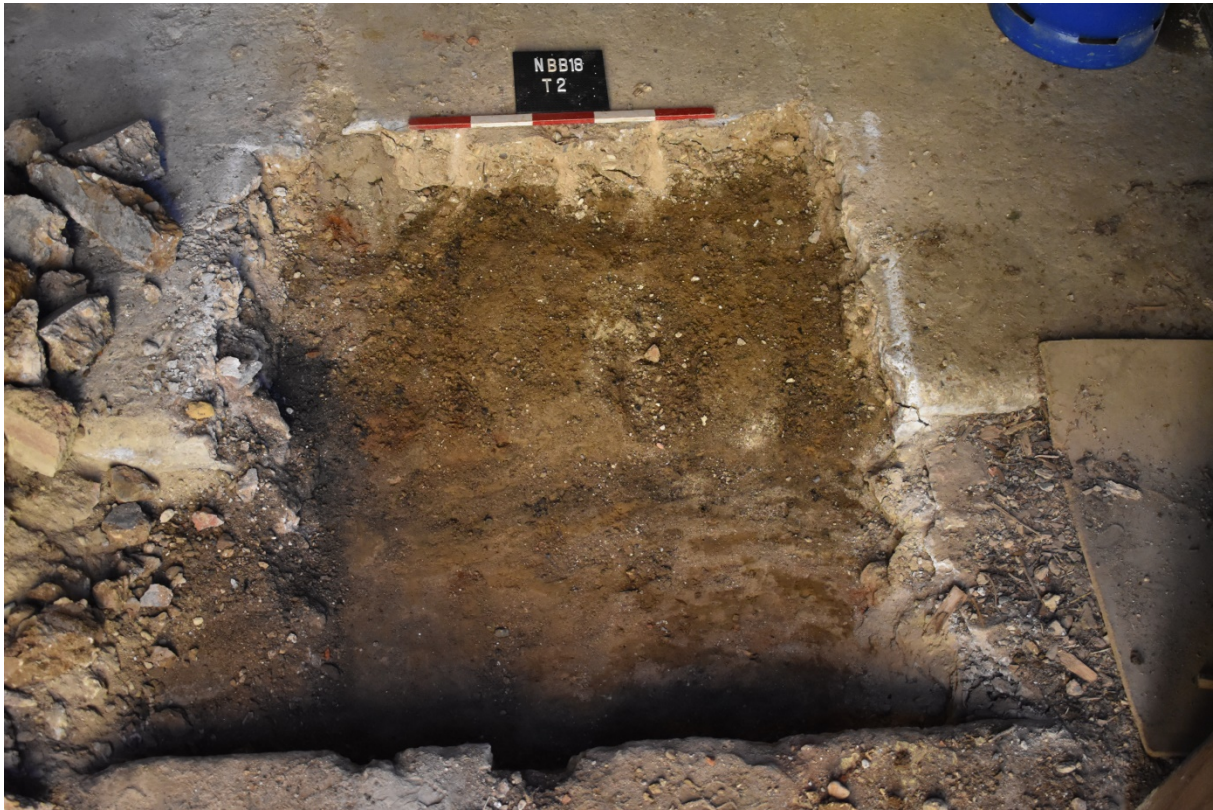
- 5.2 The removal of the concrete (up to 0.13m thick, 200) was a continuation of the brown, yellow clay floor (201) recorded in TP1. It was also cut by a NW-SE slot, 0.20m wide (203), which was filled with mixed brown sandy clay (204) and like slot 103 in TP1 it was likely to have been for an internal partition for an animal stall.

3. Trial pit 2, showing the clay floor and partition cut
