**Ted's Barn
Welton Fields Farm
Welton
Northamptonshire**
HISTORIC BUILDING RECORDING

Archaeology Warwickshire Report No 1878

Project: Ted's Barn, Welton Fields Farm, Welton,
Northamptonshire

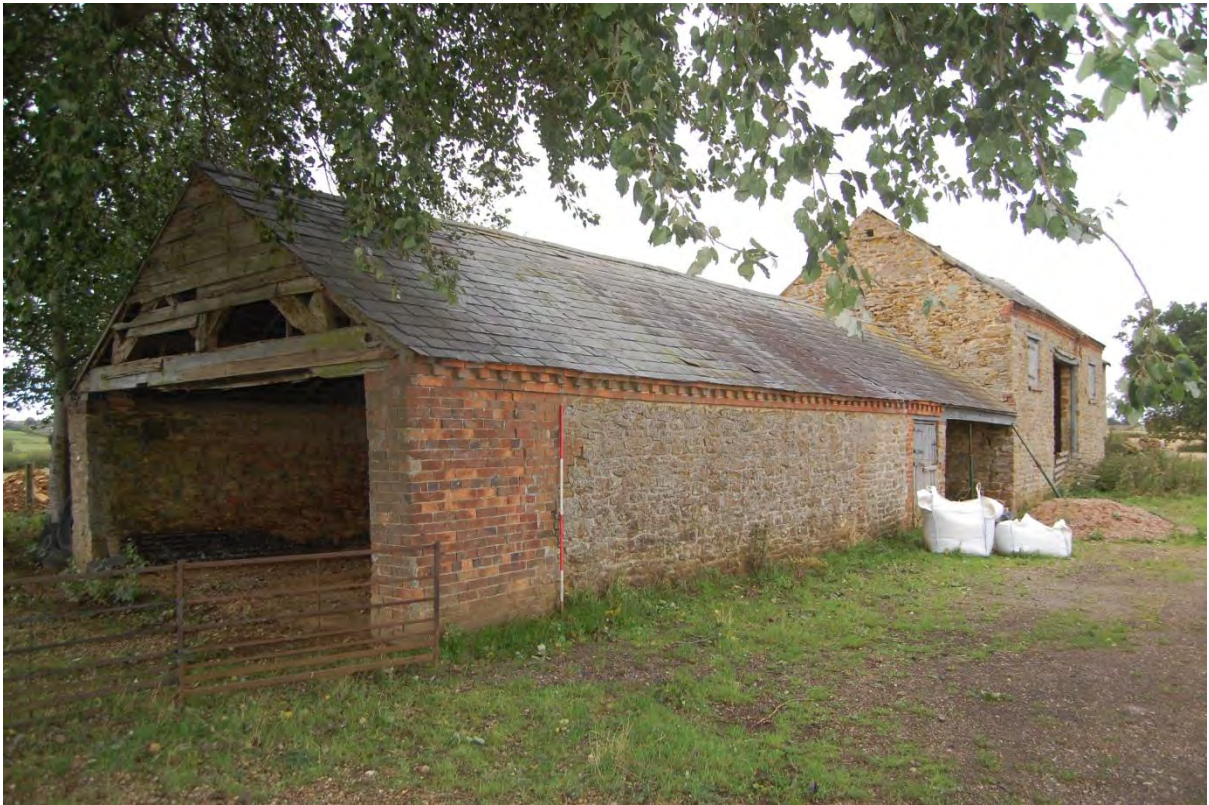
1: View south-west along the north side of the early range

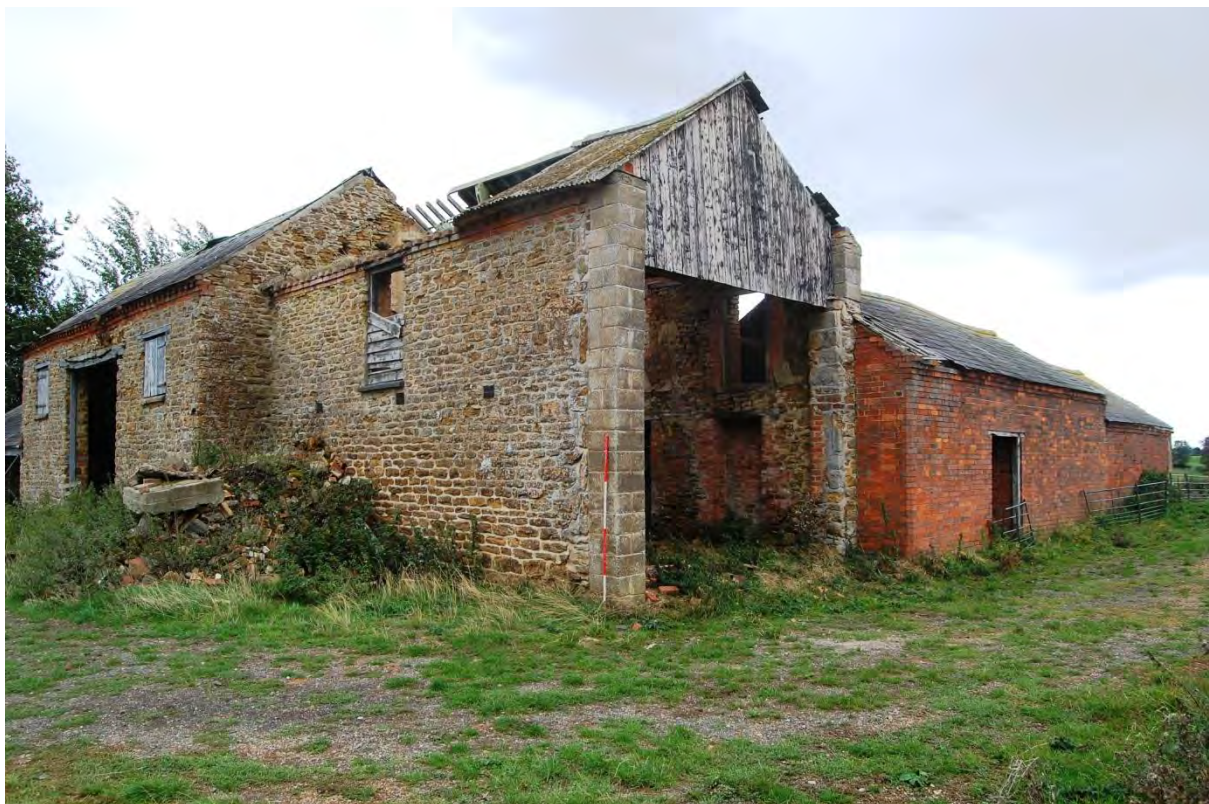
2: Entrance in west wall of granary (Room 3)

- 5.4 This structure occupies the west end of the early range and has stone walls on its south, north and east sides and it has a two-storey full width opening in its west side, facilitating later use for vehicular storage. It measures c.7.8m x 4.3m internally and it was formerly of two storeys, but the floor for the upper storey has been removed, presumably to turn the room into a full height cart or vehicle shed. The northern edge of the opening in the west wall and upper part of the south side has been rebuilt with concrete blocks and the upper part of the gable has modern, vertical weatherboarding.
- 5.5 The floor is constructed from red bricks laid on edge and the timber roof structure is of king-post construction with a slate covering. The walls on the former upper floor have remains of a painted plaster finish (see Photo 2).

- 5.6 There are openings in all of the walls, with a taking-in door to the upper floor in the north wall and a door connecting to the upper floor of the threshing barn (Room 4) in the east wall. The south wall ground floor had a door and a window onto the yard and a blocked door in the western part of the wall, which was probably blocked when the later west range was built and the blocked door was also visible in Room 2 (see below). The south wall upper floor contained two windows overlooking the yard, one of which had been bricked up and a small entrance that had been knocked through the wall to provide access into the roof space above Room 2 in the west range. Bull-nosed bricks have been utilised around many of the openings, at both ground-floor and first-floor level. There is evidence for the internal walls having been plastered, particularly at first-floor level.

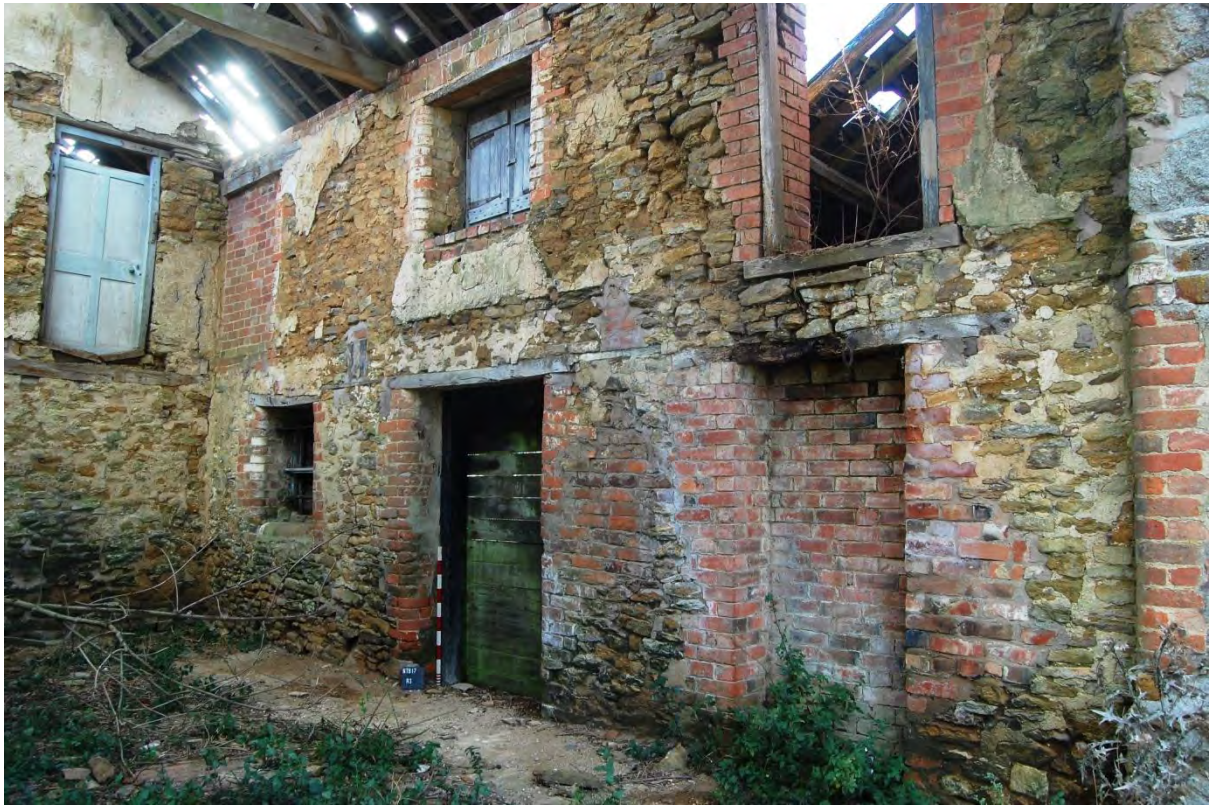
3: South wall of granary (Room 3) looking south-east

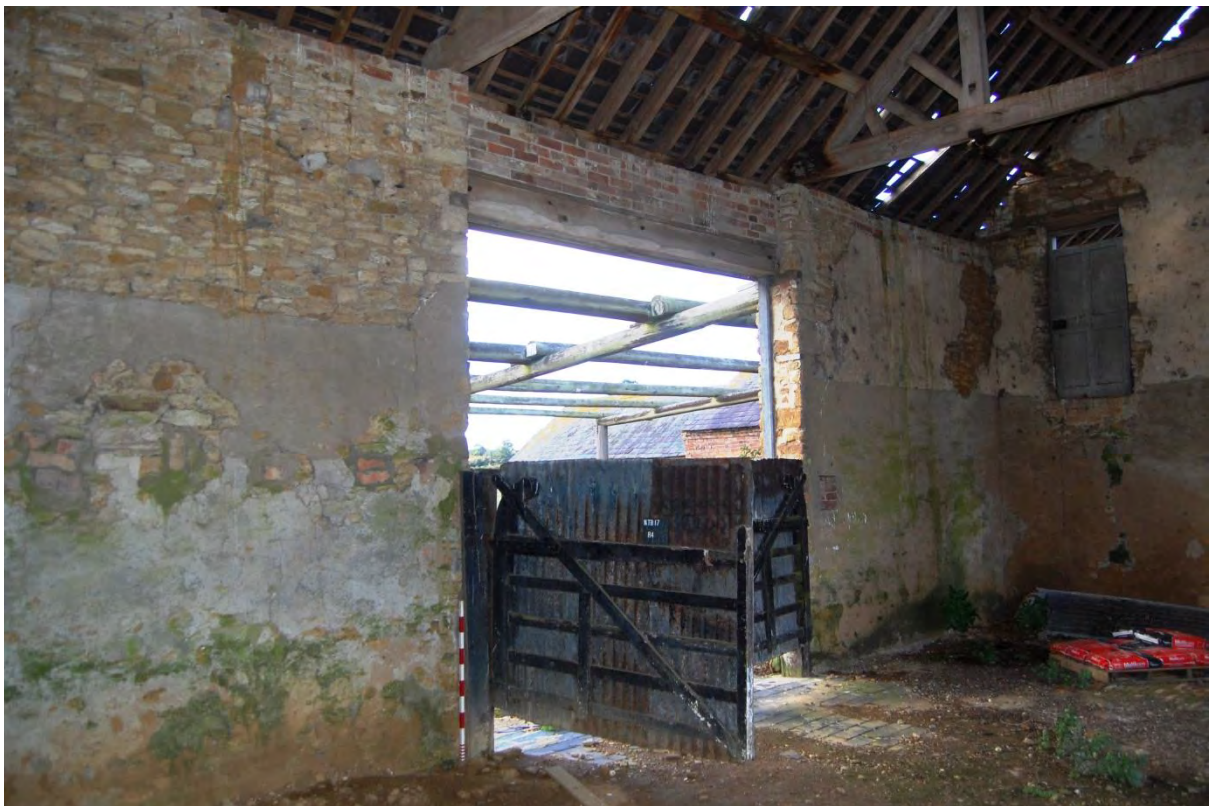
4: South wall of barn (Room 4) showing full height central door onto yard

- 5.7 The threshing barn is a (formerly) two-storey rectangular structure, measuring c.11.2m x 5.5m, with full height opposing central doors. Square, shuttered windows exist on the north wall either side of the threshing door, at first floor level. This structure formed the centre of the early range and was stone built with a slate roof. The structure was plastered internally and a change in the plasterwork and location of a door at first floor level in the west wall suggests that the outer bays had storage lofts. The central threshing area was floored with large rectangular blue bricks or tiles and the floors of the storage areas to either side were made of red bricks laid on edge. The red bricks for the floors in the storage areas were irregular and may have been hand made. The slate roof was of queen-post construction, with iron strapping below

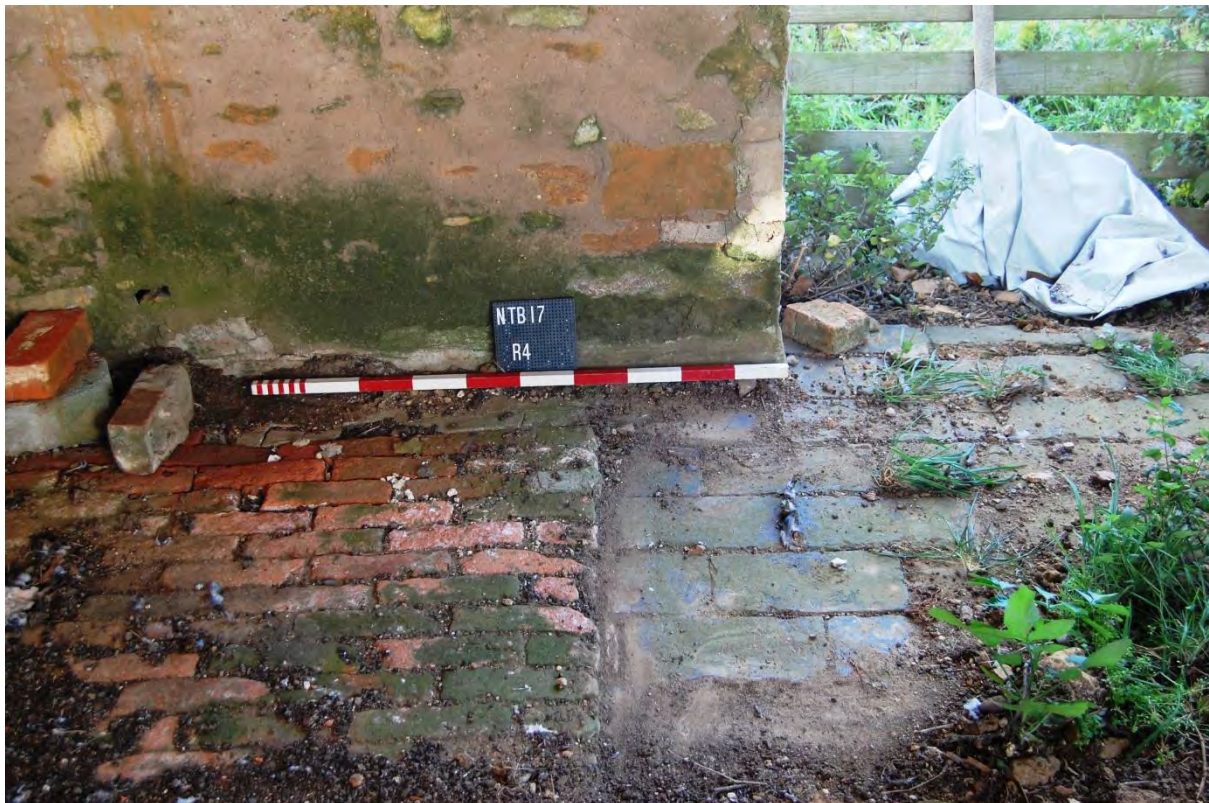
5: Brick floor in barn (Room 4) showing differences in the floor between the central threshing area and side storage areas

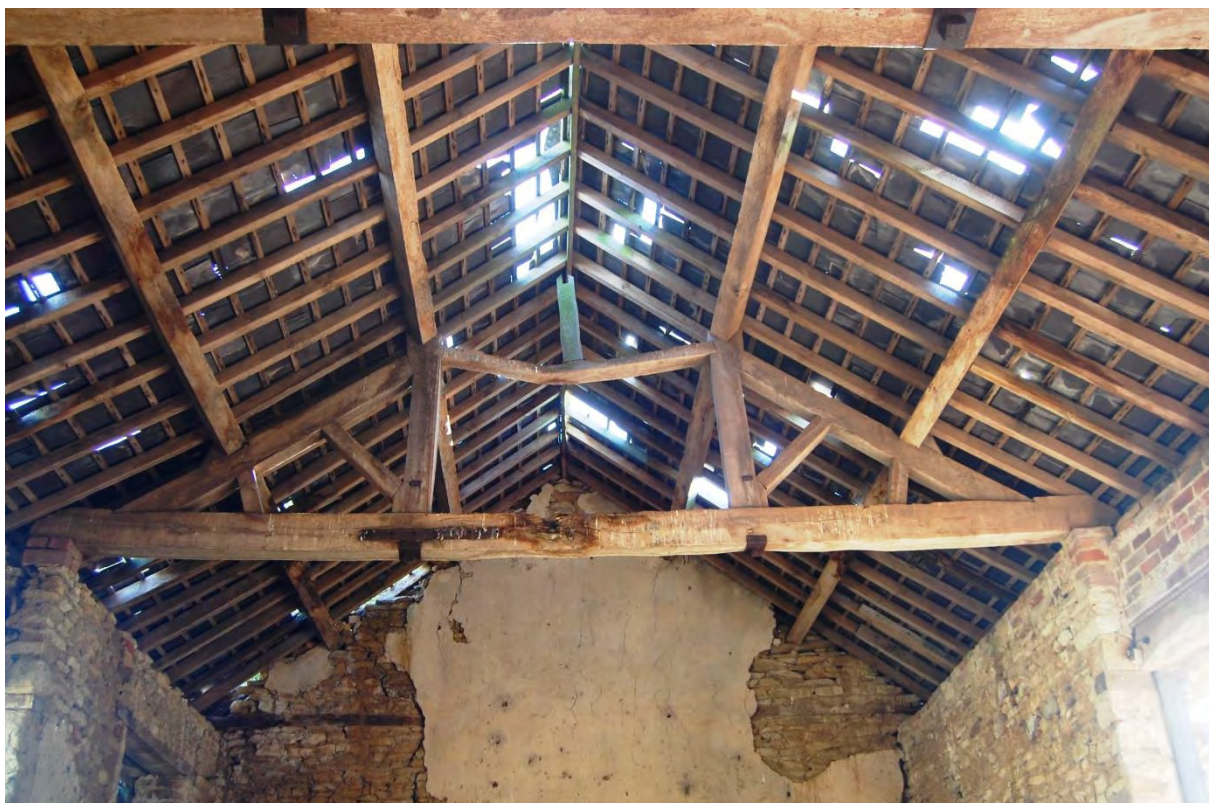
6: The roof structure of the threshing barn (Room 4)

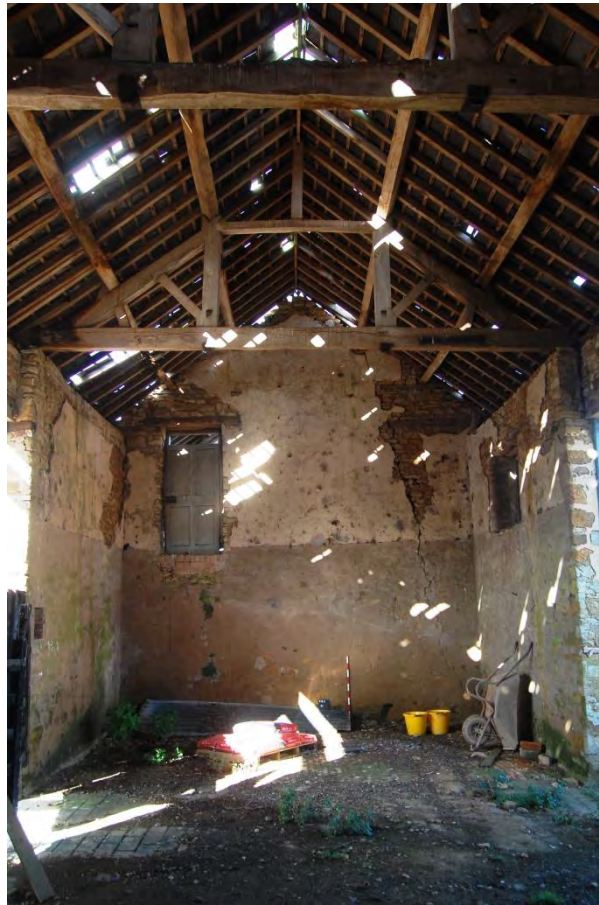
7: West wall in Room 4 showing former upper floor level marked by different paint colours and connecting door to Room 3

- 5.8 The room would originally had upper floors on either side of the threshing area and the walls retained some painted plaster, which showed the level of the upper floors in the different paint colours. There was a connecting door to the former upper floor of Room 3 in the west wall and there were small square taking in doors to the upper levels in the north wall.

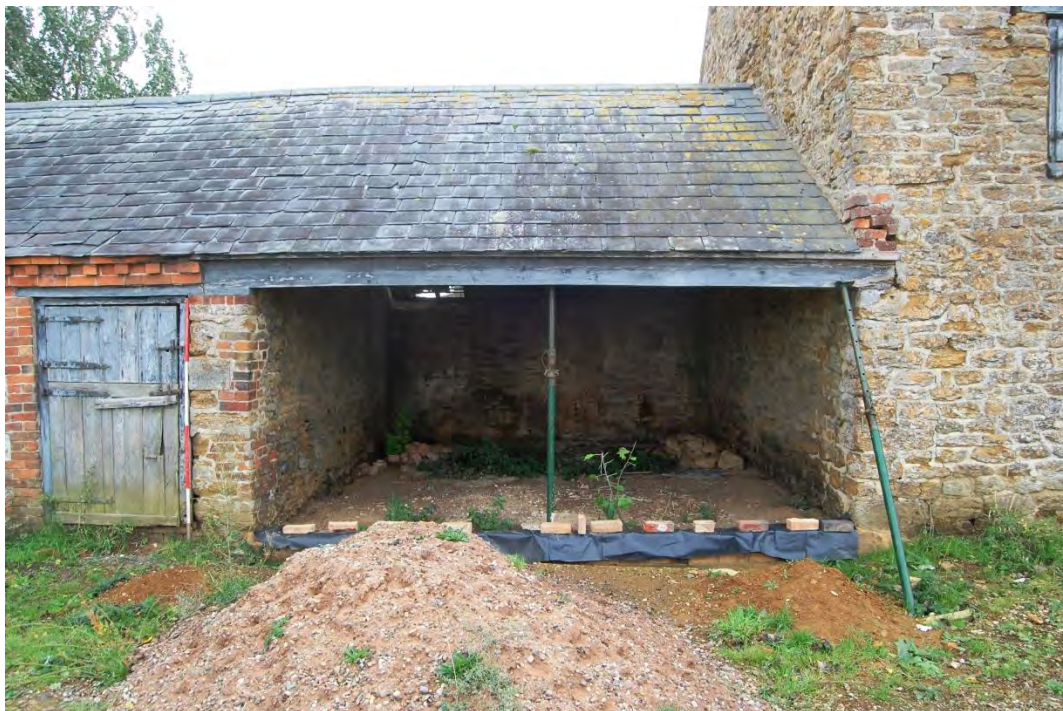
8: View into former cart shed (Room 5)

- 5.9 A former cart shed, c.6.1m x 4.8m, on the east side of the threshing barn, open fronted on the north side for access. Stone-built with a slate roof and clay floor. King-post roof structure. Walls unplastered.

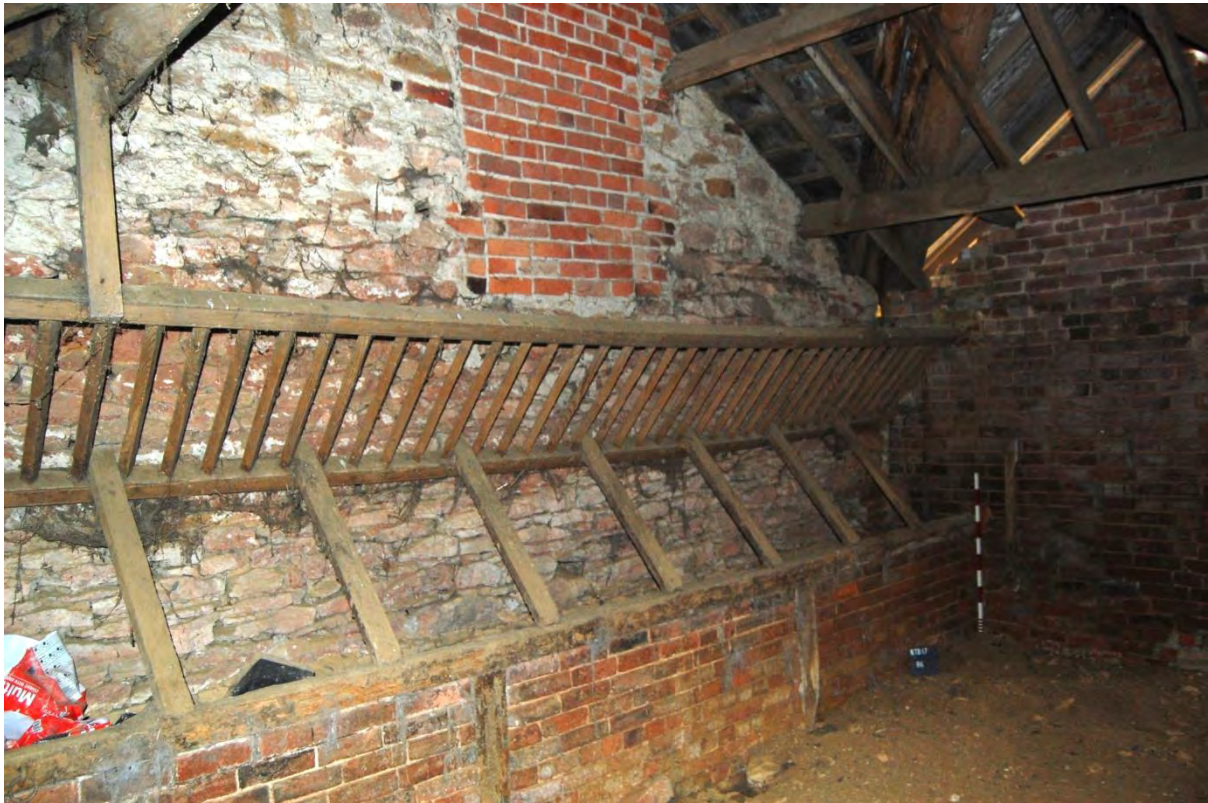
9: East wall of Room 6 showing feeding trough, hay rack and blocked opening

- 5.10 A small animal shed and feed room, c.5.5m x 3.5m, on the east side of the cart shed Room 5. The room was part of the original range and is stone built, although the south wall is of red brick, with a slate roof, suggesting it may originally have been open to the yard. It has a brick floor and a brick-built feeding trough with timber hay rack above along the east wall.
- 5.11 The north and east walls have some repairs in brick and there is a blocked opening in the upper part of the east wall that was also visible in the adjacent Room 7, although it is not certain what the opening was for. There are opposing two-part stable type doors in the north and south walls, with that in the north wall possibly a later addition as joints in the stonework of the north wall suggest it has been inserted, or is a rebuild of an earlier door.

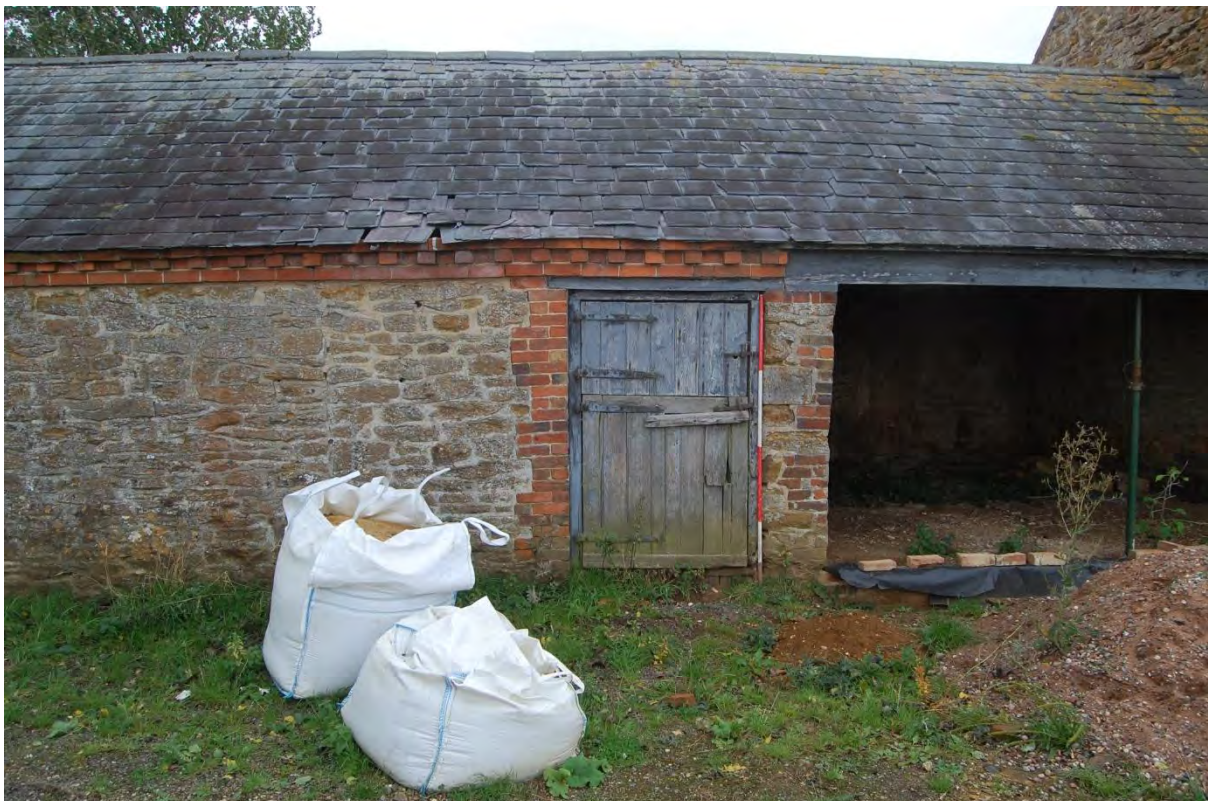
10: Door in north wall of Room 6 showing joints in the stonework

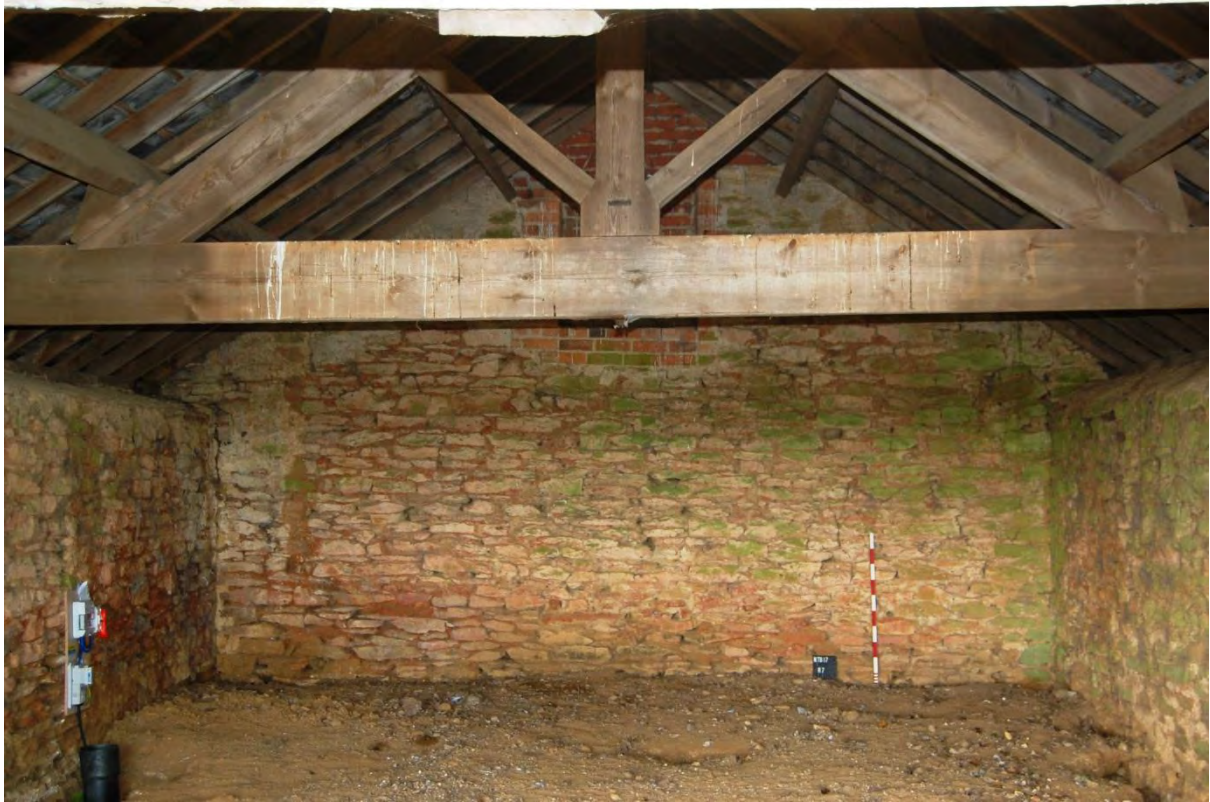
11: View into cart shed (Room 7) from open east end

- 5.12 A rectangular, c.7.9m x 5.3m, open-ended room on the east end of the early range. The east end of the north wall is in brick and appears to be a rebuilt section. The south, west and north walls are stone built and it has a slate roof supported by a king-post truss structure. The east wall has a full width opening with the upper part of the gable end horizontally weather-boarded. It had a clay floor and was presumably a cart or vehicle shed.

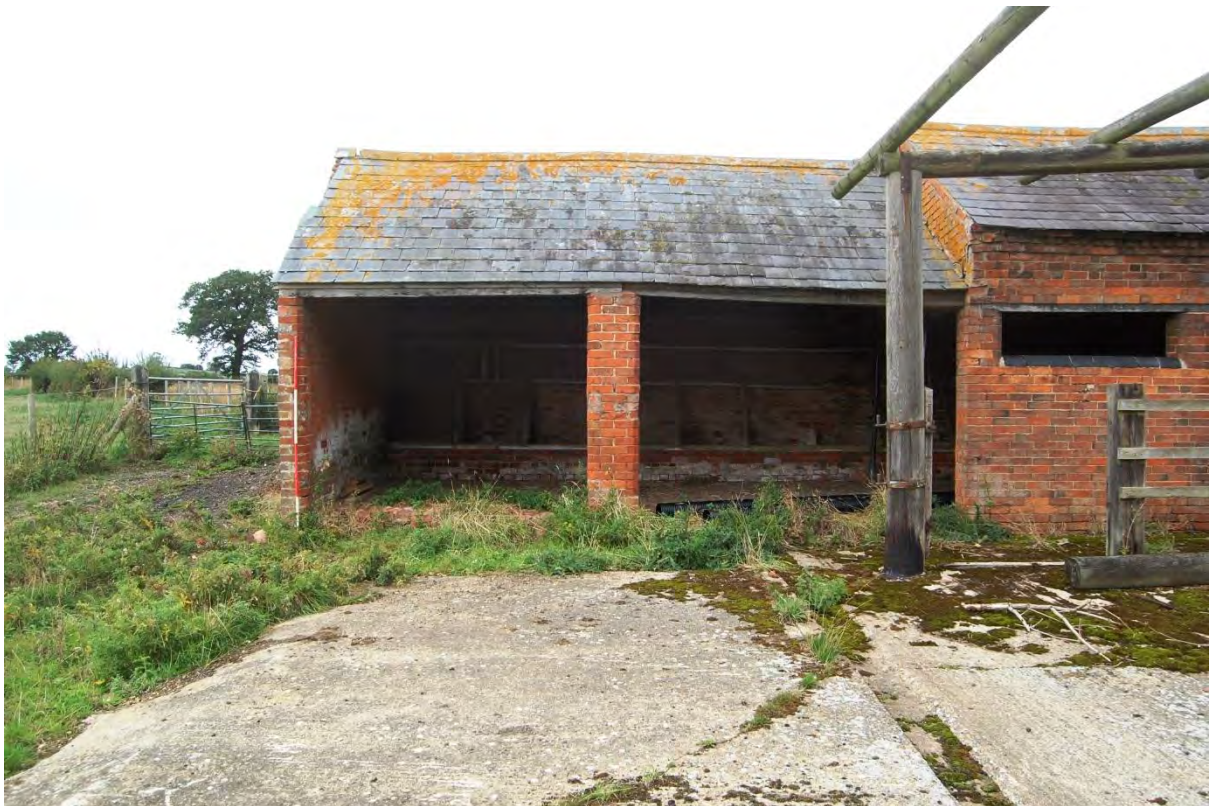
12: View east into western shelter Shed (Room 1) showing the open east side and feed troughs along west wall

- 5.14 A rectangular brick-built structure measuring c.11.1m x 4.2m occupying the southern part of the western range. It is open sided to the central yard on its east side with a brick feeding trough with a timber hay rack above along the west wall. The floor is red brick laid on end and there is a drainage channel running along the east side. The brick-built pillars on the open side have chamfered corners to protect the animals using the shed. The northern section of the east wall is bricked up to three quarter height and topped by black half-round coping bricks. The structure would have originally functioned as a shelter shed.
- 5.15 The southern half of the shed was full height, but the northern half had a small store above accessed via a square hatch in the ceiling. A wooden door in the north wall connects to Room 2.

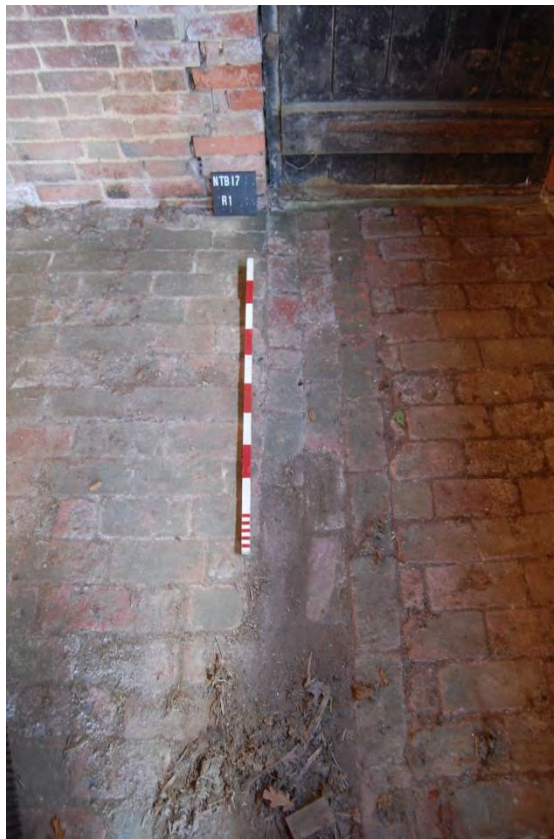
13: Detail of brick floor and drainage channel in Room 1

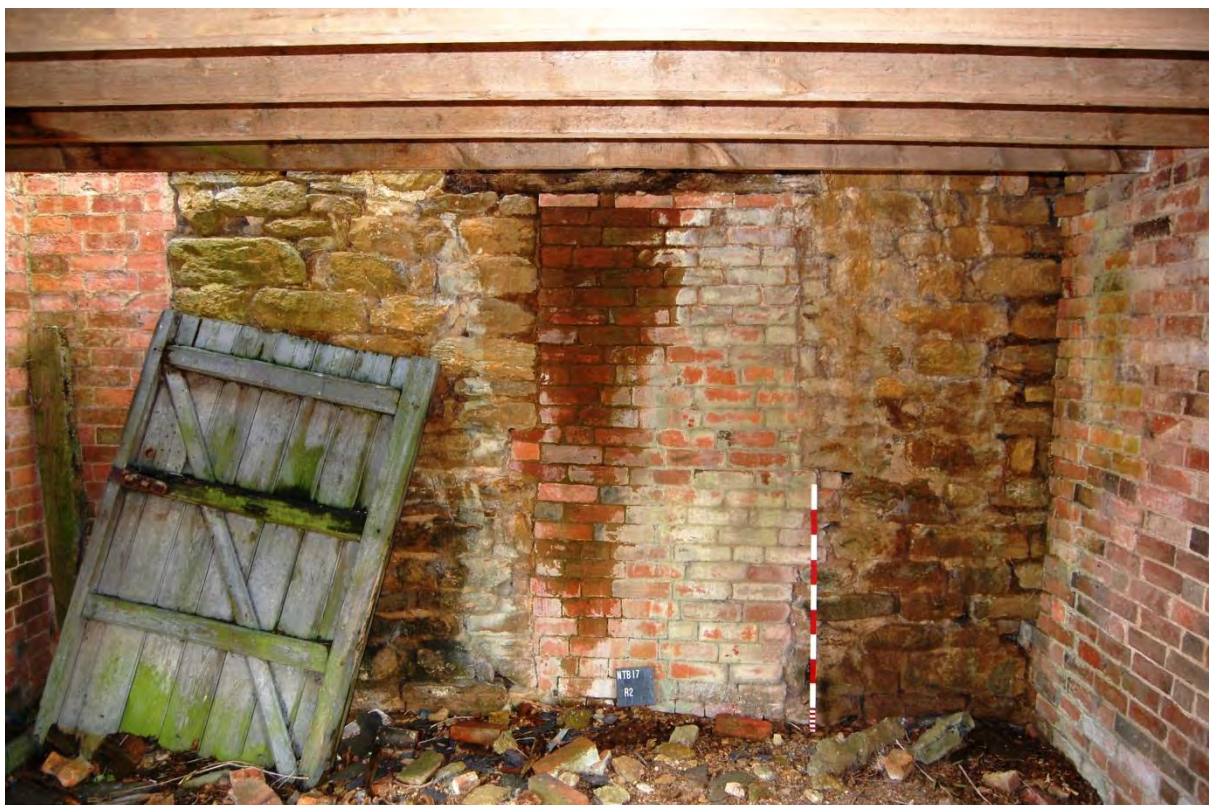
14: North wall of Room 2 and the blocked doorway into the original range

- 5.16 Room 2 is a small room on the north end of Room 1 and forms part of the same structure as the northern part of Room 1. It measures 4.2m x 4.1m. It consists of three brick walls built against the south side of the earlier stone range and a bricked-up door in the north wall into the original range (Room 3) was presumably blocked when the west range was added. A wooden door in the south wall connects to Room 1 and there are opposing doors in the east and west walls. A small upper storage space was accessed from the upper floor of Room 3 to the north.
- 5.17 The room has a red brick floor and there were no fittings or fixtures in the room to suggest its former use and it is likely it was small store room. There is a wooden floor to the first floor, which was not accessible.

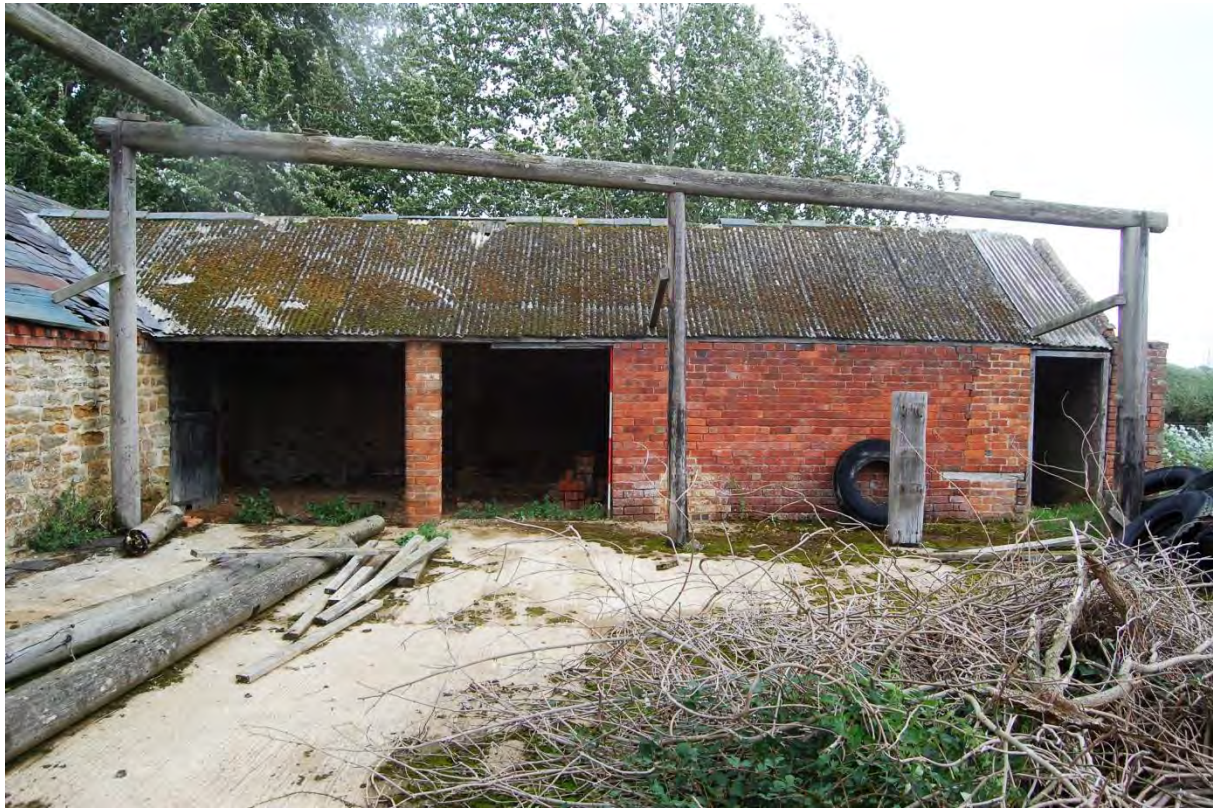
15: Eastern range viewed from the yard (Rooms 8 and 9)

- 5.18 A rectangular open sided animal and feed shed, c.7.6m x 3.8m, occupying the north end of the east range and built against the south wall of the earlier range. The floor is

red bricks set on edge with a drainage channel running along the west edge, suggesting there was originally a feeding trough along at least part of the east wall. It connected to Room 6 via a two-part stable type door. The south is a later addition to form a small store (Room 9) on the south end.

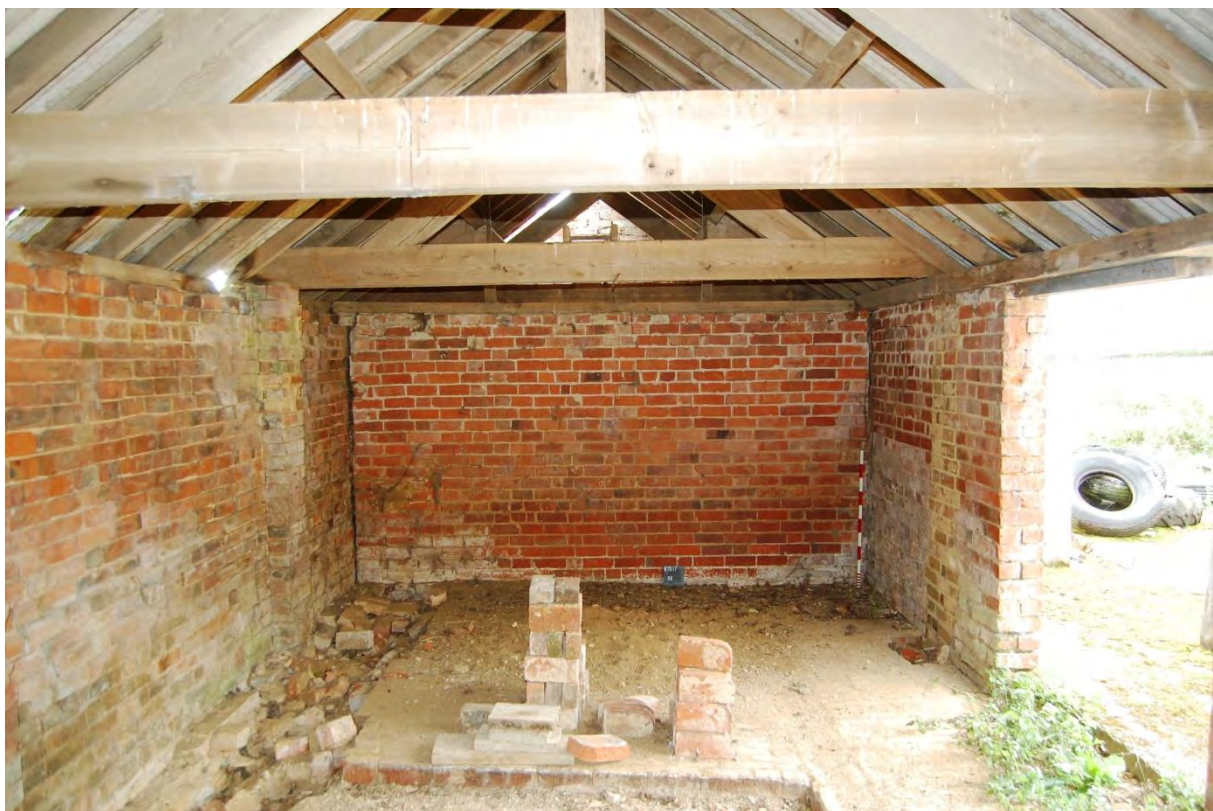
16: South wall of Room 8, a later insertion to create a small store room (Room 9) on the south end of the east range

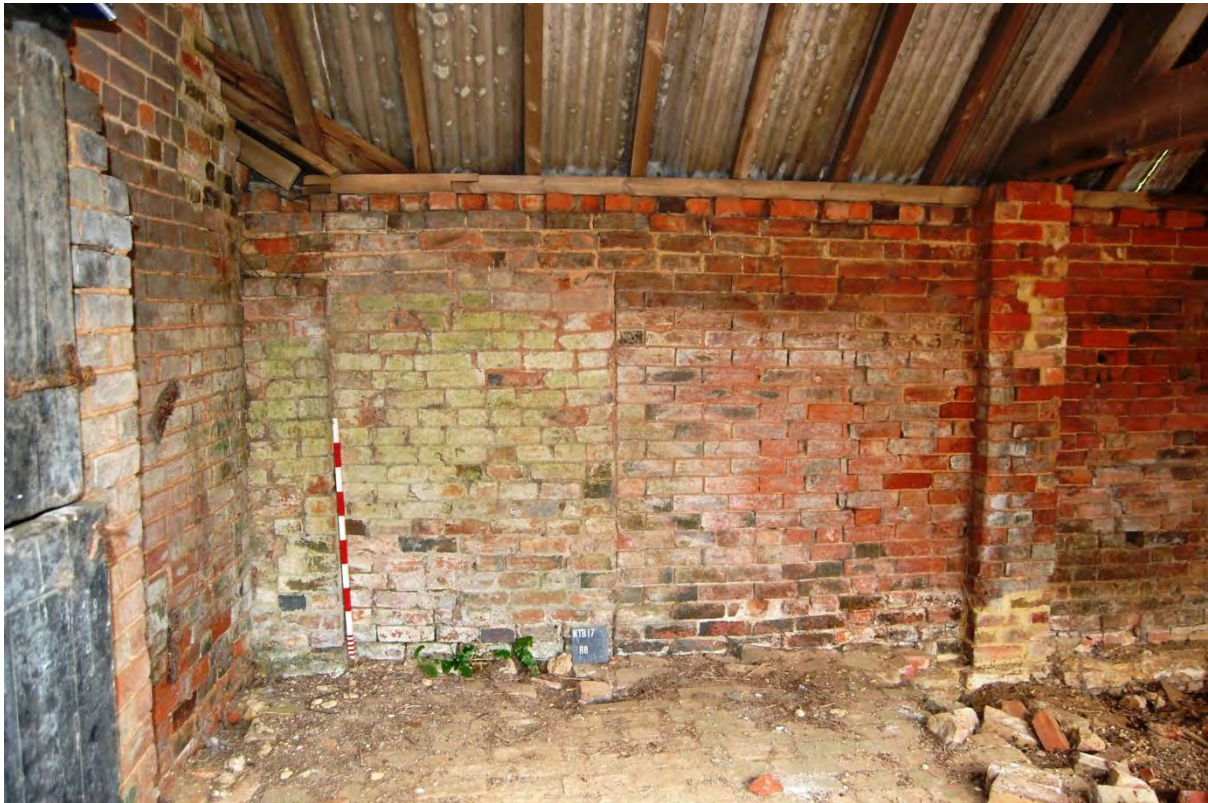
17: Blocked doorway in east wall of Room 8

- 5.19 There is a blocked door in the east wall that formerly gave access from the track and fields to the east of the yard. The east wall was constructed on a sandstone block foundation that also continued below the east wall in Room 9.

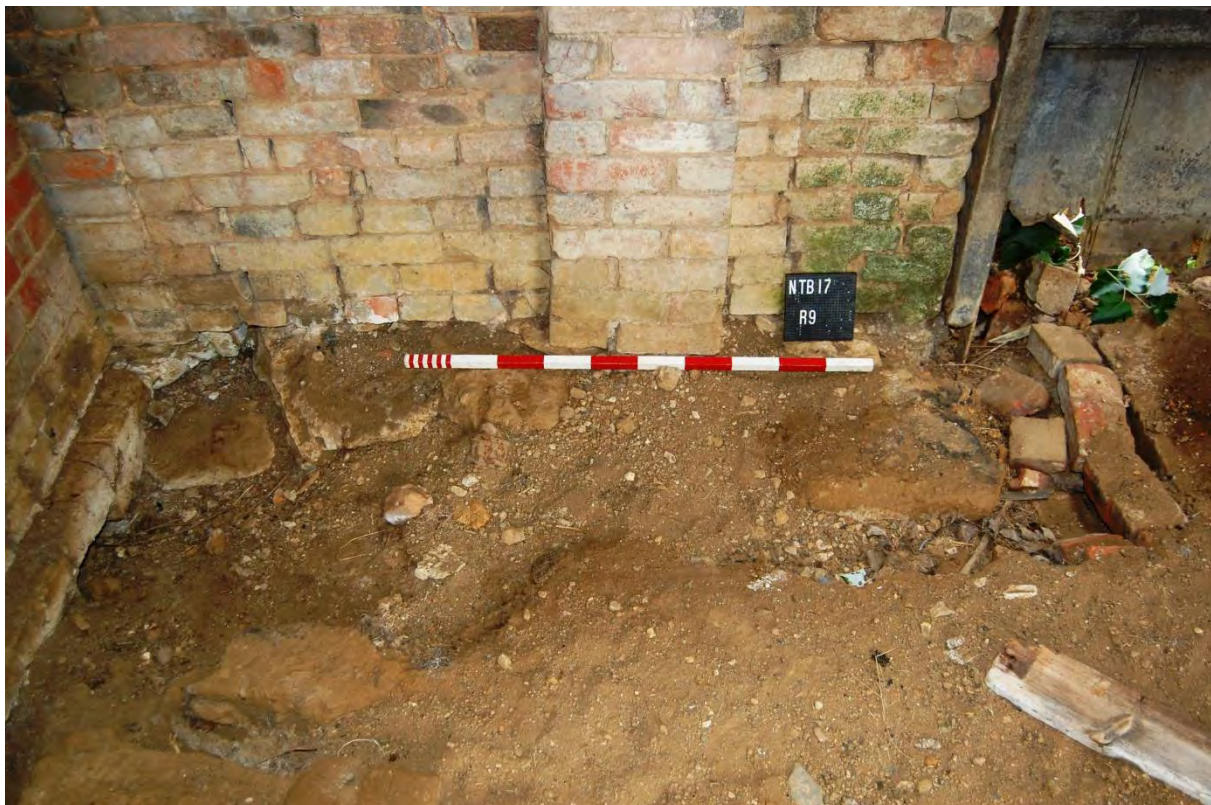
18: Sandstone block foundation below the east wall of Room 9

- 6.4 It is clear that the north range was the earliest building within the complex and it consisted of a threshing barn with adjacent storage and cart sheds and the presence of the sandstone blocks below the east walls in Rooms 8 and 9 may suggest that originally it also had a range on the east side of the yard. Although there were no clear dateable structural elements in the surviving buildings of the early range, and it was not shown on the early 19th-century Ordnance Survey drawings, it is possible it dates from the 18th century. The later east and west ranges, which were both shown on the late 19th-century Ordnance Survey 1st-edition map, were added against the south wall of the north range during the mid-19th century.

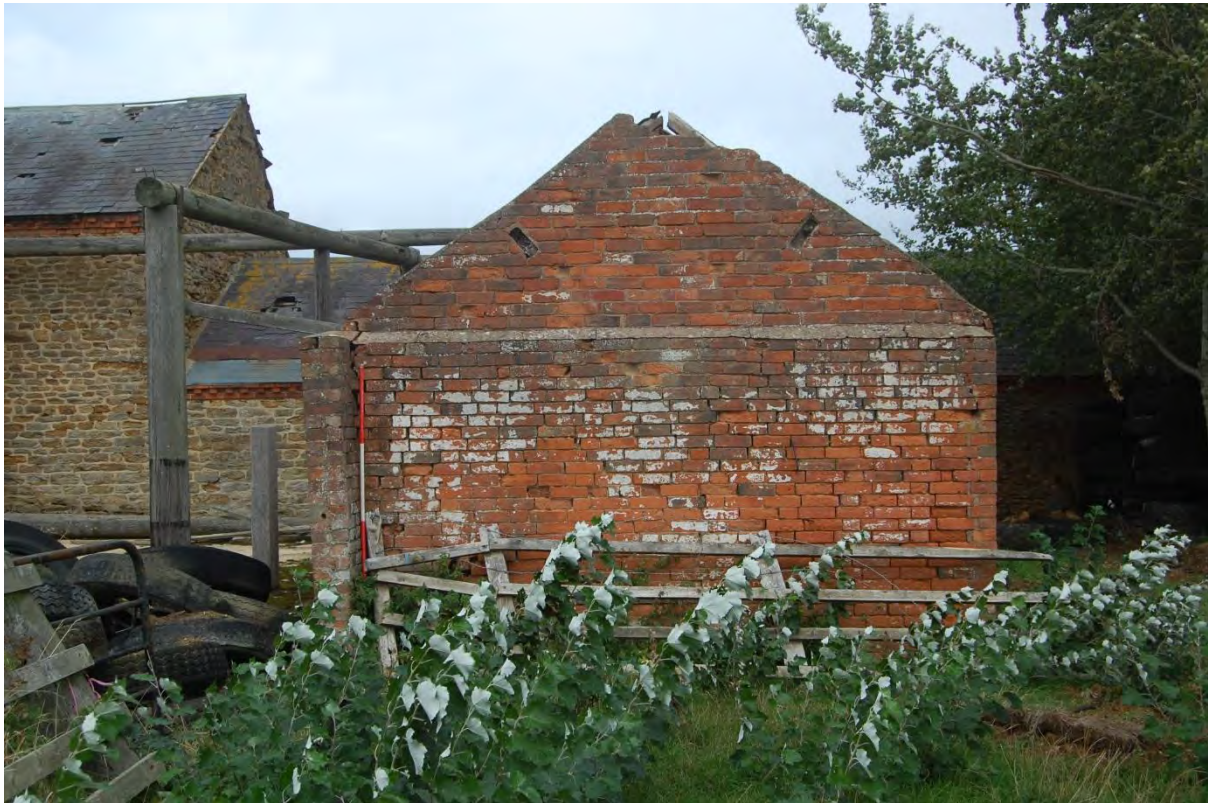
Photo 19: Purlins visible on the south gable wall of eastern range

- 5.20 A small room, 3.85m x 3m, formed by the insertion of the south wall of Room 8. The brick floor and roof structures area continuation of those in Room 8 and the purlins continued through the south wall and were visible on the external elevation, suggesting they may have originally continued into the demolished building on the south end of the range.
- 5.21 There are opposing doors in the east and west walls, which would have allowed access to and from the central yard and the track and fields to the east.
