Prologis Park Ryton-on-Dunsmore Warwickshire

ARCHAEOLOGICAL OBSERVATION AND RECORDING

Archaeology Warwickshire Report No 1626

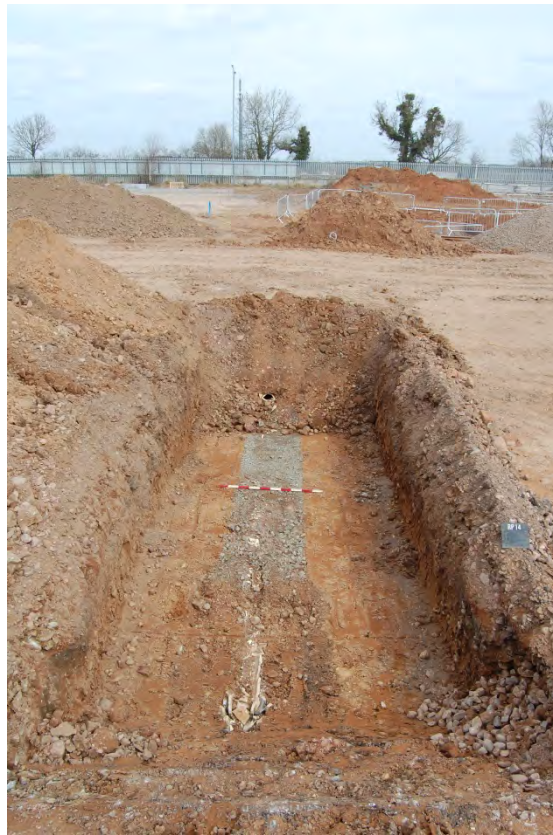
1. Initial ground reduction in 2014

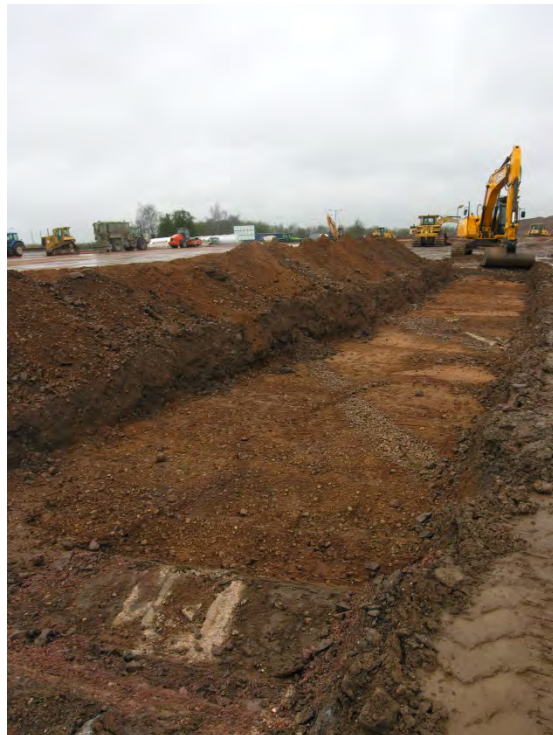
5.4 The natural sand was overlain by a make-up layer, which contained building debris, including fragments of brick and stone as well as Tarmac and concrete (100). This was recorded within trenches and across the central area (Photo 2).

5.7 Evidence of previous disturbance of the site was recorded, including concrete intrusions and drain cuts. The deposit sequence recorded at the northern edge of site revealed extensive depths of make-up deposits with no evidence of geological natural exposed.

2. Ground reduction showing intrusive concrete and drainage cuts in 2014

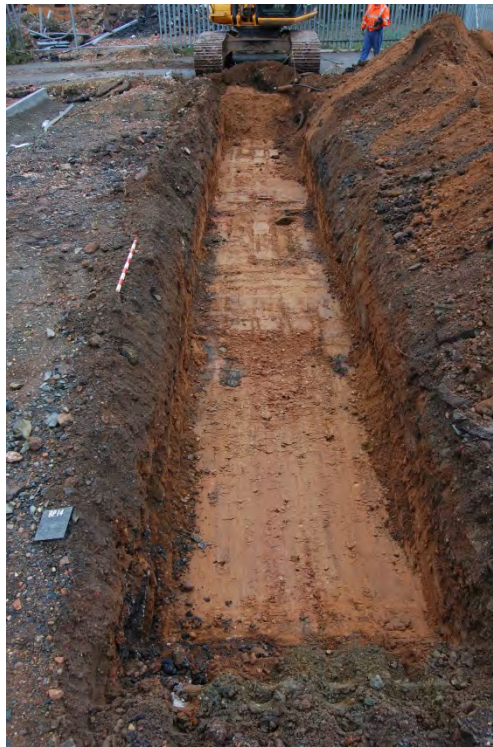
5.3 Trenches observed in the central area revealed a layer of brown sand or sand and gravel (102). This natural geological layer was recorded at between 0.45 and 0.55m below ground surface and contained no archaeological remains.

3. Revealed natural and deposit sequence in 2014

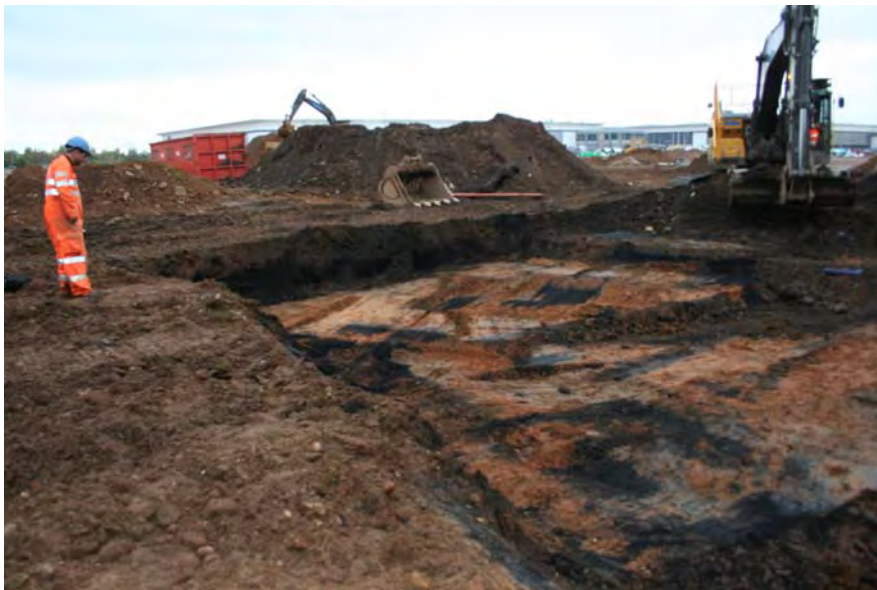
5.16 This silt layer was overlaid by a deposit of coal slag or waste (20), which ranged in thickness between 0.4m and 0.5m. This layer was reduced in spits and produced no finds. A further dump layer of brownish grey silty sand (19) with a few inclusions of pebbles and crushed building material was recorded. This crushed building material overlaid the coal waste deposit and this modern layer varied in thickness between 0.3m to 0.5m across the area of investigation and produced no significant remains or finds (Table 3).

4. Contexts 19 and 20 looking north-east

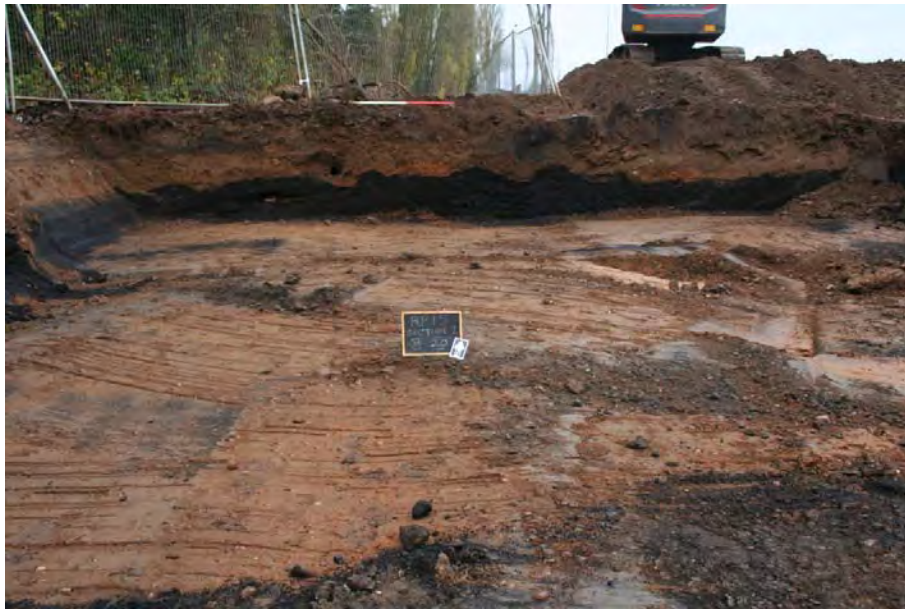
5. Ground reduction showing extensive modern redeposition

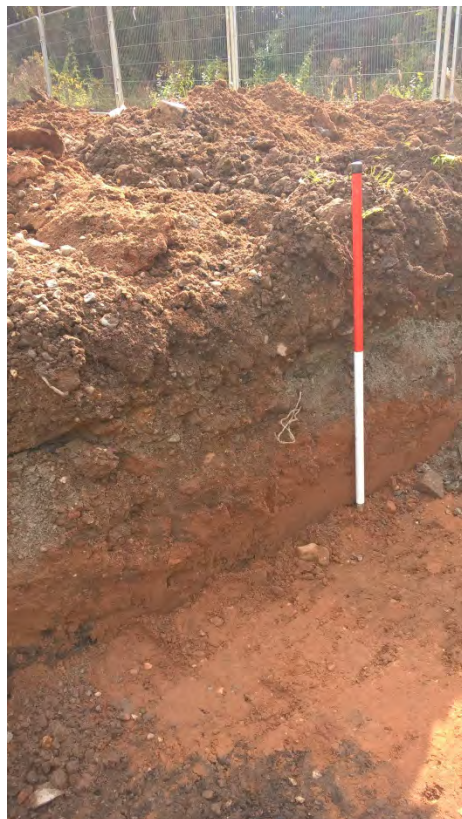
5.12 Areas 2 and 3 were approximately 6m long and 2m wide and excavated to a depth of between 0.85m and 1.5m deep. In both cases a simple deposit sequence was revealed (Photo 6), which consisted largely of modern deposits relating to previous construction, demolition or levelling (see Table 2). Several concrete or modern intrusions were exposed (Fig 4).

6. Section showing deposit sequence in Area 2

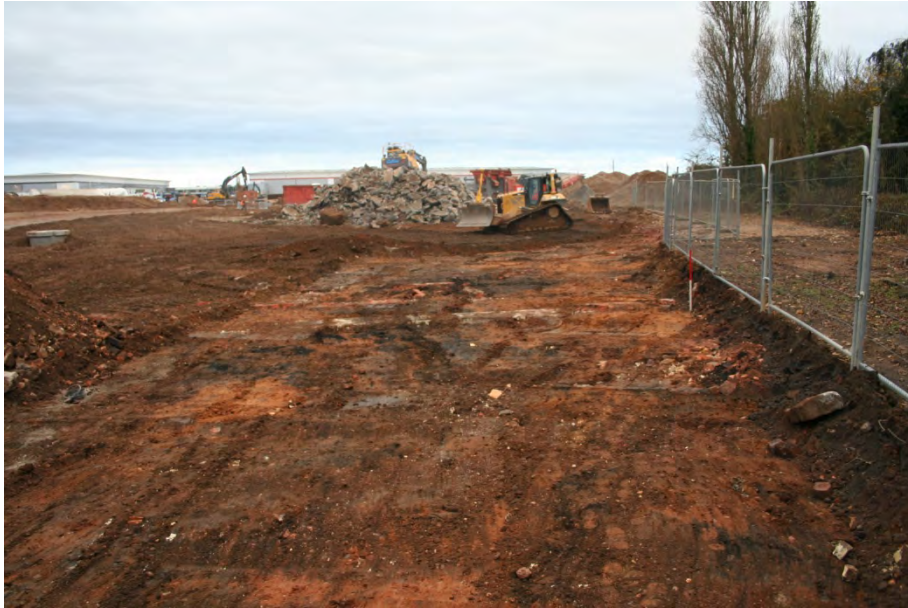
7. Ground reduction looking south-east

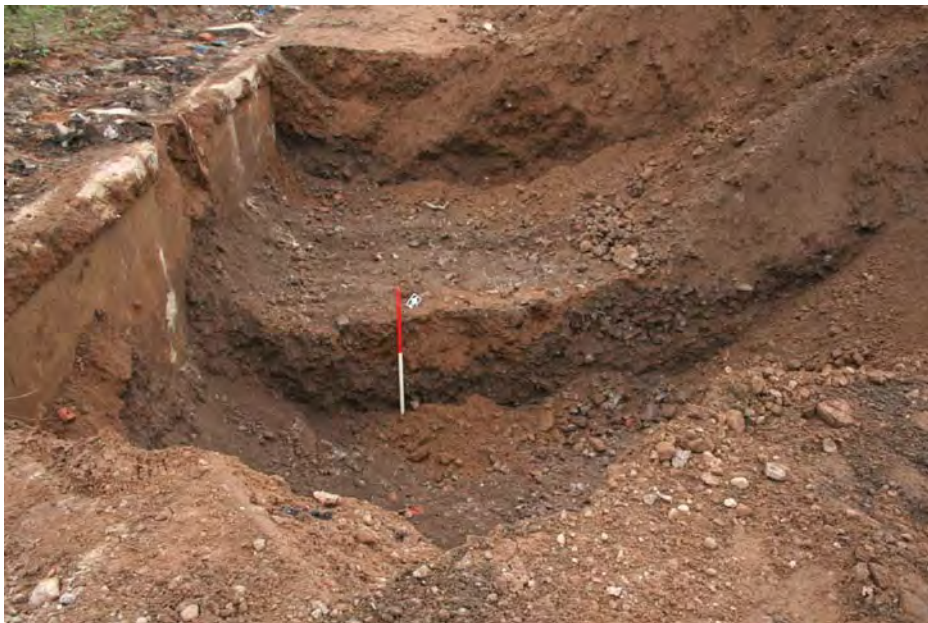
5.20 A borrow pit was excavated in the south-eastern part of the watching brief area (Fig 3) and ground reduction was undertaken in spits. The area measured c.35m long and 32m wide and revealed a concrete wall foundation (35) and a cast iron service pipe. The area of reduction was amended to avoid the service pipe and further substantial concrete foundations were revealed (Photo 8).

8. View north-west showing extensive truncation

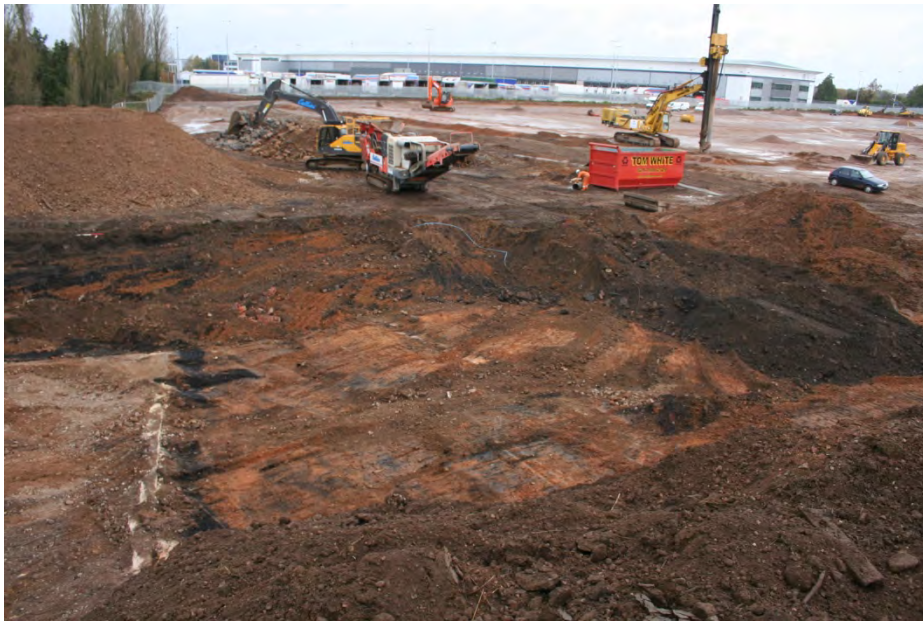
9. Area reduction looking north-west
