Spinney Brook, Glebe Farm Road, **Bourton and Draycote,** Warwickshire

Archaeological Evaluation

Report No 1202 January 2012

Site Code: BD12

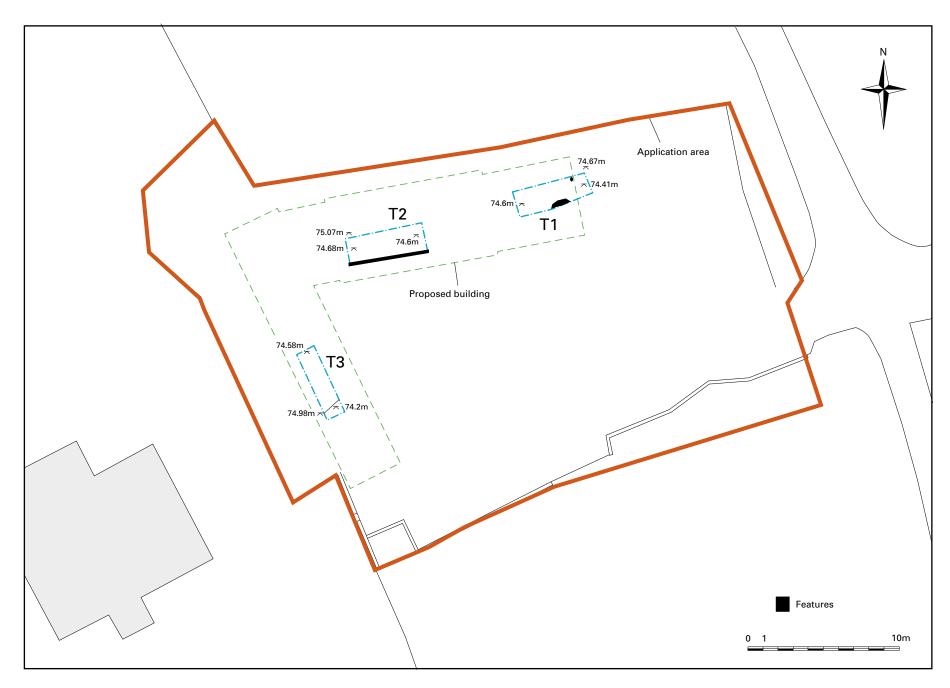
Fig 4: Evaluation trench locations

5.3 Trench 1 was located in the eastern half of the site and was 5m long and 1.6m wide (Fig 4).

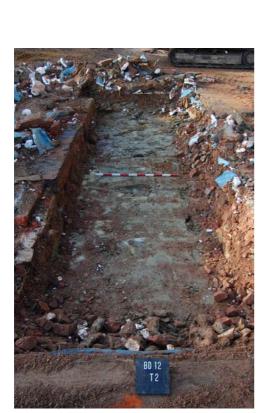
Fig 8: Trench 2 looking west

- 5.8 A layer of yellowish grey clay (204) containing some fragments of limestone was revealed at the bottom of the trench. This layer was similar to the natural geological layer recorded in Trench 1.
- 5.9 No significant archaeological features or deposits were revealed in the trench. A brick wall (203) extended along the southern edge of the trench. The regular bricks were bonded with lime mortar and formed a foundation a minimum of 0.25m wide. This foundation was associated with the brick buildings previously on this part of the site.

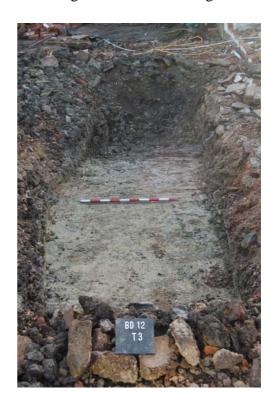
Fig 9: Trench 3

- 5.10 Trench 3 was located in the western half of the site and was 4m long and 1.6m wide. No archaeological features were revealed in the trench. Geological natural clay was revealed across the trench, but this was not cut by any significant features.
- 5.11 A concrete slab (300) and its make up layer (301) extended across the trench and this relates to previous floor slab and external hard standing.
