# Baginton Mill Weirs, Baginton, Warwickshire

## Archaeological Watching Brief

Report No 1209  
February 2012

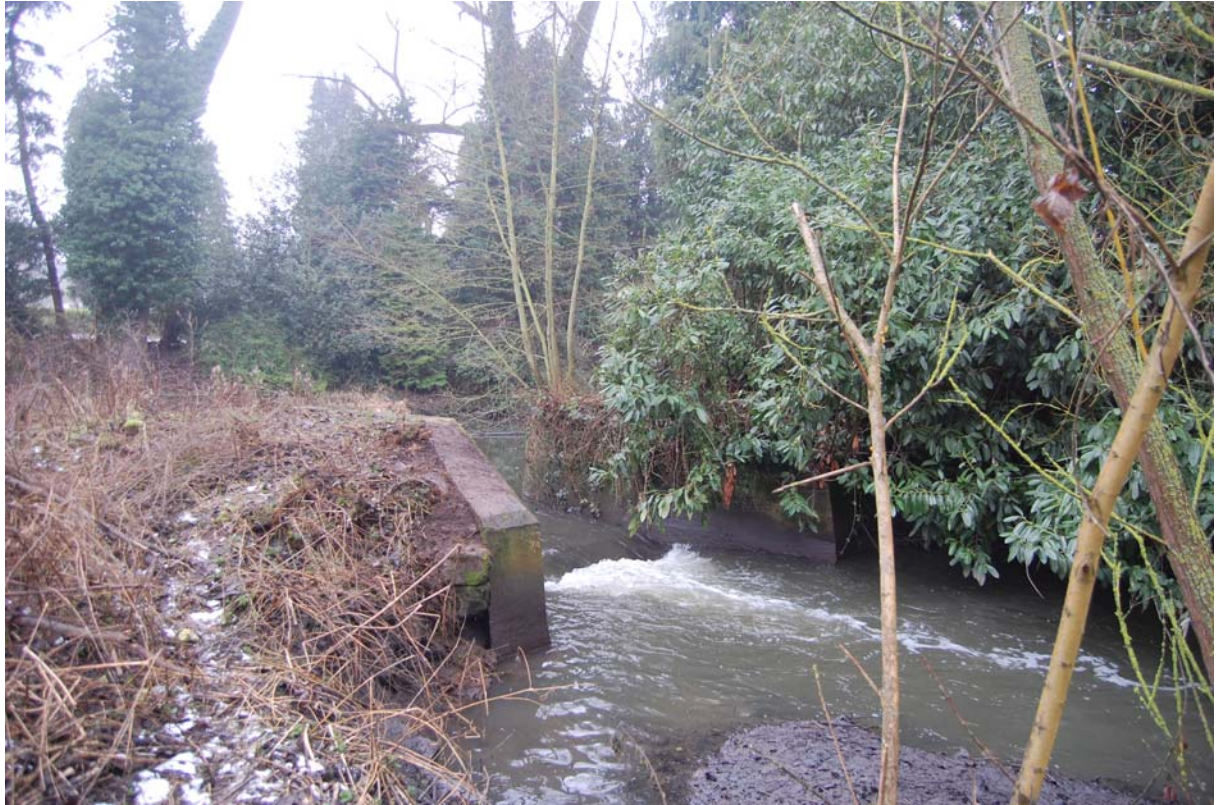
Fig 9: Photograph showing weir before demolition

5.2 Initial work involved stripping the vegetation from behind the top of the eastern wingwall (1), which exposed the concrete walling (Fig 9). This had a curved southern edge, then 2m of straight section before it splayed back and down to the north-east for a further 2.50m. The concrete walling itself was 0.50m thick and a maximum of 1.90m high. Immediately behind the concrete walling was brick and sandstone rubble (6) which may be the fill of a construction cut (8) for the wingwall structure. When the wingwall was removed a section through the dam which lay behind it was exposed (Fig 10). The make up of this was more clearly revealed when the channel leading up to the sluice was drained. This showed the dam to be made up of over 0.4m of brown clay (bottom of layer was not exposed). On top of this was a 1m thick layer of red clay (5), which was clearly the core of a constructed dam as clay is not the geological natural of the area. This was overlain by 0.8m of topsoil (4).

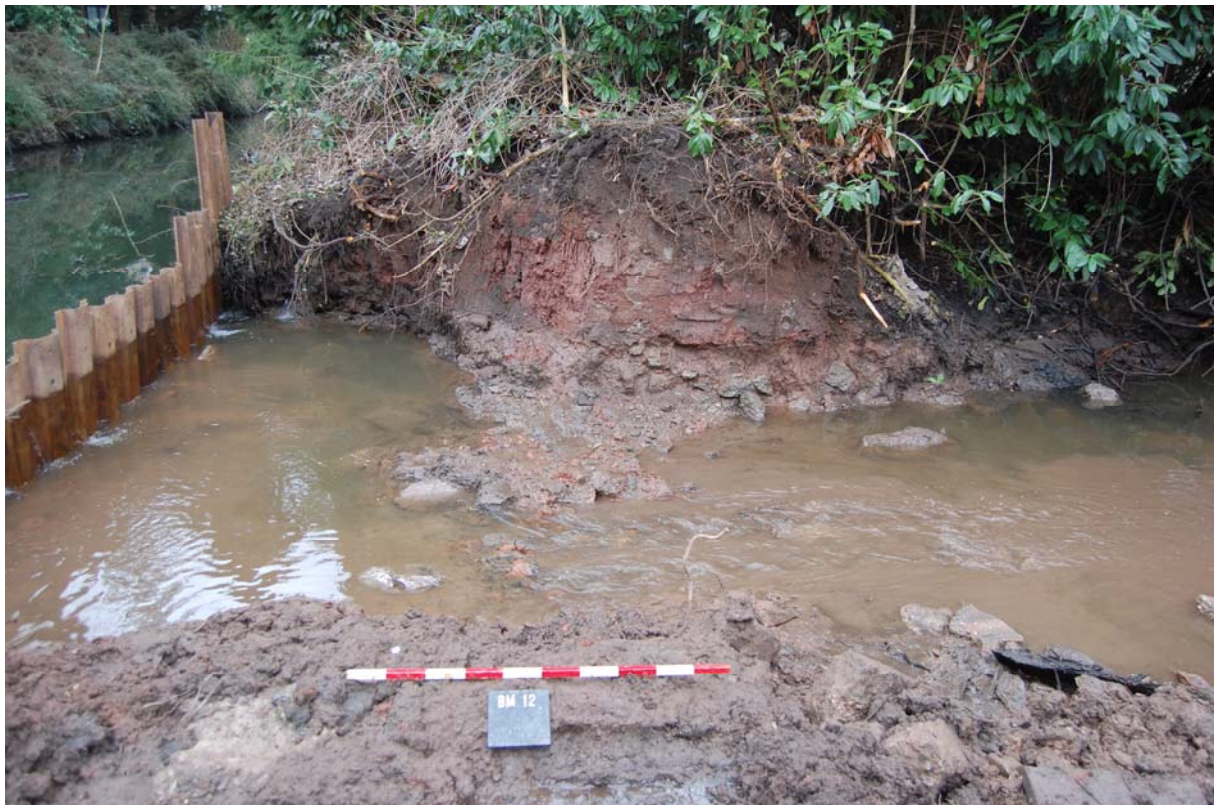
Fig 10: Photograph showing section through sluice dam with channel partly drained, looking north

was broken up by machine and allowed to drop onto the weir, where it assisted in impeding the water flowing up the sluice channel. The western wingwall (2) was similarly broken up but due to its inaccessibility it was not surveyed (its precise form and position on Fig 8 is conjectural, based partly on Ordnance Survey mapping). The walls were made of concrete with occasional, steel reinforcing bars (but not a full mesh/cage skeleton) and sat on a concrete base (3). Following the removal of the wingwalls, the base slab itself (approximately 0.25m thick) was removed by machine and during this process the remains of the wooden sluice-gate were noted (7). More soil was removed from the area beneath the slab once the channel was mostly drained of the water. Except for revealing the section of the dam, mentioned above, no earlier remains or additional layers were exposed.

6.1 The earliest feature exposed during the work was almost certainly the dam associated with the weir structure. This was probably constructed when the northern sluice channel was originally built, probably in the late 18th or early 19th century. No remains of an earlier weir structure appeared to survive on the site and it was the opinion of the contractors that the type of re-enforcing visible within the concrete wingwalls of the weir during demolition were typical of 1950s or early 1960s construction. This would imply that these were replacement wingwalls for the weir that has been in this location since the beginning of the 20th-century at least.
