5 Avonbank Drive, Luddington, Old Stratford and Draycote, Warwickshire

Archaeological Watching Brief

Report No 1114
July 2011

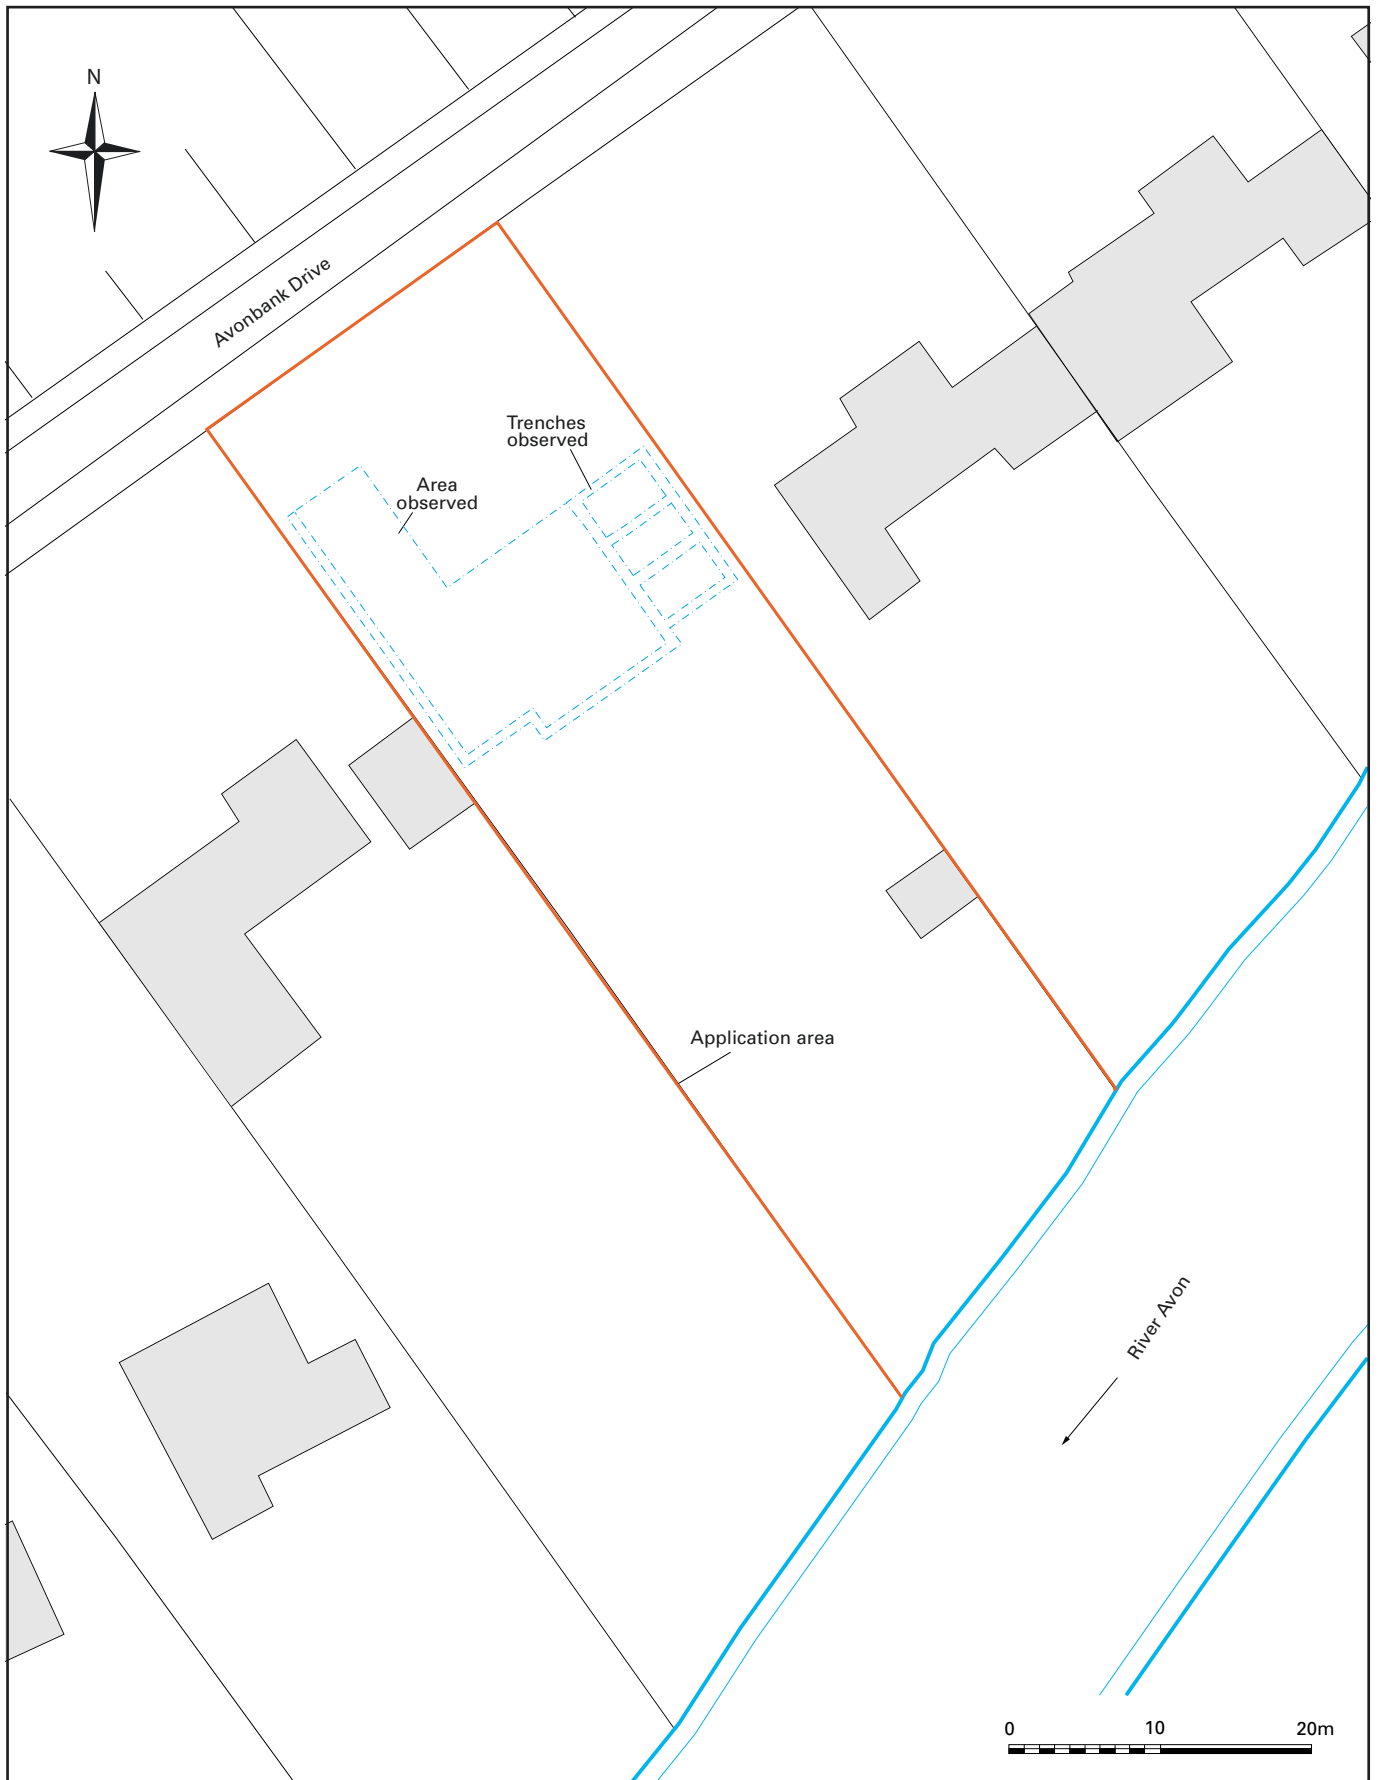
Fig 2: Area and trenches observed

5.1 The former bungalow on the site was demolished prior to site being visited. The new footprint (Fig 2) was partially stripped of up to 0.3m of topsoil whilst only the eastern, southern and northern foundation trenches for the new building were observed.

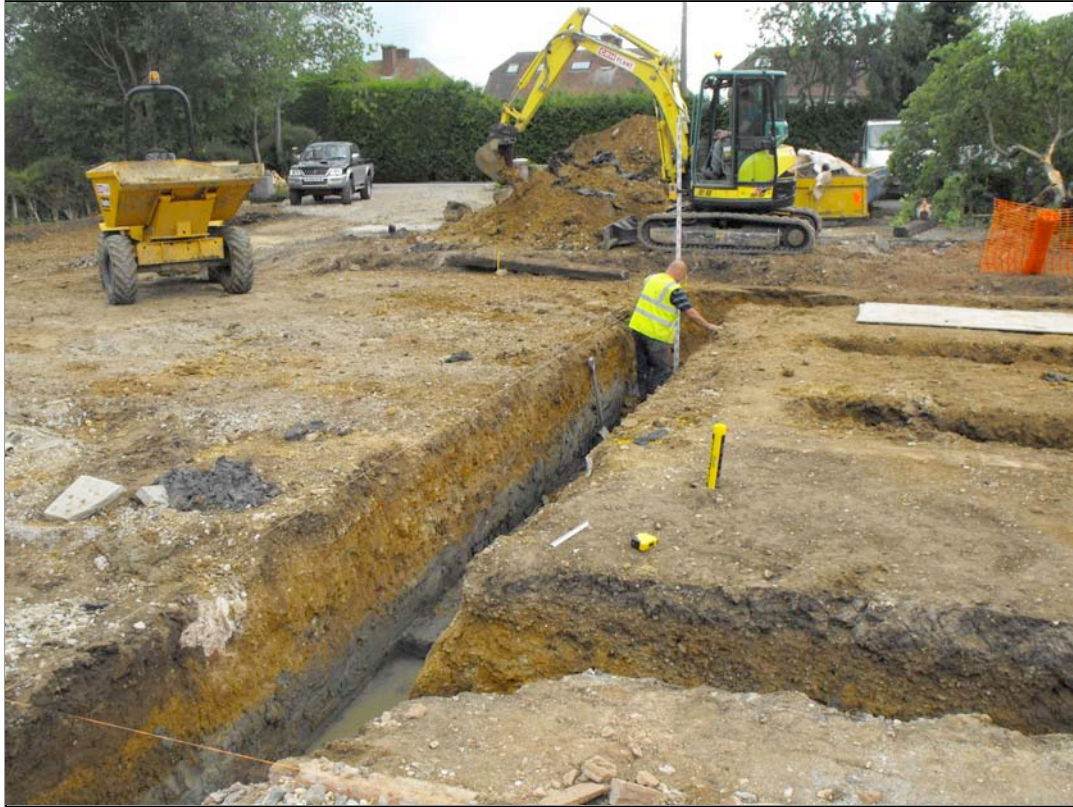
5.2 The foundation trenches were all over 1m deep and dug into 0.55m of geological natural deposits: firm sand and gravel (3) or dark grey clay (2), both overlain by 0.4m of brownish yellow sand and gravel (4) (Figs 3 and 4);

Fig 3: View of site looking north-west, showing typical foundation trench with layers of geological natural

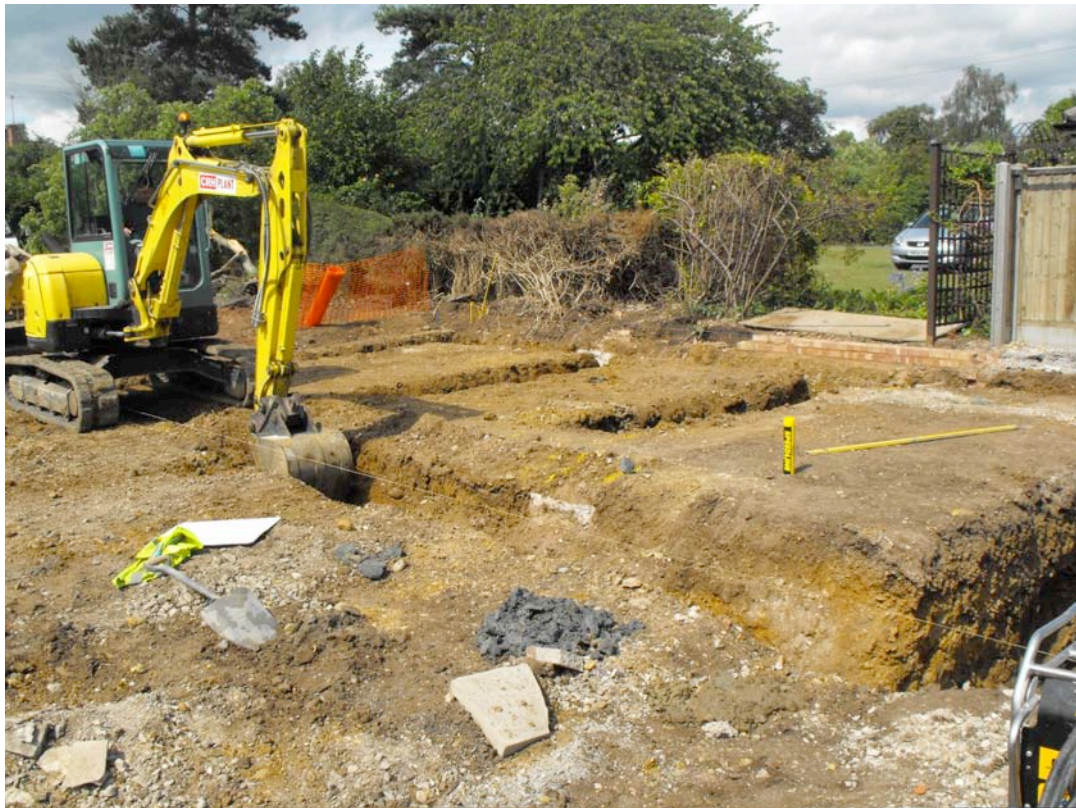
Fig 4: General view of site looking north

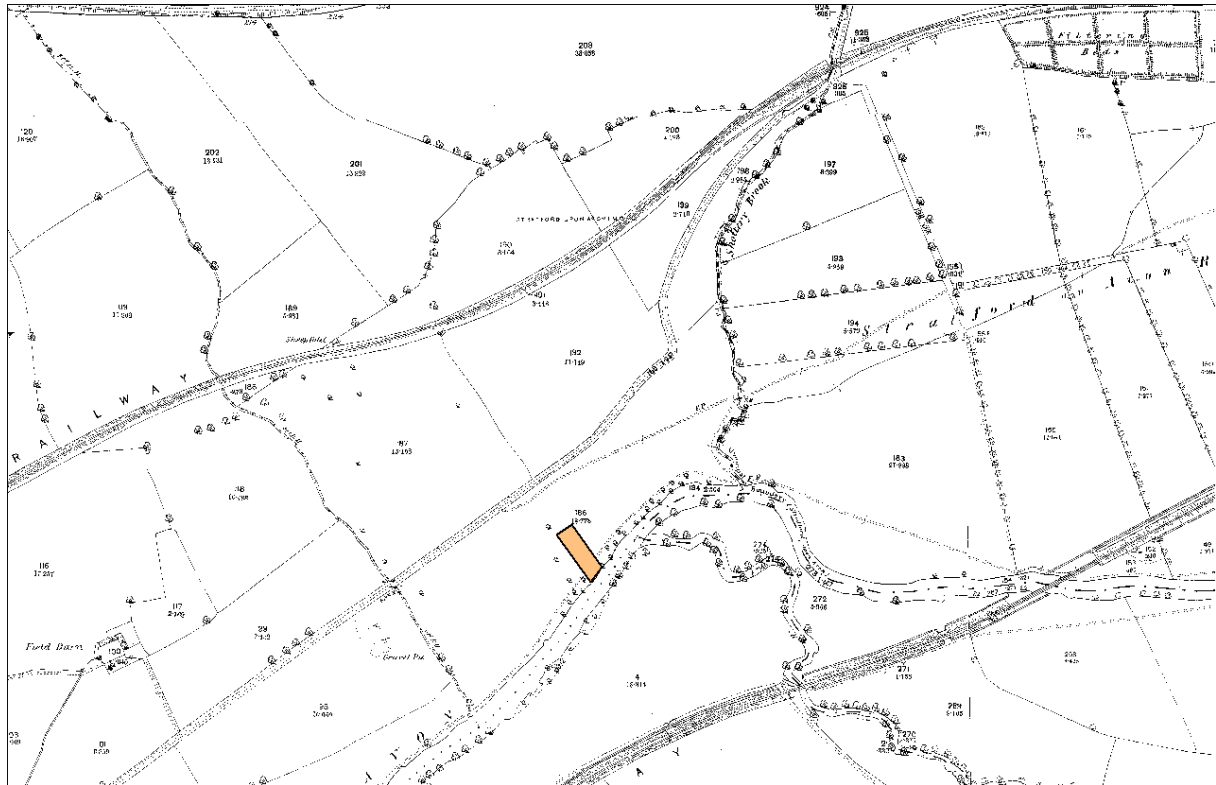
4.4 The present site lies within an area of residential properties which lies to the west of Stratford-upon-Avon and to the east of Luddington. It was under the plough in the 19th century (Ordnance Survey 1834 and 1887; Fig 5) whilst the present estate has all been built after 1938 (Ordnance Survey 1938).

Fig 5: Location of site on First Edition Ordnance Survey map of 1887
