Cider Mill House, Welford-on-Avon, Warwickshire

Archaeological Watching Brief

Report No 1138
December 2011

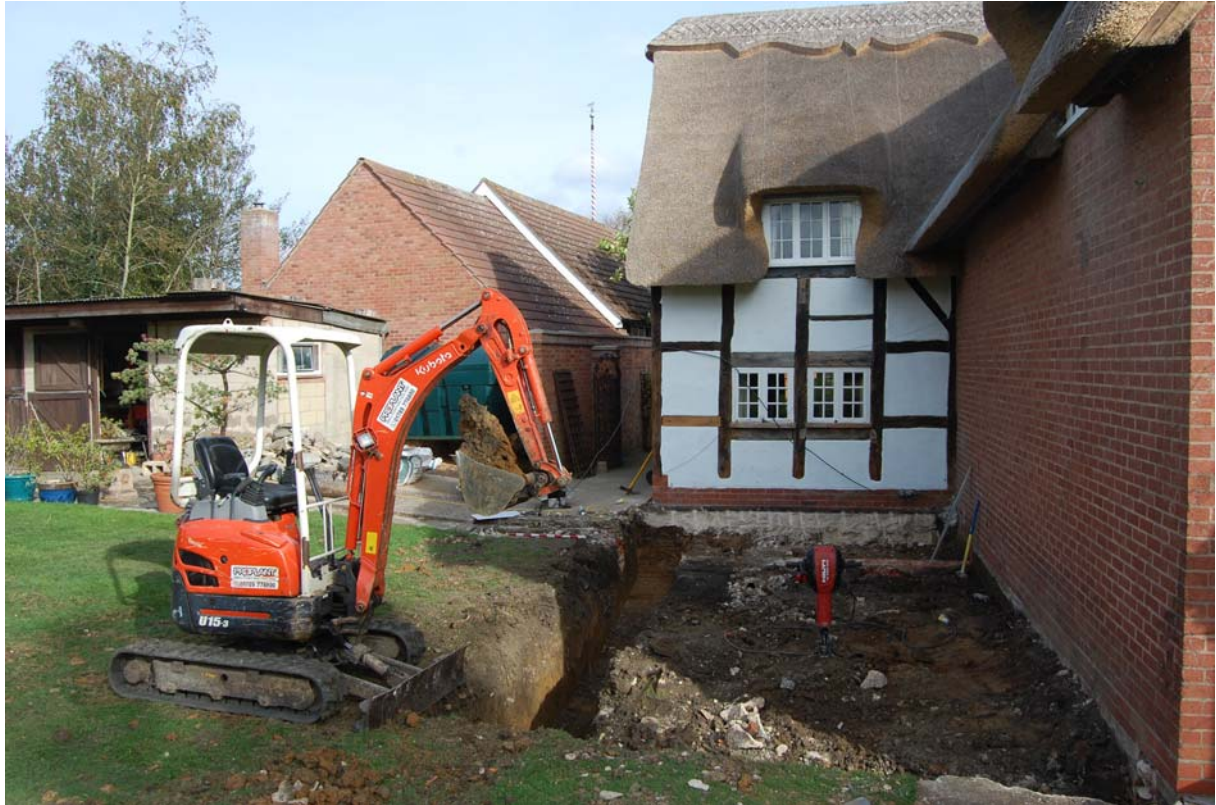
4.1 Foundation trenches were excavated along two sides of the new orangery and the area within was stripped of approximately 0.25m of soil (Fig. 4). The trenches were cut down to a depth of 1.1m. Geological natural brownish yellow clay (104) was reached at between 0.45 and 0.6m below the existing ground surface. At the eastern end of the area the natural clay (104) was cut by a small ditch (102) running in an approximately north-south direction. This had moderately steeply sloping sides and a rounded base. It was 1.4m wide and up to 0.5m deep and had two different fills. The lowest was a brown sandy loam (106) mixed with fragments of lime mortar, making up about 60% of the fill. Above this was a layer of black sandy clay loam (103) which contained frequent charcoal flecks. Pottery dating from between mid 17th to the later 18th century was recovered from this fill. To the west of this ditch a layer of brownish clay loam (101) lay on top of the natural clay (104) and was also visible in section. This layer only existed at the western end of the site and was not entirely stripped off during the ground reduction. In section it could be seen to vary in depth to between 0.25 and 0.35m. This was overlain by 0.2m of dark greyish brown clay loam topsoil (100). At the eastern end a brick foundation (105) was visible in a foundation trench (120) that cut both the geological natural (104) and ditch fill 103. This foundation was part of a low wall that helped support a concrete slab path (121) removed during the work (not on plan). A narrow service trench was also partially observed. This was up to 0.4m wide and 0.65m deep and reached the natural clay (104) at a depth of 0.5m.

Fig 5: The area of the new orangery at the rear of the house

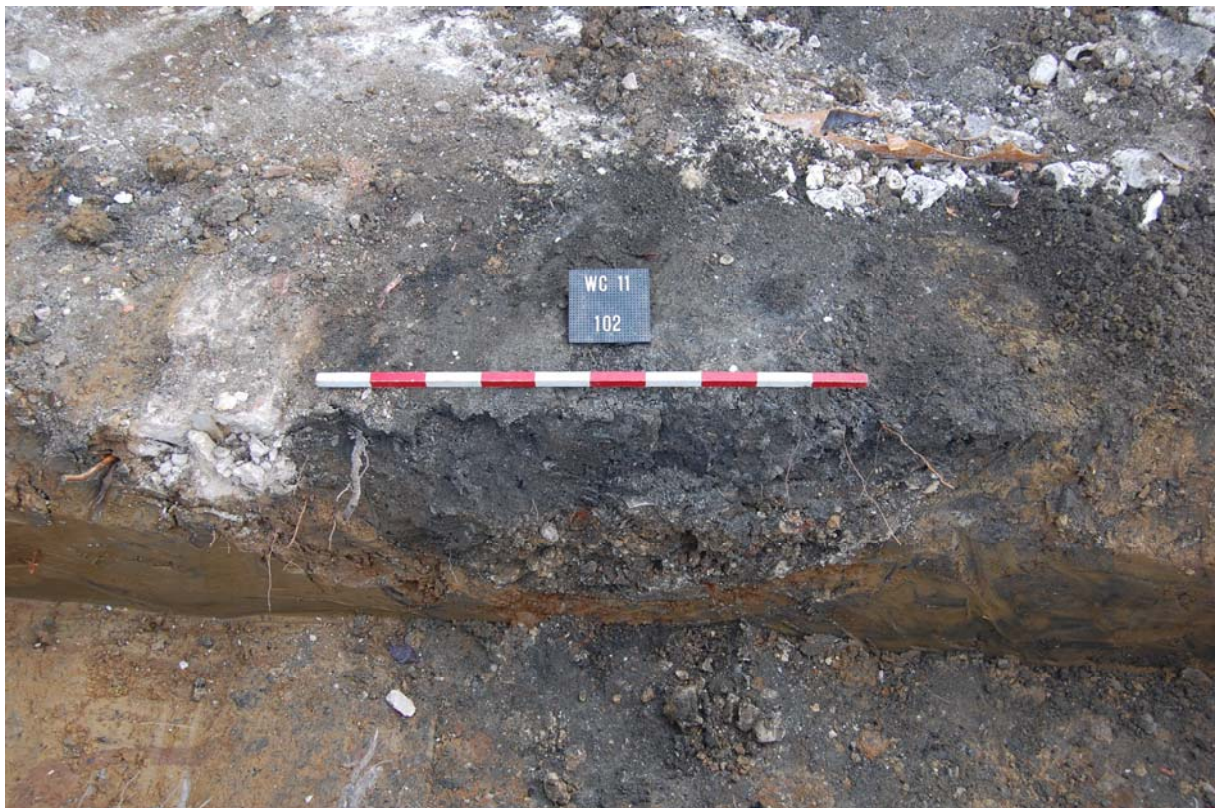
5.1 The occupation layer (101) at north-east end of the house contained an interesting selection of pottery, including five sherds of 14th- to 15th-century pottery, and 29 sherds with a date range from the mid 16th century to the mid 18th century. A clay pipe bowl with the makers stamp IP may have been made by John Partridge, a pipe maker recorded between 1660 and 1680 at Broseley, near Ironbridge. Broseley was a major Midlands centre of tobacco pipe making. The small ditch (102) must have been filled in by the mid 19th century.

It doesn't appear as a feature on any of the available maps and appears never to have been a major boundary. It might perhaps have been used for drainage.

Fig 6: Ditch 102

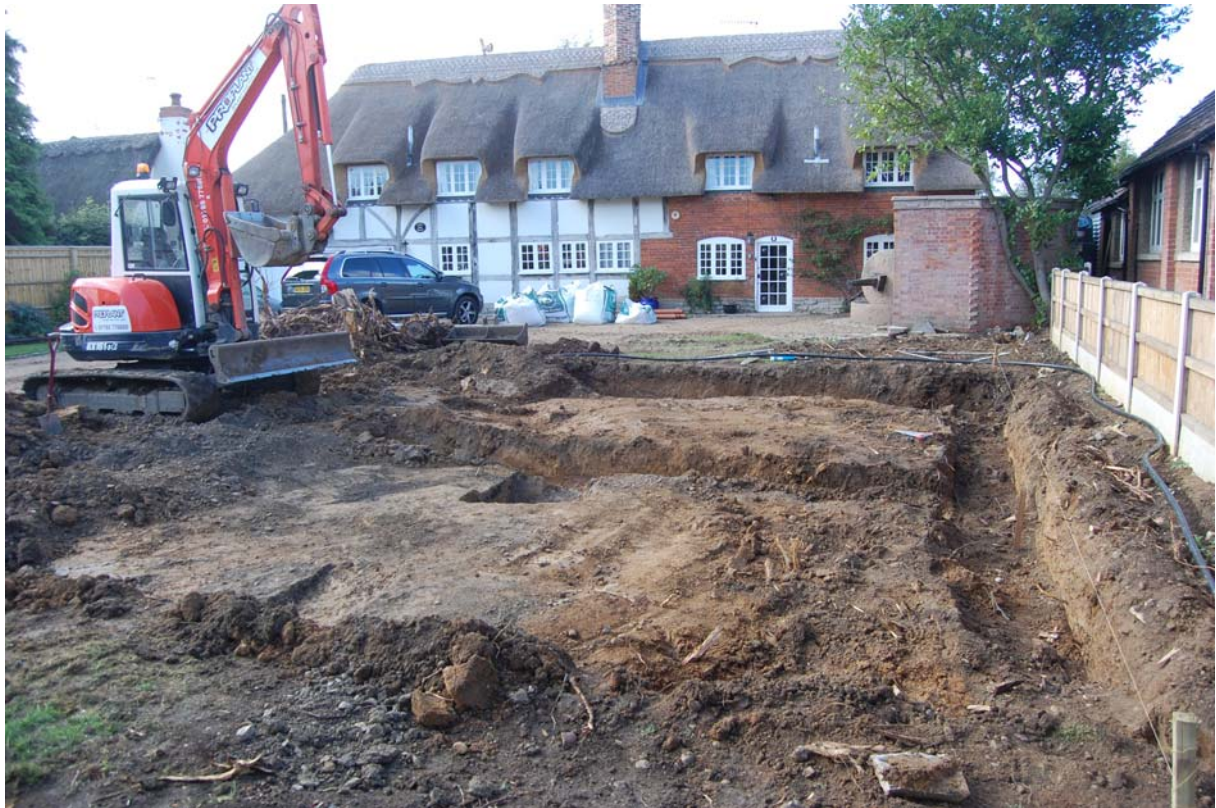
4.2 Foundations for a car port, along with soil stripping within its footprint, were observed outside the front (east side) of the house seen covering an area 9.7m by 6m. The area was stripped of 0.35m of brown clay loam topsoil (107) down to geological natural brownish yellow clay (119). Trenches were 0.8m wide and 0.8m deep. Two pits could be seen cut into natural clay (Fig. 4). Pit 108 was a small sub round feature, 1.3m in diameter and up to 0.12m deep. Its fill (109) contained finds of 18th-century date. To the west of this was a longer pit (110) which extended partially beyond the limits of the stripped area. It was over 2.7m long and up to 0.66m deep and contained eight different fills (111-118). The pit was dated to the late 18th or early 19th century by pottery found within fill 113, although single sherds of medieval and Roman pottery were also found within it. A small amount of soil stripping for the new driveway was observed at the same time as the car port. This was between 0.15 and 0.2m in depth and only disturbed topsoil (107) and the existing gravel drive surface. No further stripping of the driveway was observed.

Fig 7: The car port area and the front of the house

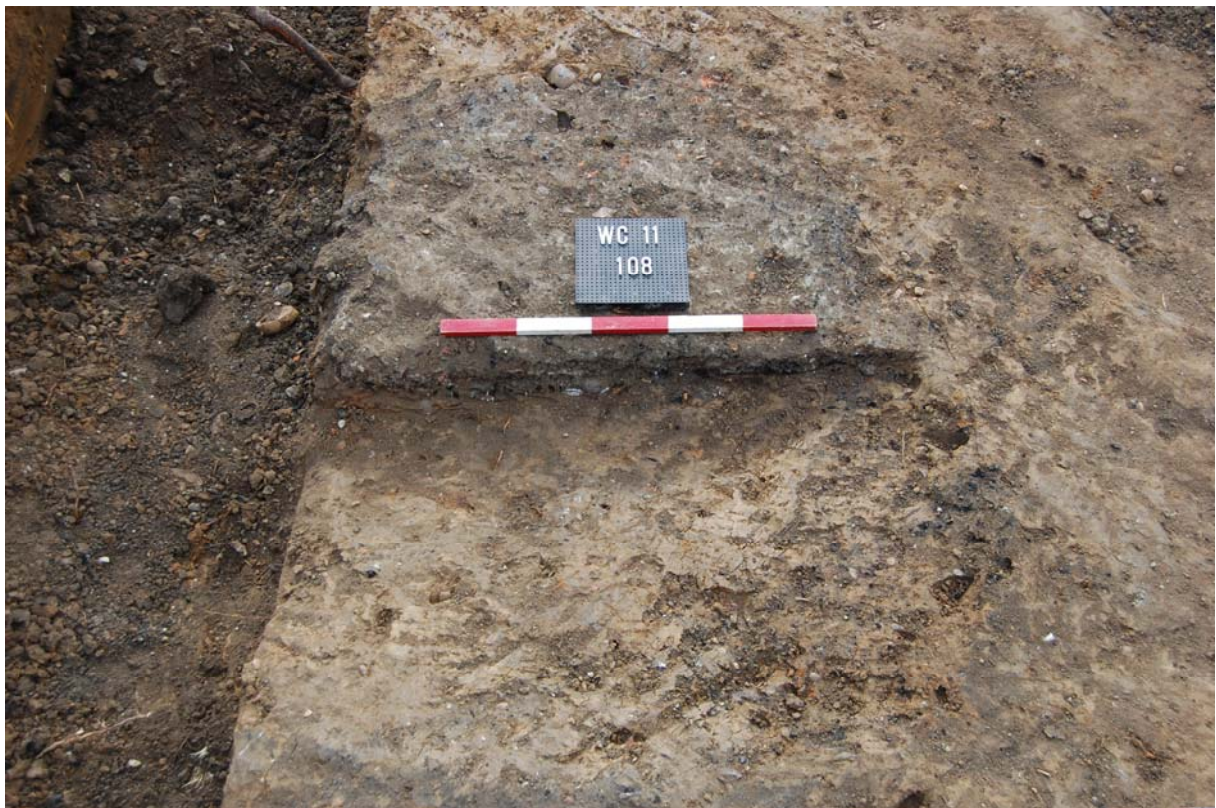
5.2 One of the pits (110) found to the west of the house was dated to the 19th century by pottery within its fill. The other small pit (108) was probably of 18th-century date. It is uncertain what either pit was dug for. The single sherds of medieval and Roman pottery found within pit 110 must be residual finds but the Roman sherd does give a tantalising hint of a site of that date in the vicinity.

Fig 8: Pit 108

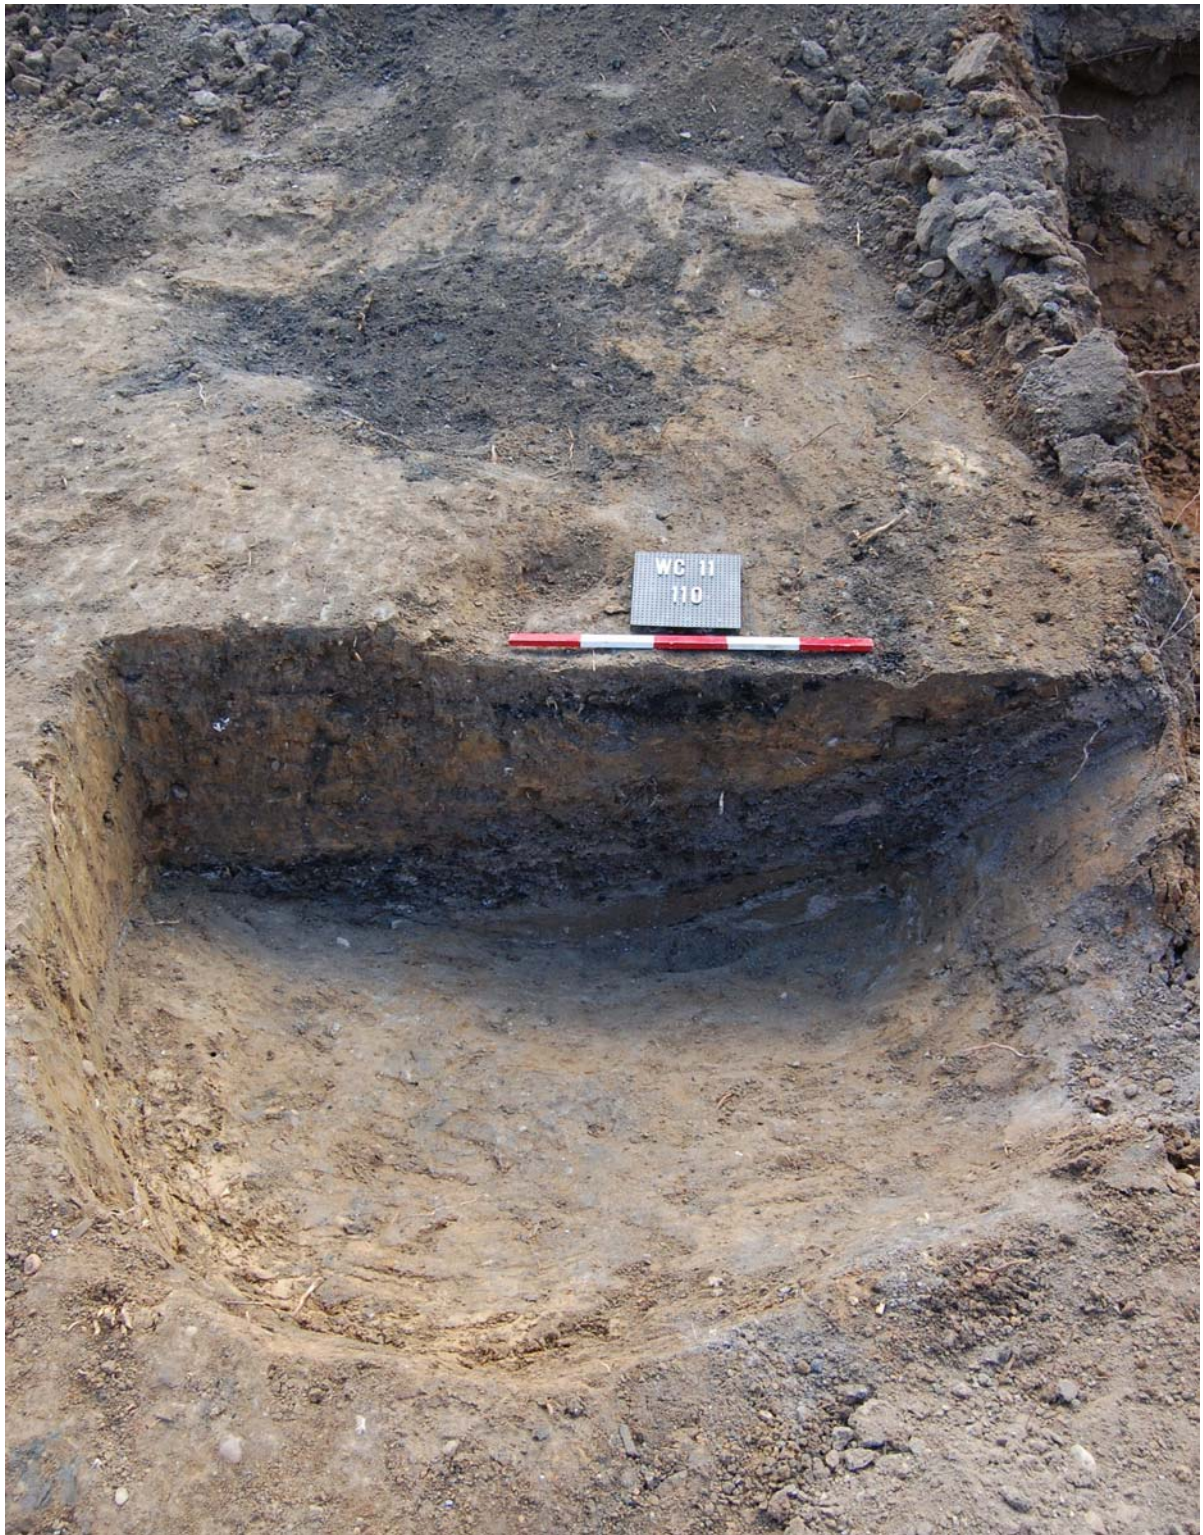
Fig 9: Pit 110
