Abbey Fields, Kenilworth Abbey, Kenilworth, Warwickshire

Archaeological Watching Brief

Report No 1117 July 2011

Project Report No. 1117

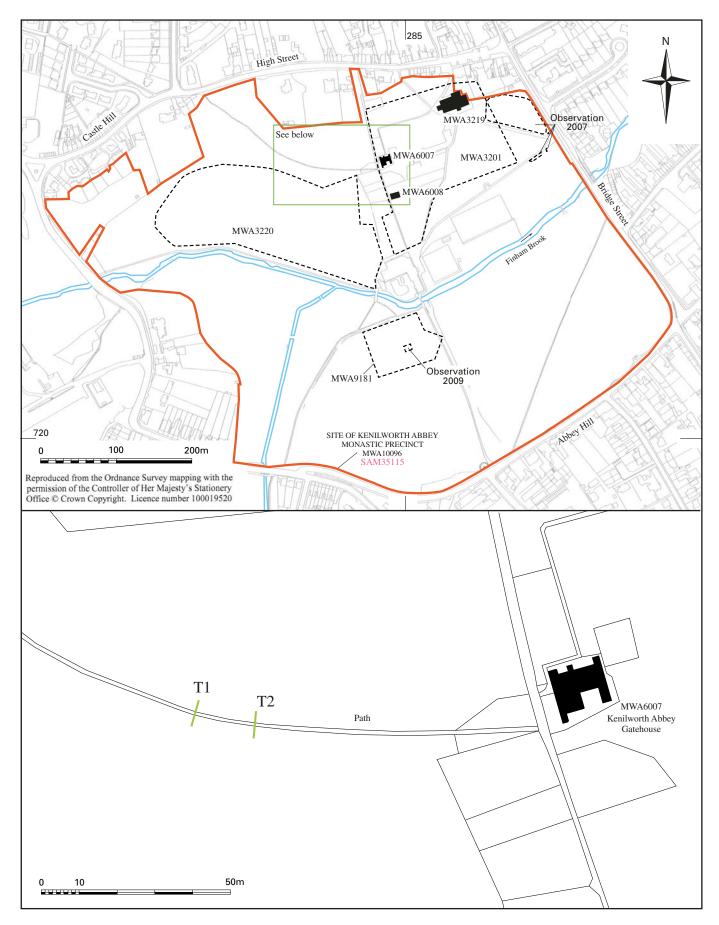
Fig 1: Site and trench location

- 5.1 The path running from the abbey gatehouse (HER MWA 6007) towards High Street was to be improved as part of the project. This included a proposal to improve drainage and surfacing. Two areas were subject to proposed improvement works; one approximately 90m west of the abbey gatehouse (T1) and a second (T2) approximately 75m west of the gatehouse.

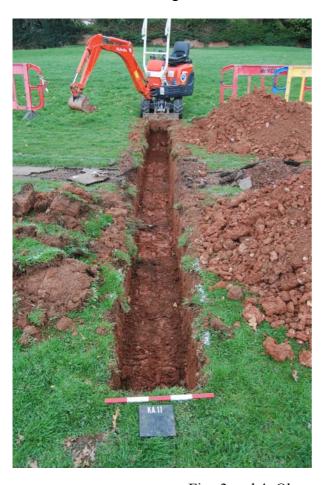
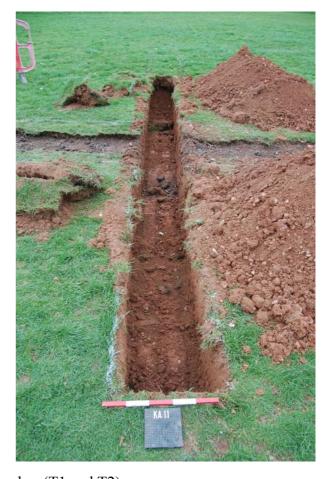
Figs 3 and 4: Observed trenches (T1 and T2)

- 5.3 The excavation of both trenches was observed by an archaeologist and both revealed the same deposit sequence (Figs 3 and 4). The lowest revealed deposit was a layer of reddish brown clay, which was at least 0.38m thick (3). This layer was interpreted as redeposited natural clay based on the composition of the layer and the level of occurrence. This was sealed by a 0.12m thick layer of reddish brown clay loam topsoil (2). Surfacing material for the path (1) was removed across the width of the path.

- 5.4 No archaeological features were observed and no finds were recovered during the work.
