St Andrew's Church Shilton

Archaeological Evaluation

Report No 1139 December 2011

Project: St Andrew's Church, Shilton, Trial Trench

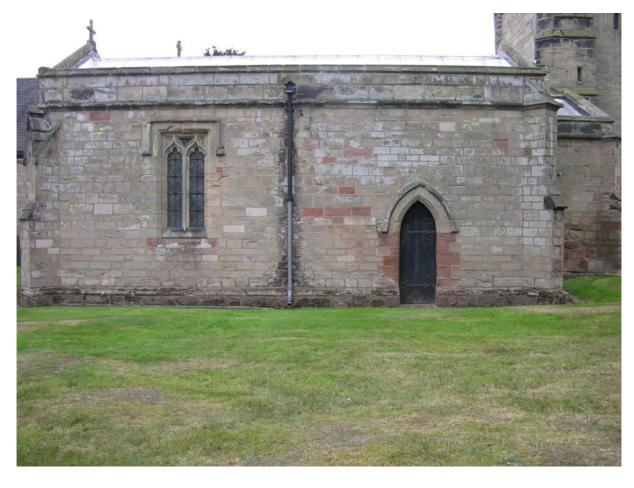
Fig 3: Present outer north aisle wall

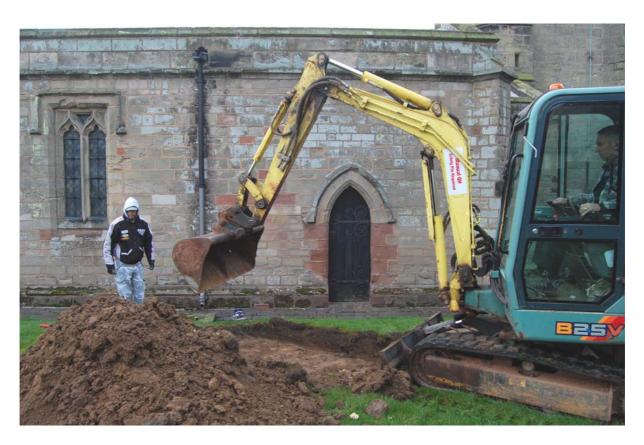
Fig 4: Excavation of trial trench

- 4.1 One trial trench was excavated in the footprint of the proposed north extension by mini-excavator equipped with a 1.20m wide, toothless ditching bucket. The trench was 4.50m long at the base and 1.60-1.80m wide. The ground was reduced carefully down to the level at which skeletal material and grave cuts began to appear and this level was then cleaned and recorded. The graves cut into a layer of compact brownish yellow clay (120) which did not appear to be the geological natural. The level of the visible skeletal material in the two graves at the south-west end of the trench and the top of the graves with coffin lids, to the north-east, were all roughly at the same level, between 106.81m and 106.87m aod, covered by between 0.78m and 1.10m overlying material, depending on the slope of the ground.

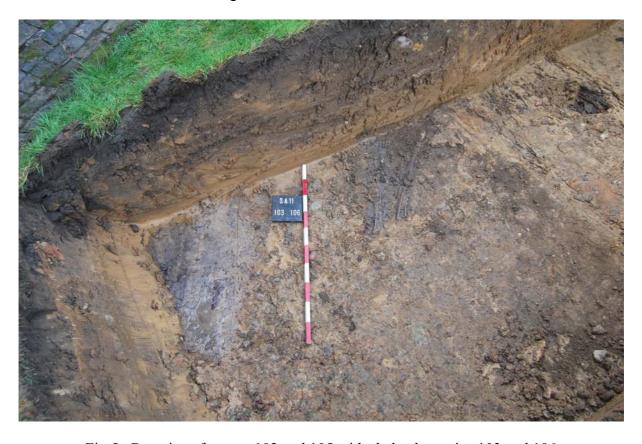
Fig 5: Remains of graves 102 and 105 with skeletal remains 103 and 106

in two of the graves; a mandible (remains of skeleton 103) in grave 102 was visible near the trench section, and the lower part of a skeleton (106) was visible in grave 105. It appears that these graves, and the upper part of their coffins, had been truncated (121) some time in the past. The coffins in graves 108 and 111 appeared to have been buried at a slightly lower level; these had sunken coffin lids, with the remains of indecipherable name plates and c.0.18m of grave fill above the coffin lids. In all cases the wood and skeletal remains were in very poor condition. A single dome-headed screw was recovered from the wood of coffin 118.

- 4.3 There were no grave cuts visible in the layers above the graves, nor was there any trace of the coffins or grave fills of graves 102 and 105 in the trench section. Above coffins 117 and 118, and above the skeletal remains in graves 102 and 105, was a layer of clean brownish yellow clay (114), up to 0.32m thick. This layer contained no finds and was not the usual mixed graveyard soil that generally occurs above graves. It appears to have been a layer deliberately laid, possibly with the express notion of covering burials, or associated with the groundworks for the 1865 outer north aisle.

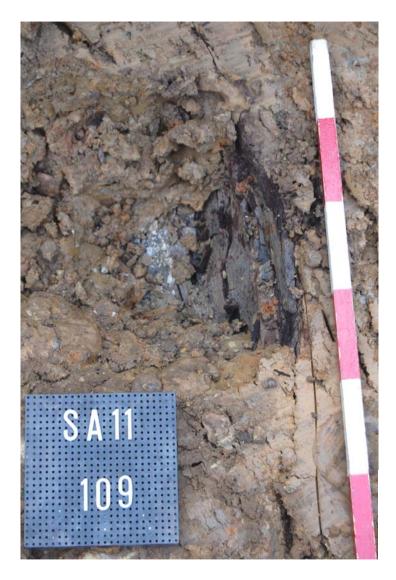
Fig 6: Grave 108 with sunken coffin lid

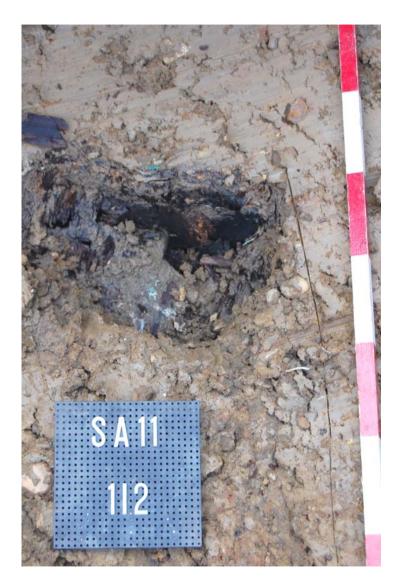
Fig 7: Grave 111 with sunken coffin lid

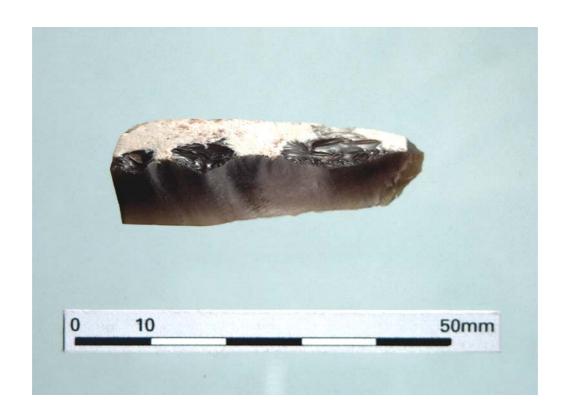
Fig 8: Flint blade, dorsal view

- 5.1 The evaluation consisted of a trial trench to the north of the church, in the area which would be disturbed by groundworks for the proposed north extension. A series of burials was recorded at a depth of 0.78-1.10m below present ground level
- 5.2 A number of finds were recovered from a mixed layer above the level of the graves. The late Mesolithic/early Neolithic flint is probably of local production and scatters of similar

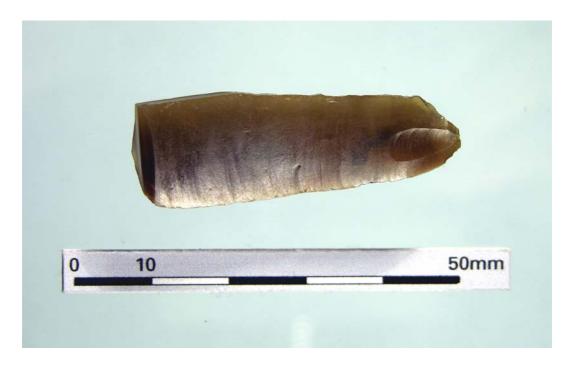
Fig 9: Flint blade, ventral view

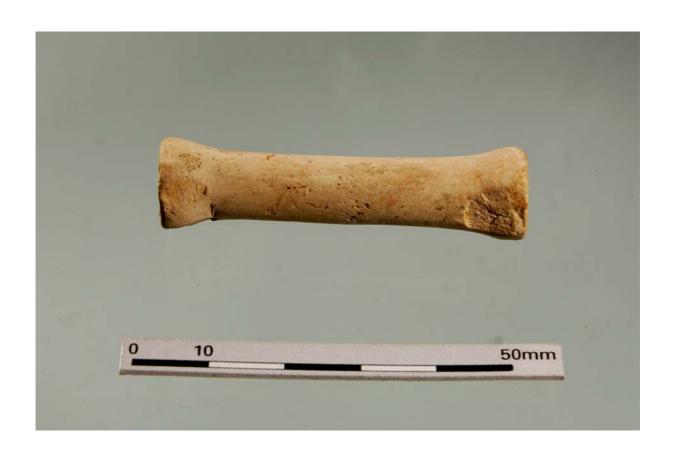
Fig 10: Pipe clay wig curler

- 4.5 A slightly more unusual find was that of a ceramic wig-curler, dating to c.1700 by parallel to ones in The Museum of London collections (Le Cheminant 1978, 188). These were made of the same type of clay as tobacco pipes, and were used extensively in the 18th century to keep the curls of fashionable wigs in shape. More recent finds are sherds of internally black-glazed pottery of 18th-century date and a sherd of 19th-century earthenware. Metalwork recovered included an iron bolt, probably of 19th-century date.
