# Co-op Store, Warren Field, Ryton-on-Dunsmore, Warwickshire

## Archaeological Evaluation

Report No 1126  
September 2011

**Project:** Co-op store, Adjacent 1 Warren Field, Ryton-on-Dunsmore, Warwickshire

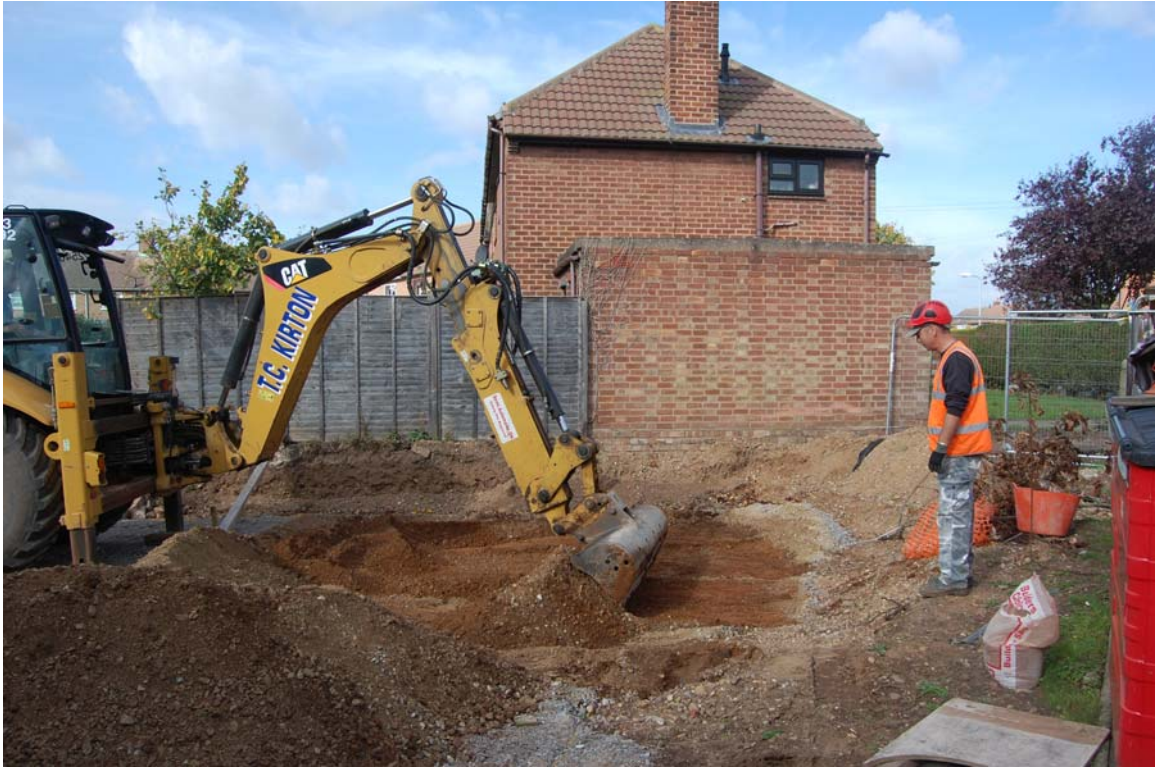
4.2 Removal of the temporary hard-standing revealed natural geological sand and gravel. No significant archaeological remains were observed and no artefacts recovered from this area.

Fig 5: Removal of temporary hard-standing in progress

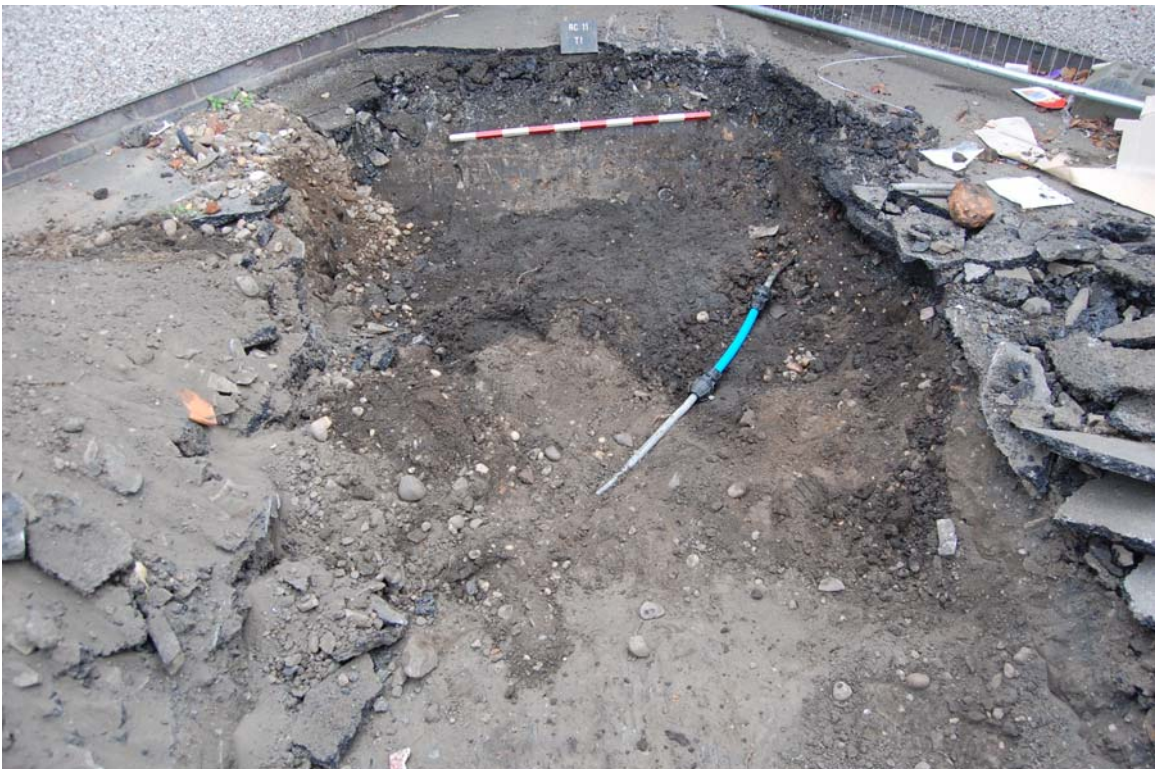
4.4 Trench 1 was placed at the north-easterly end of the proposal area and aligned N-S. A toothed bucket was used to break through the uppermost 0.07m of tarmac (100), then a 1.6m wide toothless bucket was used to reduce the remainder of the trench. Geological natural was not reached in this trench due to the presence of drains and a lead water pipe (103). At 0.17m deep the lowest layer in Trench 1 was very dark greyish brown sandy loam (102) that

contained two sherds of 17th-century slipware pottery and clay pipe fragments as well as a small rotary sharpening stone.

Fig 6: Trench 1 showing location of broken lead water pipe viewed from the north

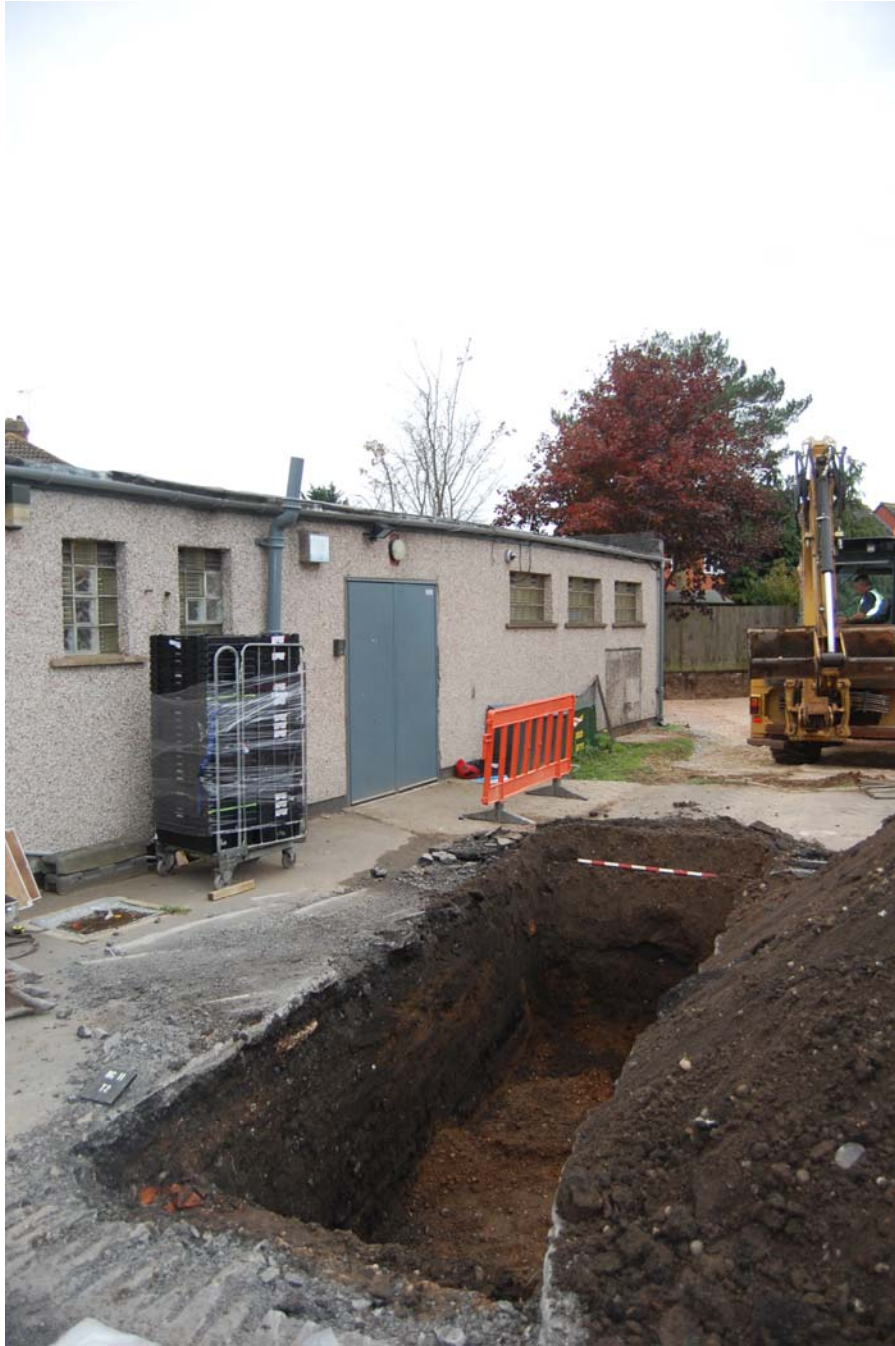
4.5 Trench 2 was positioned to avoid the electricity supply, the drains and the service entrance on the north-west side of the building. It was aligned NE-SW and was 4.82m long. Geological natural sand and gravel (204) was reached at 1.47m below ground level. It was sealed by a 1.29m thick layer of very mottled dark greyish brown/yellowish brown sandy loam (202) which contained 18th- to early 20th-century pottery, glass, asbestos and ironwork, and appeared to be the back-fill of a pond. This was cut by a modern electrical cable (203) and sealed by 0.10m of modern surface bedding.

Fig 7: Trench 2 viewed from the NNE
