'The Motte', Ell Lane, Brinklow, Warwickshire

Archaeological Watching Brief

Report No 1352 September 2013

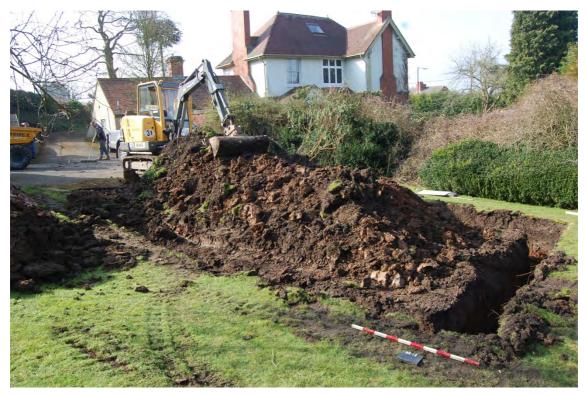
5.2 A brownish-grey clay loam layer (102) was observed in the base of the new garage foundation trench at a depth of c1m. It was observed in the western corner (Figure 5) and three sherds of medieval pottery and a piece of tile were recovered from it. A 0.65m deep layer of dark reddish-brown clay loam (101), containing fragments of brick and tile overlay the natural and layer 102 within the foundation trenches.

Figure 5: Excavation of garage trenches

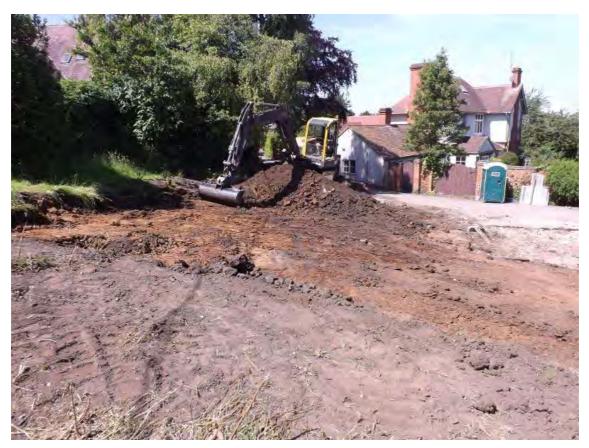
5.3 Very dark greyish-brown clay loam topsoil (100) covered layer 101 and in the area of the new garage it directly overlay the natural. It ranged in depth from 0.2m in the area of the new garage to 0.5m across the footprint of the new house, where the depth of soil had been increased as a result of terracing deposits.

Figure 6: Ground reduction for new house
