**St Thomas More School,
Greenmoor Road, Nuneaton,
Warwickshire**

Archaeological Watching Brief

Report No 1122
September 2011

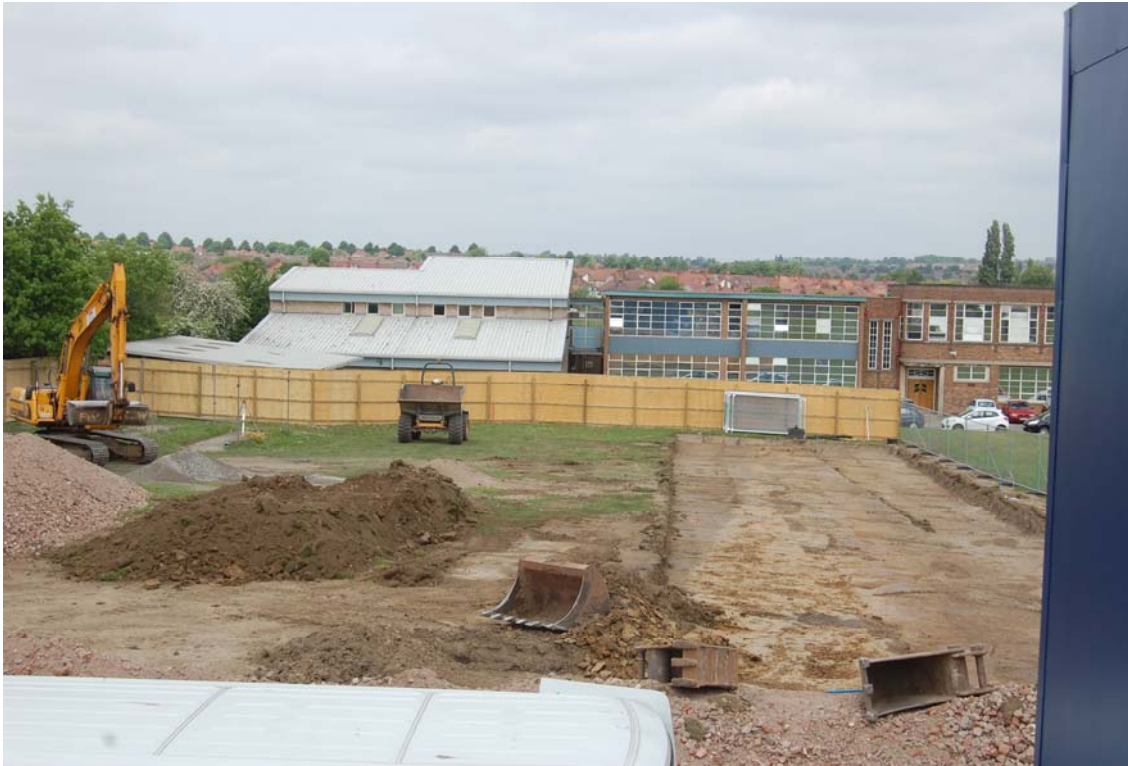
4.3 In the south-eastern part of the site within the footprint of the new sixth form block was stripped down to a layer of yellowish brown clay (6). The layer was 0.4m below the ground surface contained no evidence of intrusions and the layer was probably geological natural.

4.4 Three possible furrows (4, 13 and 15) were observed running in a north-west to-south-east direction. These three features were quite large, being over 5m wide, and it is just possible that they were actually associated with some unrecorded activity when the site was allotments or were in some way associated with the clay extraction for 19th-century brick works to the west of the school.

Fig 5: Proposed sixth form block and suggested furrows

5.5 The possible furrows in the area of the new sixth form block may also be associated with post-medieval clay extraction. There is known pitting for the former brickworks to the west and the observation of the previous extensions to the school in 1996 did expose the remains of backfilled clay pits. However, whilst similar activity associated with the brickworks may have resulted in these features no maps show the clay pits extending this far in to the site.

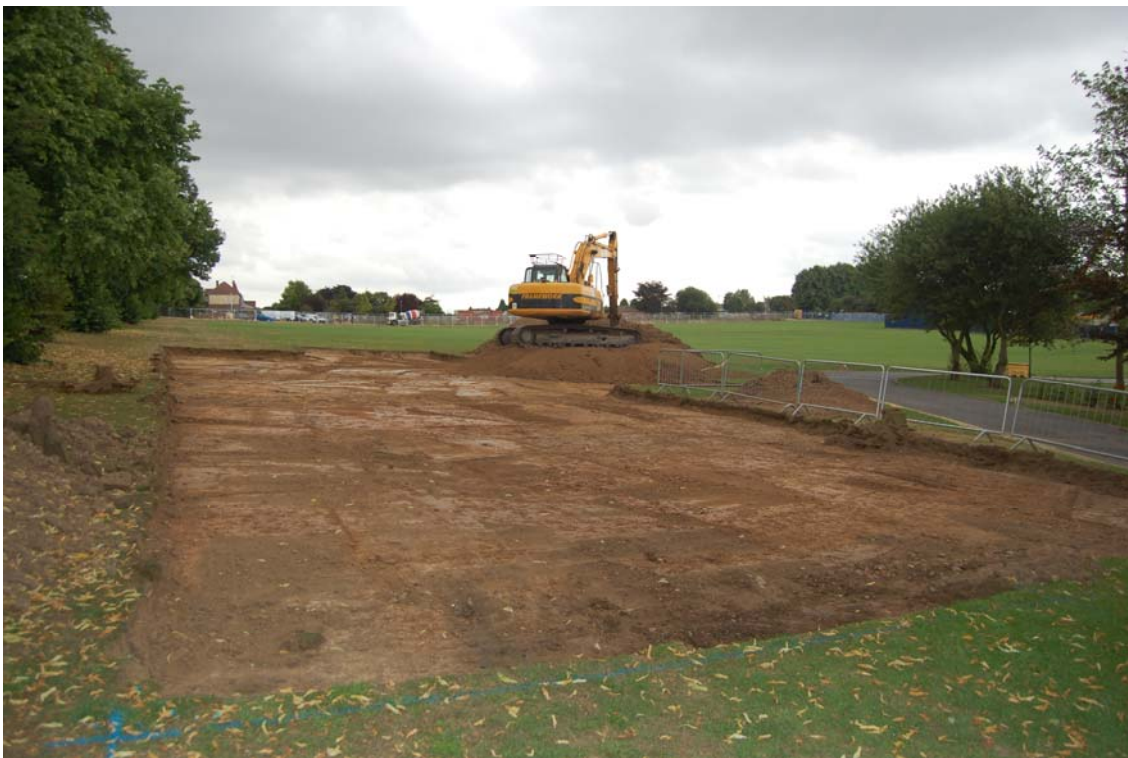
4.2 In the north-eastern part of the site in the footprint of the proposed car park area a reddish brown geological natural (25) was revealed across the stripped area. Four furrows (17-20) were observed, running in a north-easterly to south-westerly direction. These were cut into the natural and were very hard to identify as they were filled with a very dry reddish brown clay loam (21-24) which was only a slightly different colour from the natural clay. It was only the consistency of the soil as it dried out that made them visible.

Fig 6: Proposed car park areas and suggested furrows

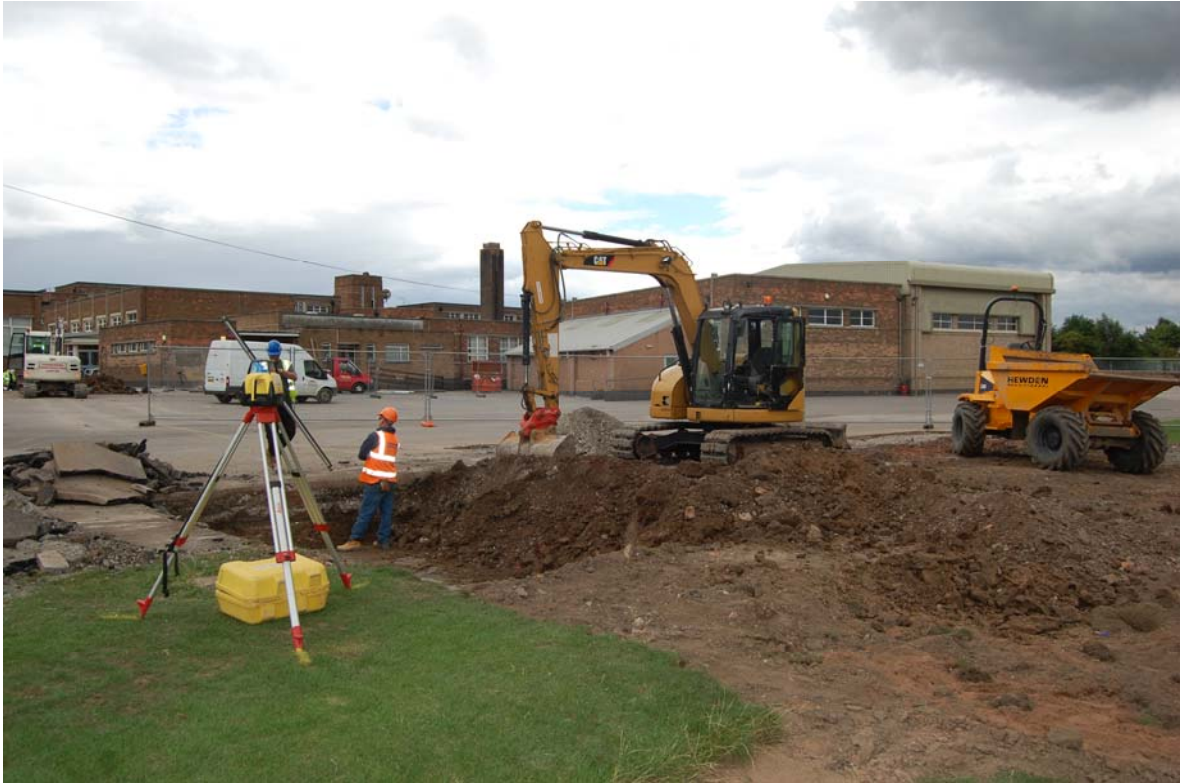
4.6 No remains of archaeological features were observed on the site of the new all weather pitch on the western side of the site. Here the area was stripped by up to a maximum depth of 0.9m. A layer of yellowish brown clay (8) was revealed 0.3m below the ground surface and approximately 0.6m of the layer was removed. No intrusions or other finds were present in the layer and the layer was probably a variation of geological natural. This was overlain by 0.3m of dark greyish brown clay loam topsoil (7).

4.7 The topsoil (7) contained a small scatter of pottery of 13th to 19th century date. The sherds were heavily abraded and had almost certainly been worn by years of ploughing.

Fig 7: Soil stripping for proposed sports pitch

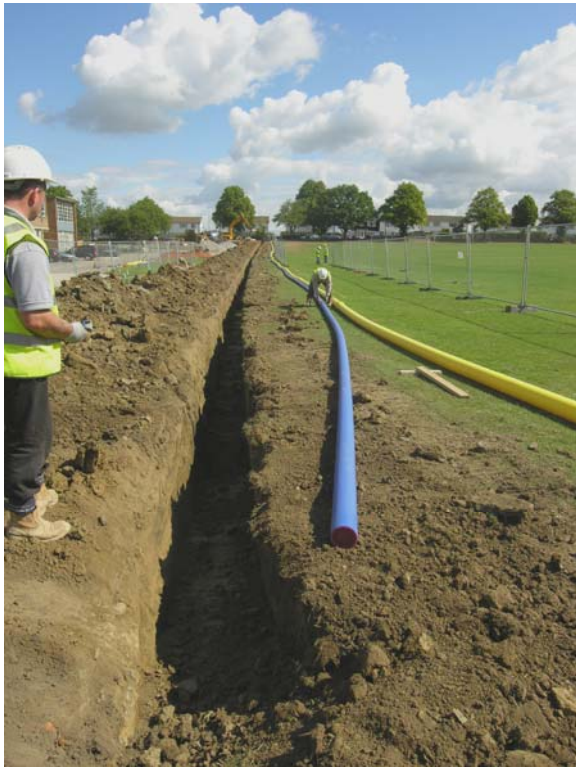
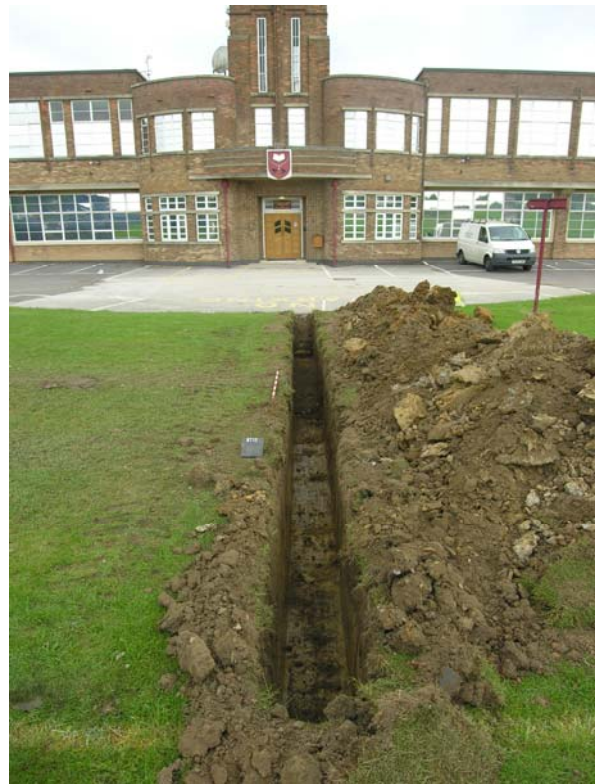
4.8 A similar deposit sequence was observed in service trenches which crossed the site; however no other archaeological remains or features were revealed during observation of these trenches. Some of the deeper excavations did confirm the expected geology of the area; for example, a trench to the north of the new sixth form centre, exposed a bed of grey shale (26) at a depth of 1.5m below the topsoil (1), which is likely to be the Outwoods Shale Formation shown on the 1994 British Geological Survey map.

Figs 8 and 9: Observed service trenches
