# Priory Park Culvert, Warwick

# **Archaeological Evaluation**

Report No 1128 October 2011

Commissioned by: The Environment Agency

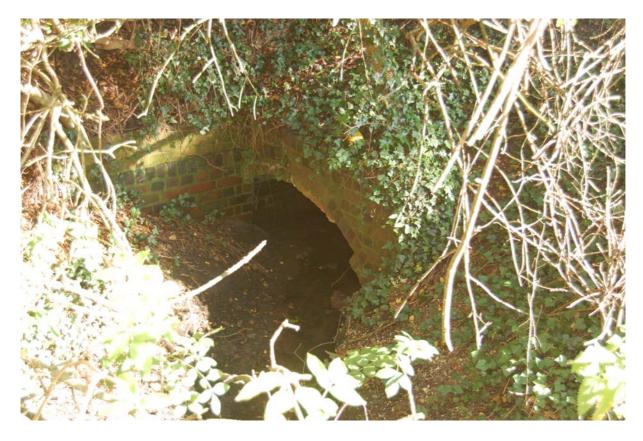
Fig. 6: Brick culvert entrance

- 1.1 The Environment Agency is proposing to relieve problems with the existing closed culvert for St John's Brook at the northern end of Priory Park, Warwick, Warwickshire. A new length of open channel has been proposed south of the existing brick culvert, which was built when the railway embankment was constructed in 1851-2.
