Nailcote Hall Hotel, Berkswell, Solihull

ARCHAEOLOGICAL EVALUATION

Archaeology Warwickshire Report No 1452
JULY 2014

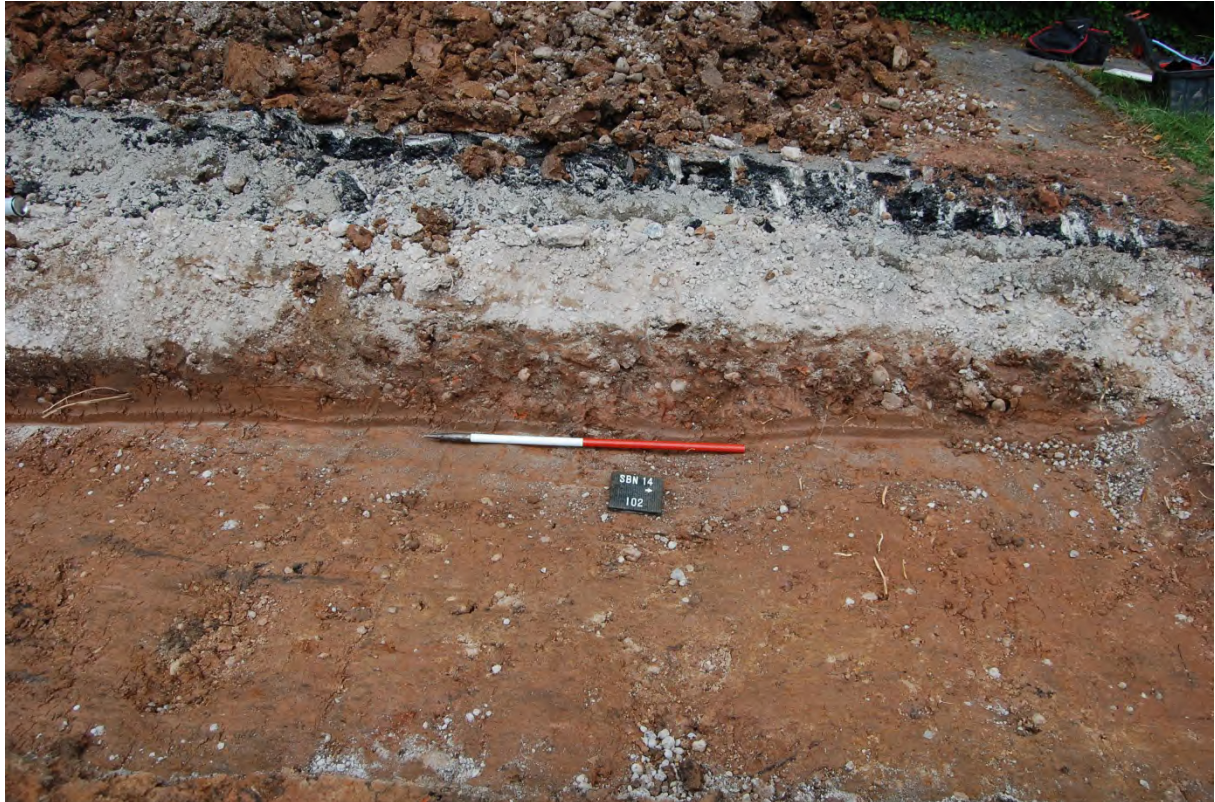
Fig 7. Layer 102 in section

5.1 Trench 1 was aligned north-south and was positioned on the west side of the development area. Geological natural strong brown clay 104 was achieved c.0.30m below the existing surface. Overlying the natural was 0.2m of greyish brown clay loam (103) which seems likely to have represented a former occupation layer. At the north end of the trench a 0.15m thick pebble surface in a matrix of greyish brown clay loam was cut into layer 103. This surface contained post-medieval roof tile and a sherd of tin-glazed earthenware. It was sealed by modern car park hardcore 101 and tarmac 100.

5.3 The deposit sequence in both trenches suggests that occupation activity around the hall had been removed when the car park was constructed. The remnant surface 102=202 could have formed a pathway of post-medieval date, which, given the small number of material finds, was laid down in an area of transit some distance from the foci of occupation. The posthole, although undated seems likely to be of post-medieval date given its square cut and fill type.
