# Mary Ann Evans Hospice, Nuneaton, Warwickshire

# **Archaeological Evaluation**

Archaeology Warwickshire Report No 1338 August 2013

Site Code: NG13

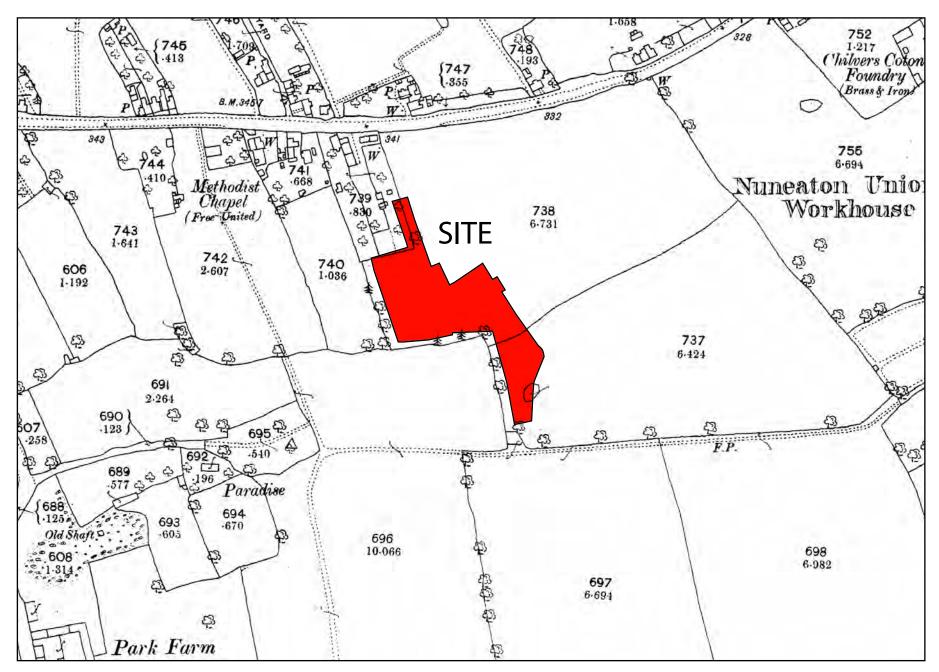
Fig 2: Detail from First Edition Ordnance Survey map of 1888

4.2 The 1888 First Edition Ordnance Survey map shows the whole area as part of a large field whilst by the Second Edition of 1903 the area of the hospice garden had been separated off into a small field and the larger one had become allotment gardens. The Workhouse infirmary, which the George Eliot hospital grew out of, is marked on the Third Edition map of 1926.

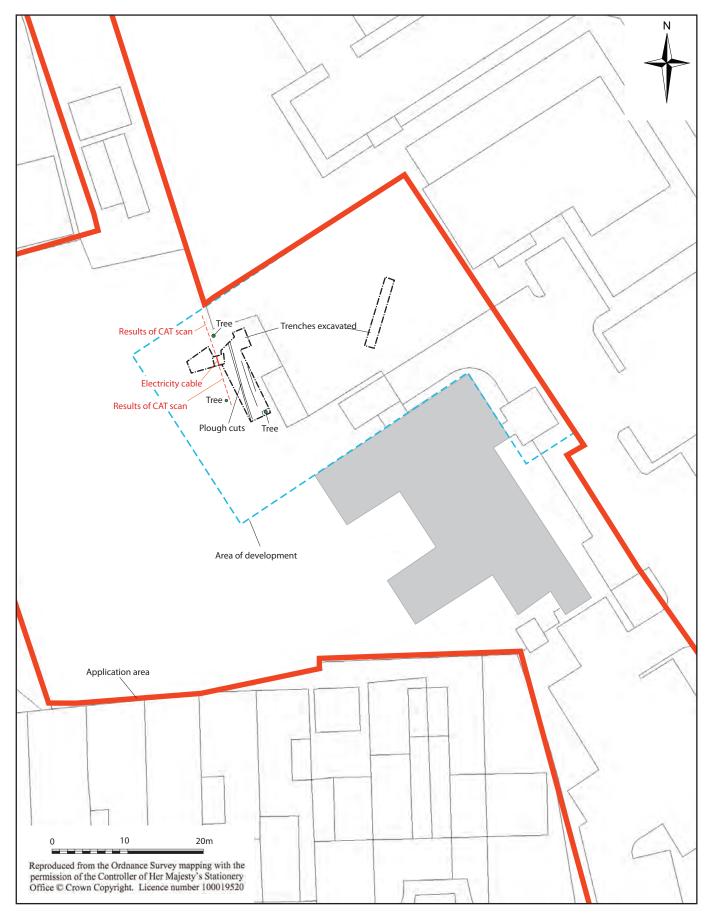
Fig 3: Trenches excavated

5.1 Two trial trenches (Fig 3) were excavated by a tracked mini-excavator using a toothless ditching bucket under archaeological supervision.

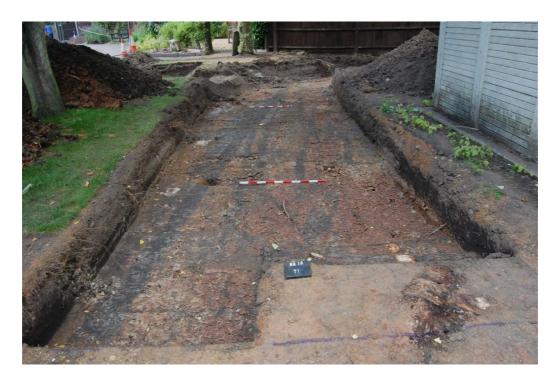
Fig 4: Trench 1 looking north

- 5.2 Trench 1 was T shaped in order to accommodate existing structures and trees. The arms of the trench were 11m and 8m long and the trench was 3m wide. Geological natural was strong brown clay with occasional patches of small pebbles (102) and was revealed some 0.3-0.5m below the current ground level at 104.10m aod. No significant archaeological features cut the natural although several linear scars filled with topsoil, attributed to recent ploughing, and an electricity cable were aligned north to south along the trench.

- 5.3 The natural was overlain by a very dark greyish brown sandy loam with very occasional small pebbles (101) which was between 0.15m and 0.17m thick. This soil contained two sherds of pottery, one dating from the 13th to 14th century and a fragment of clay tobacco pipe stem. Overlying this was between 0.29 and 0.32m of very dark greyish brown sandy loam topsoil (100) which included the turf and contained frequent tree roots.

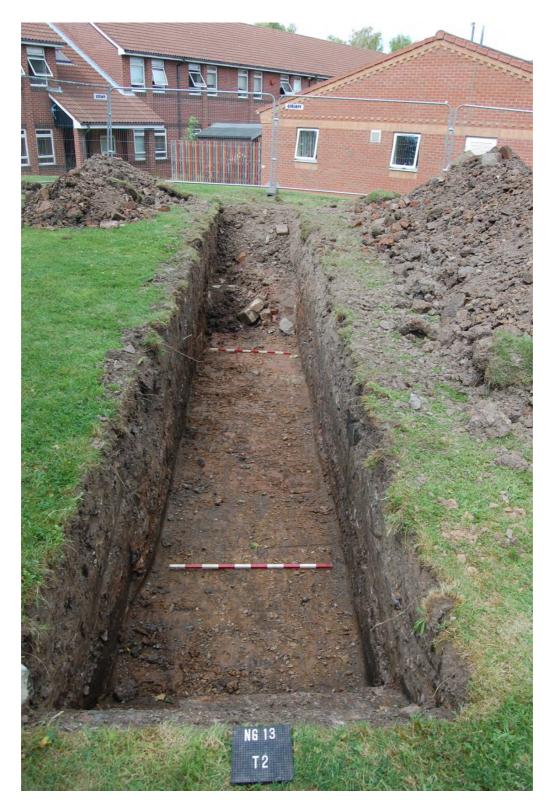
Fig 6: Trench 2 looking north-east

5.4 Trench 2 was 9.5m long by 1.35m wide. Geological natural clay (203), identical to that in trench 1, was revealed some 1.25m below the current ground level at 103.60m aod. No archaeological features were observed cutting the natural. Overlying this was a 0.30m layer of very dark greyish brown sandy loam with very occasional small pebbles (202) which was the former topsoil. It was covered by a thick layer of mixed greyish brown clay (201) which contained considerable amounts of brick and concrete. It varied in depth between 0.8m and 0.84m and was clearly landscaped building debris associated with the construction of the current hospital. Overlaying all was only 0.05m of very dark greyish brown sandy loam and turf (200).
