# St John's House Museum, Warwick

## ARCHAEOLOGICAL WATCHING BRIEF

Archaeology Warwickshire Report No 1516  
FEBRUARY 2015

<b>Project:</b>	St John's House service trenches
<b>Commissioned by:</b>	Anna Hurton on behalf of WCC
<b>Project Report No.</b>	1516
<b>Site Code:</b>	WJ13
<b>Planning Reference:</b>	WDC/12CC016
<b>National Grid Reference:</b>	SP 2972 6507
<b>Team:</b>	
<b>Project Manager:</b>	Dr Catherine Coutts FSA (Scot)
<b>Fieldwork:</b>	Dr Catherine Coutts, Bryn Gethin BA and Kevin Wright
<b>Author:</b>	Caroline Rann BA
<b>Illustrations:</b>	Candy Stevens
<b>Report checked by:</b>	Dr Catherine Coutts
<b>Date:</b>	February 2015
<b>Report reference:</b>	Rann, C, 2015 <i>St Johns House Museum, Warwick: Archaeological Watching Brief</i> , Archaeology Warwickshire Report 1516.

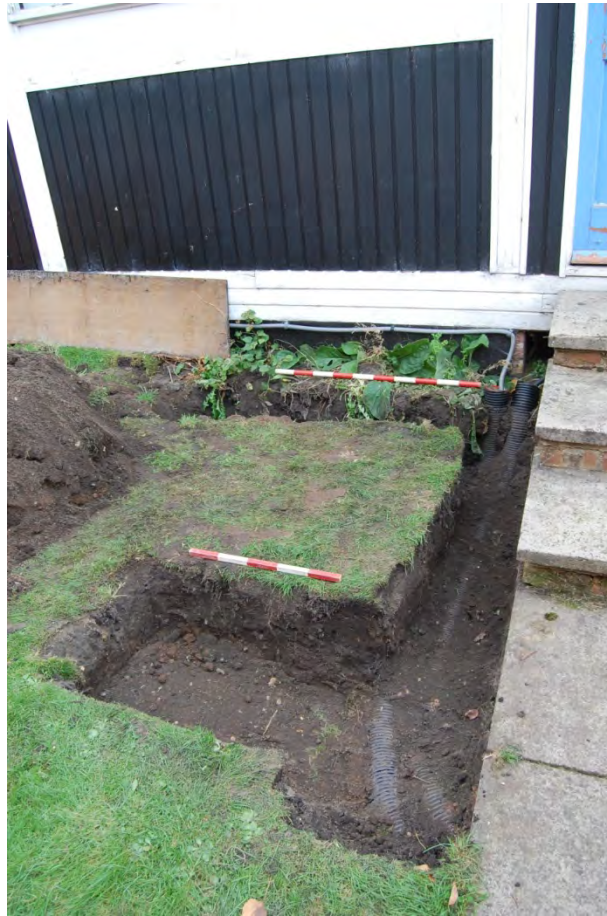
Photograph 1: Exploratory excavations

5.1 An exploratory trench was excavated to the north of the modular building to locate the existing services. The excavations revealed the top of a layer of dark yellowish brown sandy loam (5) in places. Plastic ducts (2, 3) and an electricity cable (4) were found covered in 0.4m of dark greyish brown sandy loam topsoil (1).

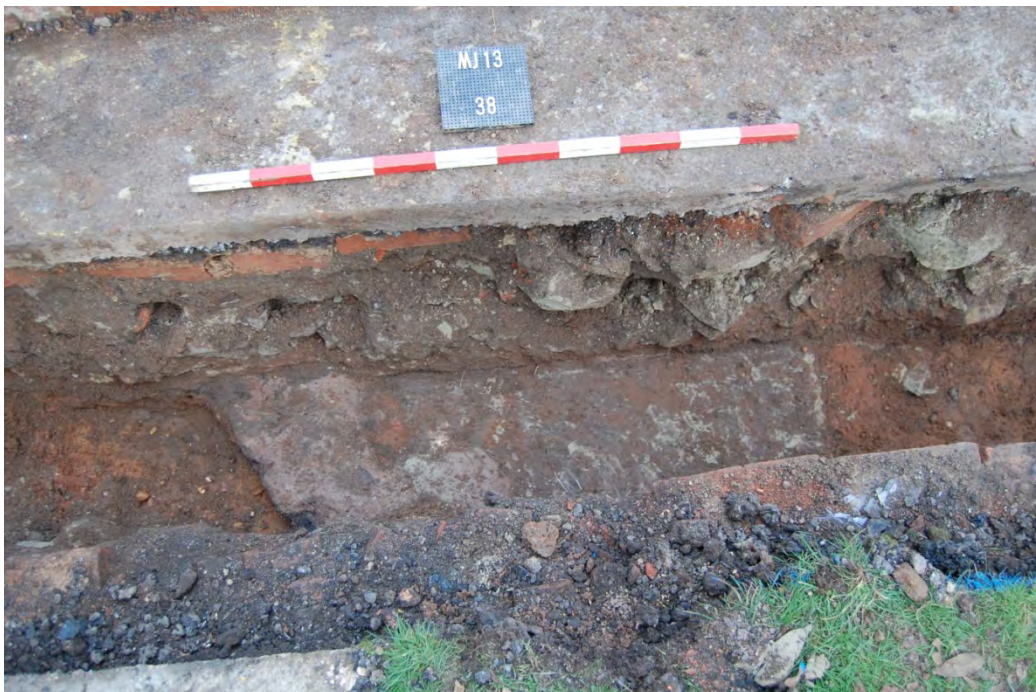
Photograph 2: Wall 38

5.5 At the base of the trenches at a depth of c.0.7m from the top of the car park surface was a layer of sand and gravel that was likely to have been the geological natural (29). At 0.58m below the tarmac one course of a 0.9m wide sandstone wall (38) was observed. It was aligned NE/SW, parallel to the back of St John's House. No dating evidence or construction cut was found. Also within this service trench foundation trench 39 cut the

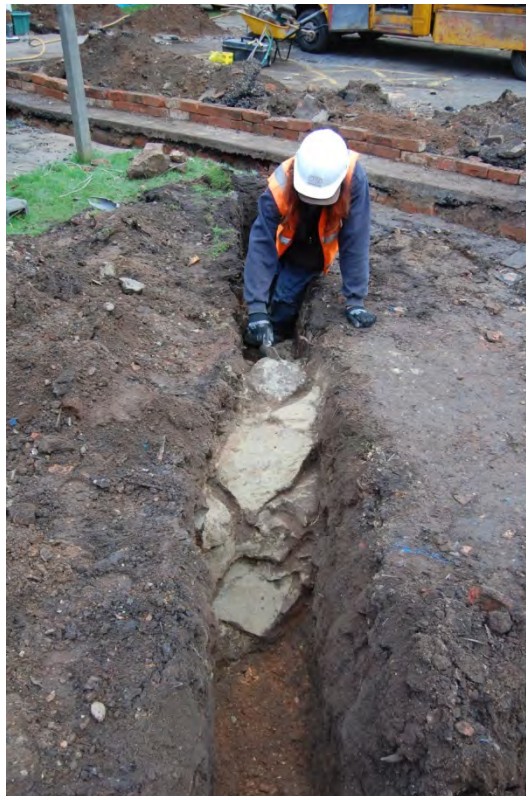
Photograph 3: Wall 30 being cleaned

5.6 Wall 30 was also aligned NE/SW parallel to the back of St John's House. Two or three courses of the up to 1.2m wide wall were visible in the service trenches. No bonding material was noted and may have washed out. No dating evidence was found within the wall or the possible construction trench. A sherd of 18th-century coarseware was recovered from a 0.1m deep layer of light grey sand (41) butting wall 30. The wall also appears on the Board of Health map of 1851.

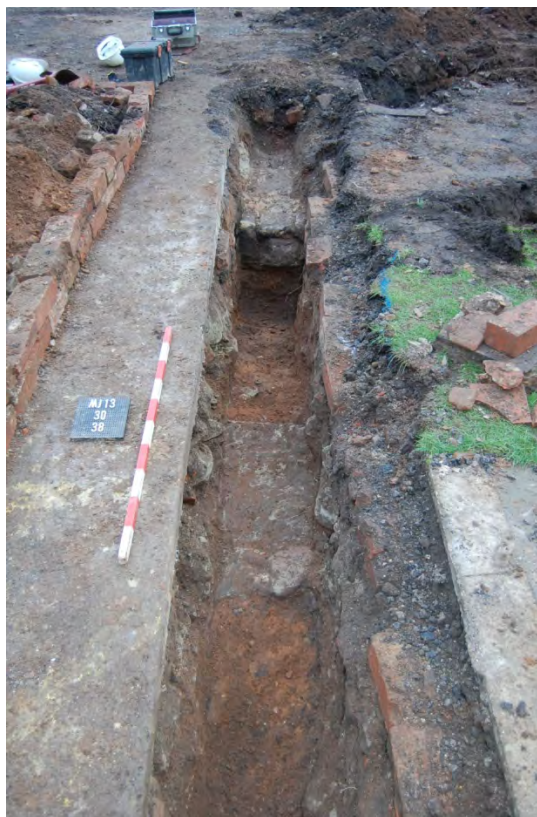
Photograph 4: Walls 30 and 38

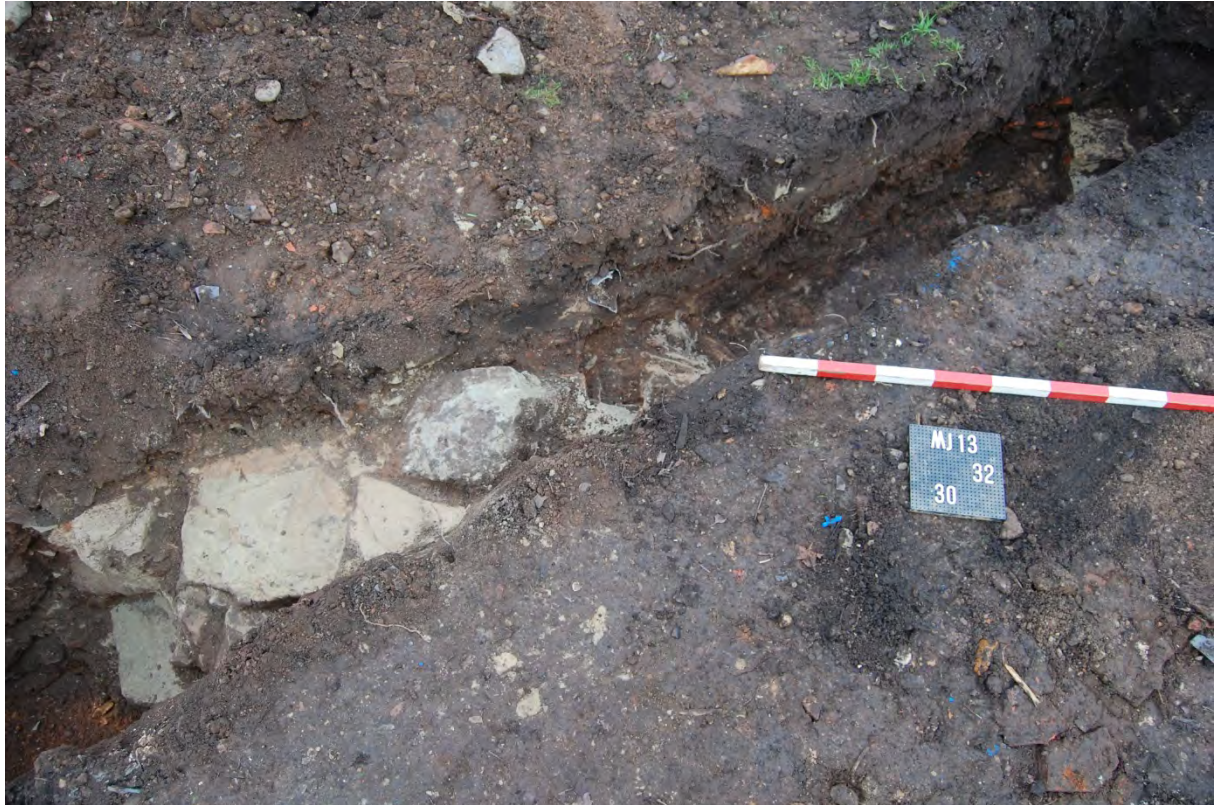
Photograph 5: Walls 30 and 32

5.7 A small part of a sandstone wall (32) was recorded to the north of wall 30 and south of wall 38. Aligned NW/SW, c.0.4m height of this wall was visible in the trench. Between walls 30 and 32 was a deposit of grey sandy loam with demolition rubble (31). One of the brick fragments appeared to be of 17th-century date.
