Nunley Farm, Wroxall, Warwickshire

ARCHAEOLOGICAL RECORDING

Archaeology Warwickshire Report No 1598
December 2015

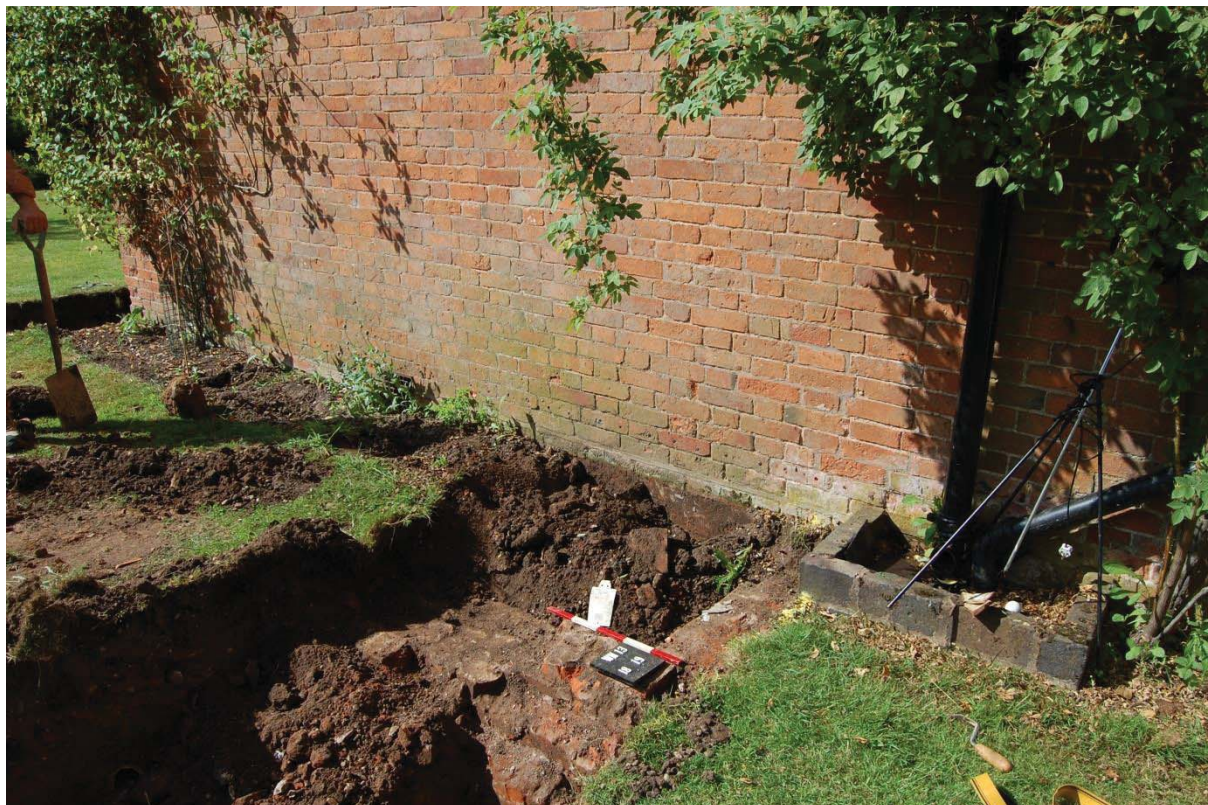
3: Walls 18 and 19 revealed

5.4 Immediately east of the house the brick footings of three brick walls were recorded (18, 19 and 20) suggesting a rectangular bay, 5m long, projecting 0.75m from the house. Indeed, such a structure is indicated on the First Edition map of 1887. There is, however, no indication of a blocked window on this wall to correspond with the walls. The side walls were 0.35m wide and the long wall 0.45m wide. This had been cut through for the insertion of modern storm drain (6). The walls were overlaid by 0.10-0.20m of topsoil (1).

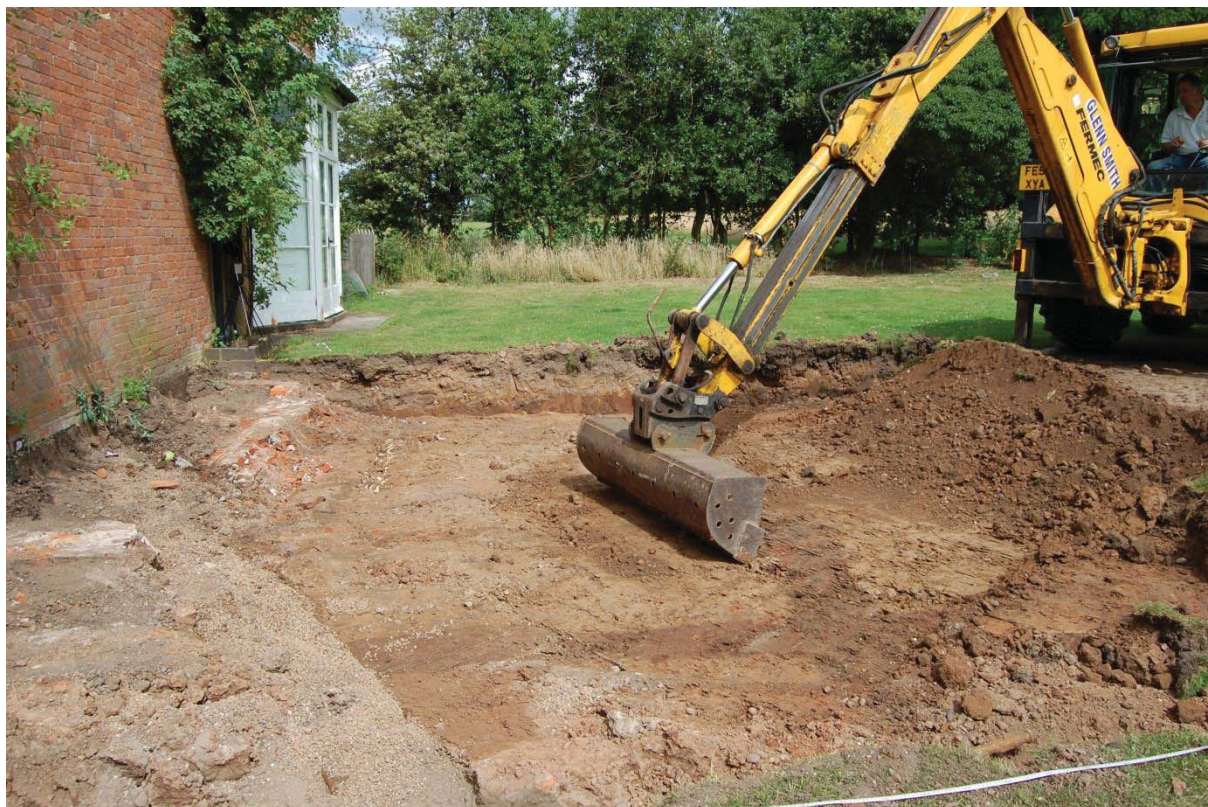
4: Ground reduction taking place

5.3 A watching brief took place during the excavation of foundation trenches for the extension to the main house in July 2013. Excavations were carried out using a JCB, to a depth of c.1.00m. The ground between the foundation trenches was also reduced to remove deposits over the natural clay, to a depth of c.0.40m. In the foundation trenches geological natural red clay and sand (15) was reached at a depth of 0.40-0.50m and was cut by a large number of post-medieval drains and other services (see below). The natural clay was overlaid by a 0.20m thick layer of mortary gravel which included a large quantity of plaster fragments (2).

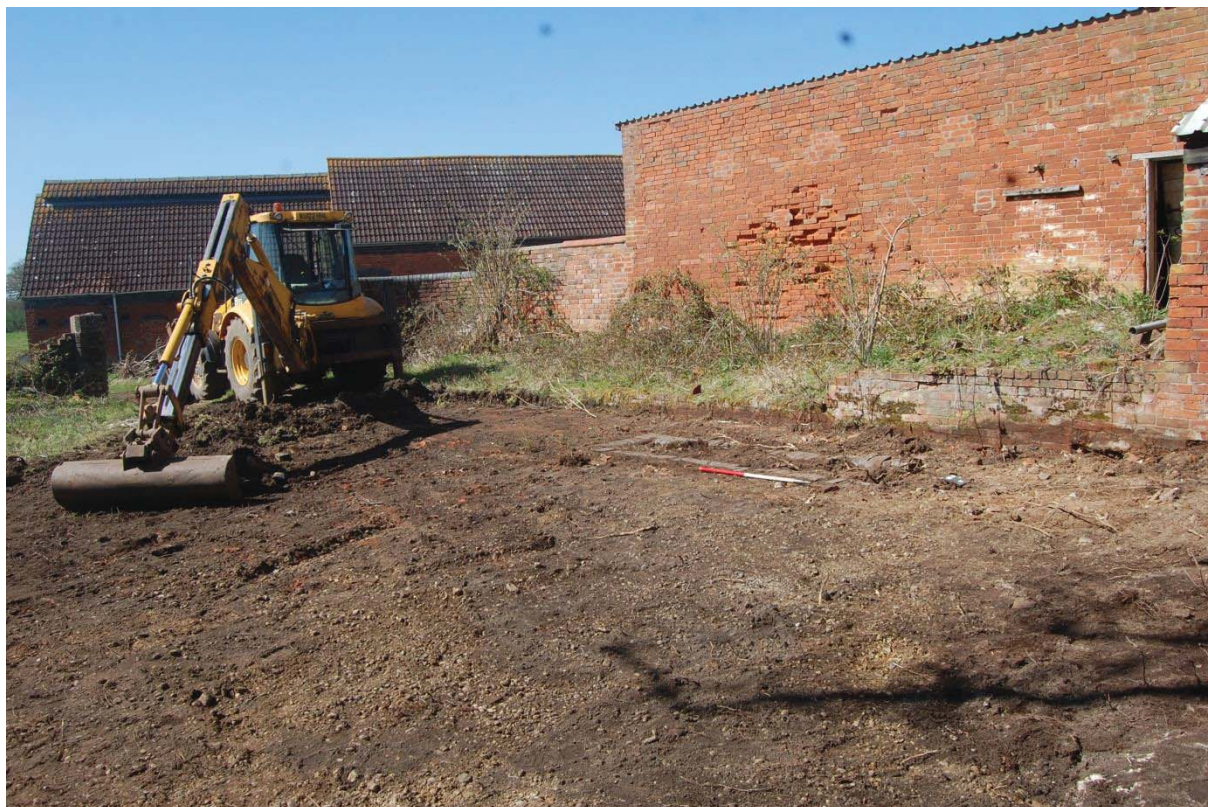
6: Ground reduction taking place, brick-lined pit (29) exposed

5.5 A further watching brief was carried out in April 2015 during groundworks associated with the alterations to the outbuilding. The vegetation was first stripped off the yard, revealing remnants of a concrete yard surface (27) near the north-east garden wall and a gravel surface (28) elsewhere. An area of brick floor was also recorded (31). A brick-lined pit feature was revealed parallel with the outside wall of the demolished part of the outbuilding (29). This measured 3.5m long and 1m wide, with an internal width of c.0.60m. It was filled with a mixture of sandy loam, bricks and modern debris (30), at least 0.30m deep but not excavated. Its purpose was unknown.

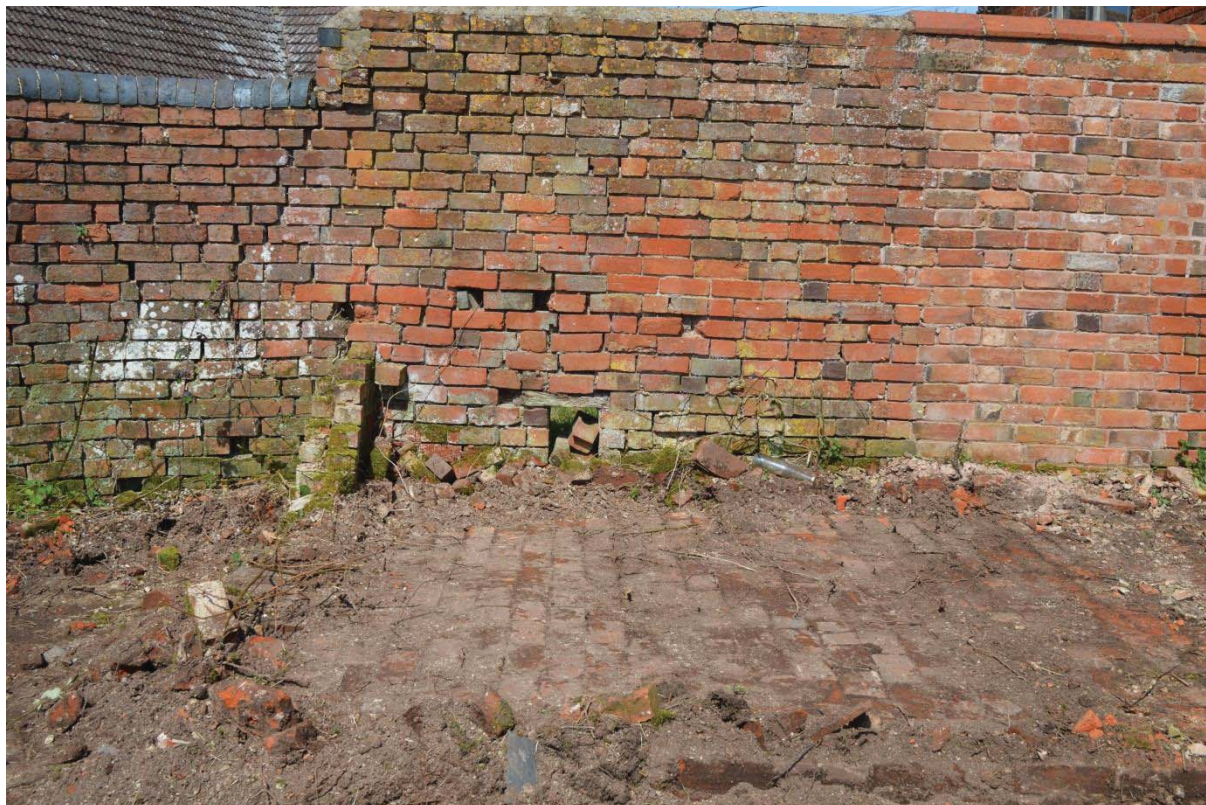
7 : Paved floor (31) of former building

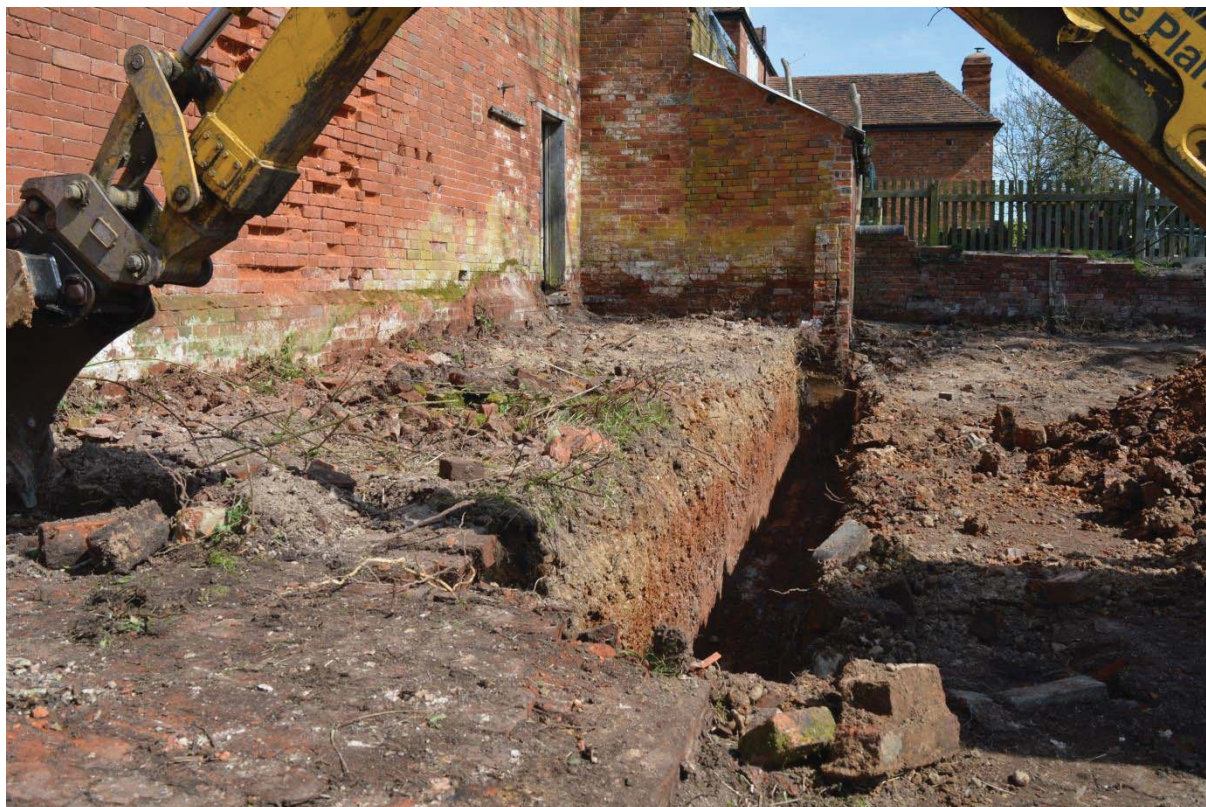
8: Trenching for new extension

5.7 The foundation trenches for the new extension followed the line of former walls of the demolished building. The trenches reached a depth of 1.00m on the outside and 1.30m on the inside of the building. Geological natural reddish brown clay (38) was overlain by natural sand and gravel (37) and the latter was overlain by 0.30m of light yellowish brown sand and gravel, itself partly overlain by the brick floor of the former outbuilding (33).
