**Victoria House,
14 Church Street, Marton,
Warwickshire**

ARCHAEOLOGICAL WATCHING BRIEF

Archaeology Warwickshire Report No 1465
SEPTEMBER 2014

Project: 14 Church Street, Marton, Warwickshire,
CV23 9RL

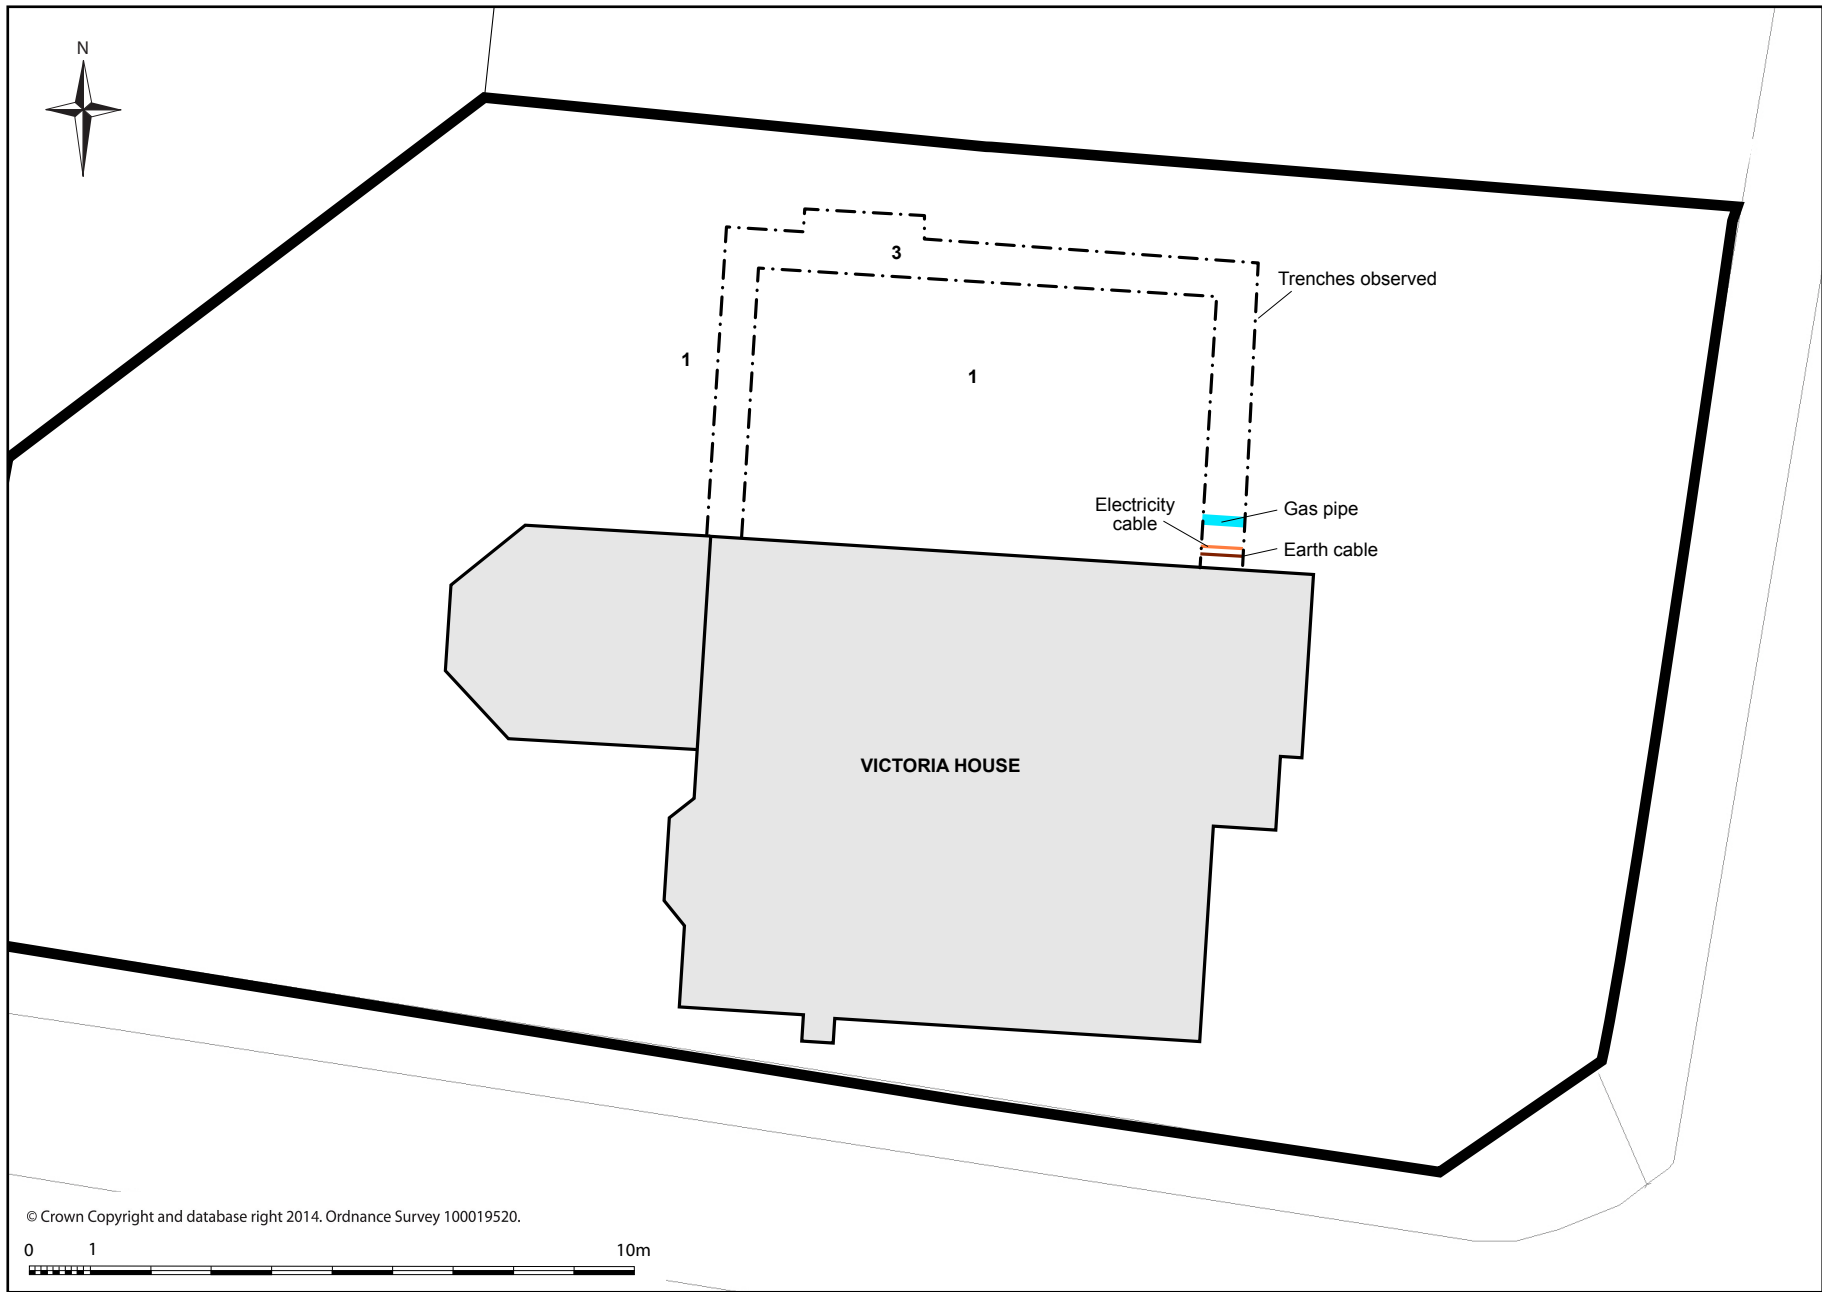
Fig 3: Trenches observed

5.1 The existing garage was demolished and the foundation trenches were excavated using a 3-tonne, 360-degree, mechanical excavator fitted with a 0.60m wide, toothless ditching bucket.

5.2 The trenches were excavated to 1.05m below the existing ground level.

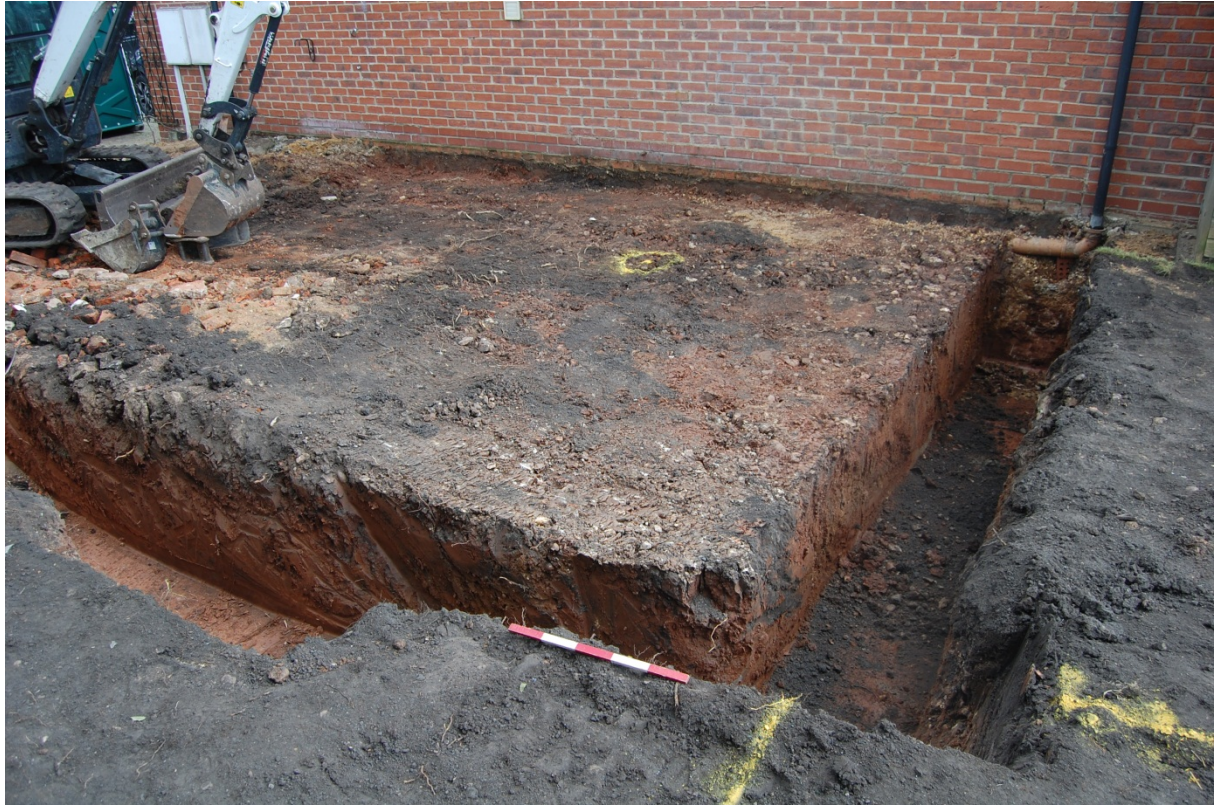
Fig 4: Trench, looking SE

5.3 Geological natural red clay (3) was achieved at 0.25m.

5.4 Overlying the natural was a 0.10m deep layer of brown clay loam (2). This contained demolition rubble (brick and tile fragments) and modern glass finds and is reminiscent of a hard-standing.

5.5 The topsoil on site was very dark greyish brown loam (1) that was 0.15m deep.

6.1 The watching brief was able to determine that no significant archaeological deposits were disturbed by the development. The deposit sequence suggests that the area had been previously stripped to natural, probably during the construction of Victoria House. During this process modern demolition rubble was imported to level the site then topsoil was laid on top.
