Land Rear of 18 The Green, Bilton, Rugby, Warwickshire

ARCHAEOLOGICAL EVALUATION

Archaeology Warwickshire Report No 1545

JULY 2015

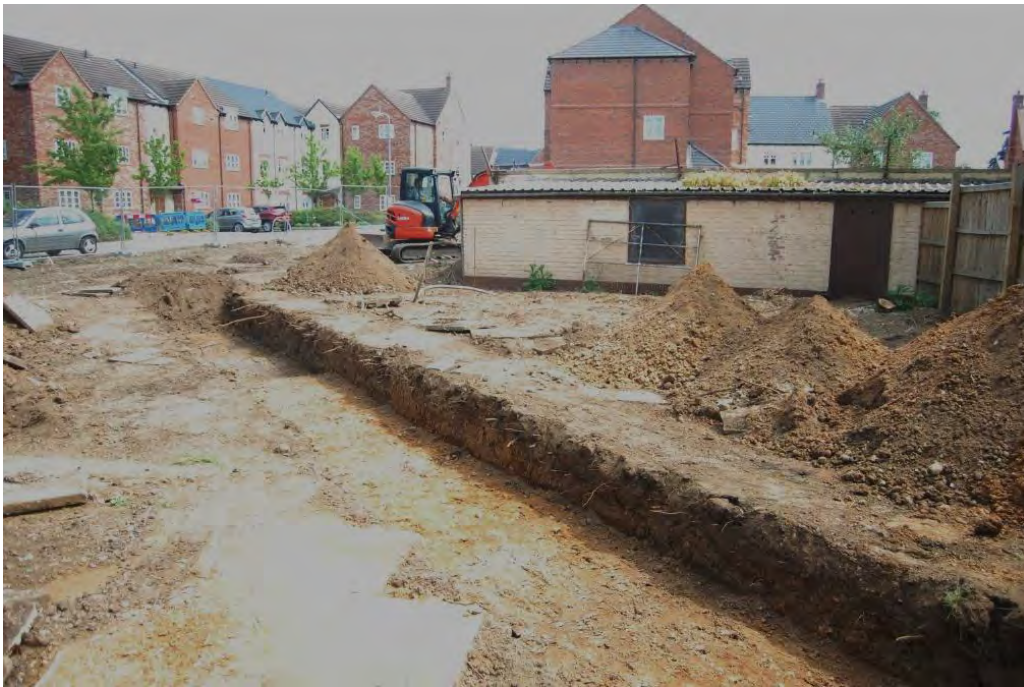
Photograph 1. Trench 1

5.2 Trench 1 was located partly within the proposed footprint of the western building. The geological natural gravel (16) was revealed at a depth of approximately 0.38m below the present ground level, between 112.53m and 112.61m OD.

5.3 The natural gravel was cut by several features. A shallow gully (18) aligned roughly west to east extended across the trench. It was a maximum of 0.15m deep and was filled by a greyish brown silty clay (17) which contained six sherds of medieval pottery and one fragment of post-medieval glass.

5.5 The stratigraphic sequence overlying the natural cut features included a layer of grey brown sandy clay (14) and a layer of sandy clay loam topsoil (15). No finds were recovered from the layers above the natural gravels.

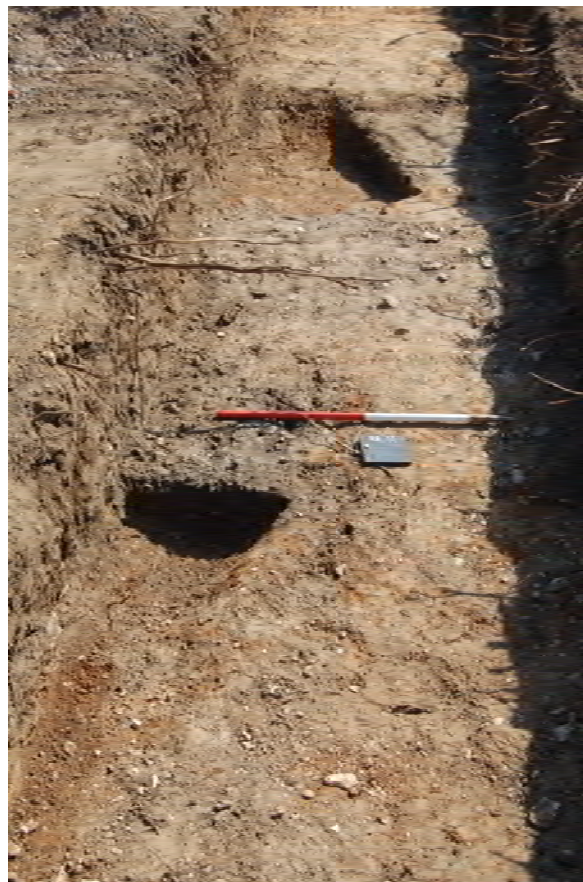
Photograph 2. Pits 20 and 22

5.4 Two possible pits were revealed but remained undated. The larger part of an oval-shaped, shallow pit 20, contained a greyish brown silty clay fill with some yellowish brown

sand (19). Pit 22 was a maximum of 0.22m deep and contained a greyish brown silty clay fill (21).

6.2 Three features were revealed in the western trench and these include one possible medieval gully. The western part of the site reflects its previous use as garden and was subject to less truncation. It is possible that the undated pits may relate to garden features or tree positions.

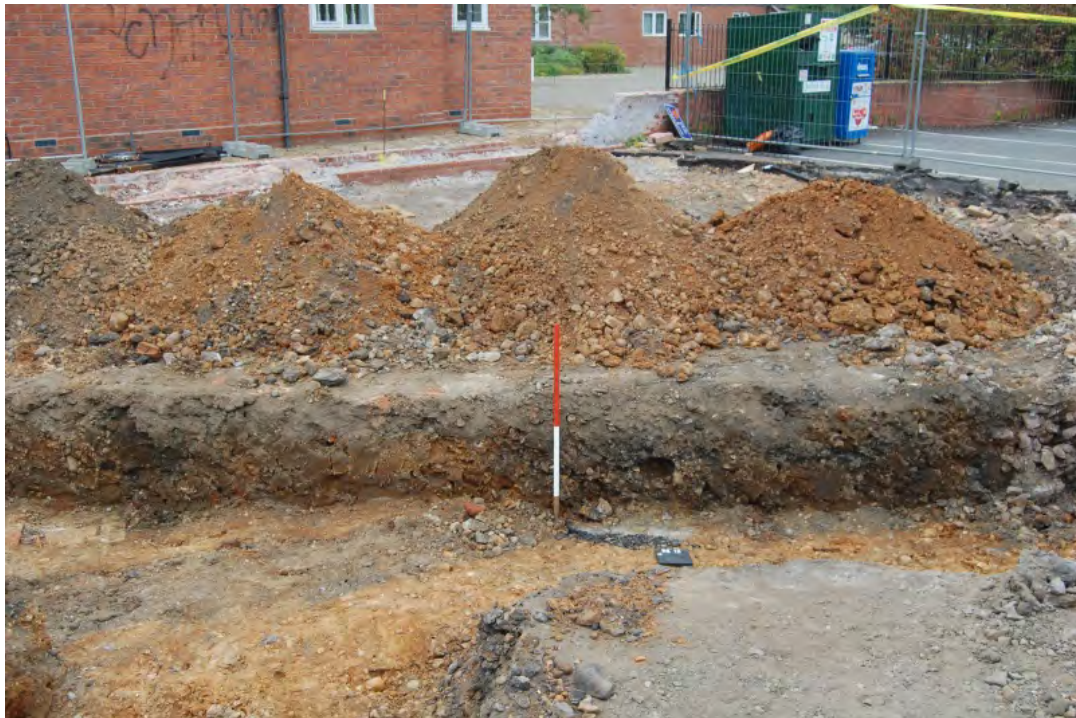
Photograph 3. Trench 2

5.6 Trench 2 was located partly within the footprint of the eastern building plot. As the southern limit of the application area remained part of an active car park it was not possible to fit the full proposed length in its agreed position. Following discussion with a Warwickshire County Council Planning Archaeologist it was agreed to extend the trench westwards in two places in order to investigate an area of undisturbed natural and further brick wall remains.

5.7 Geological natural yellowish brown sand and gravel (3) was revealed at a depth of c.0.40m below current ground level, at 112.80m aOD.

5.8 Geological natural was cut by a series of service trenches (4 and 8) including modern drainage and water.

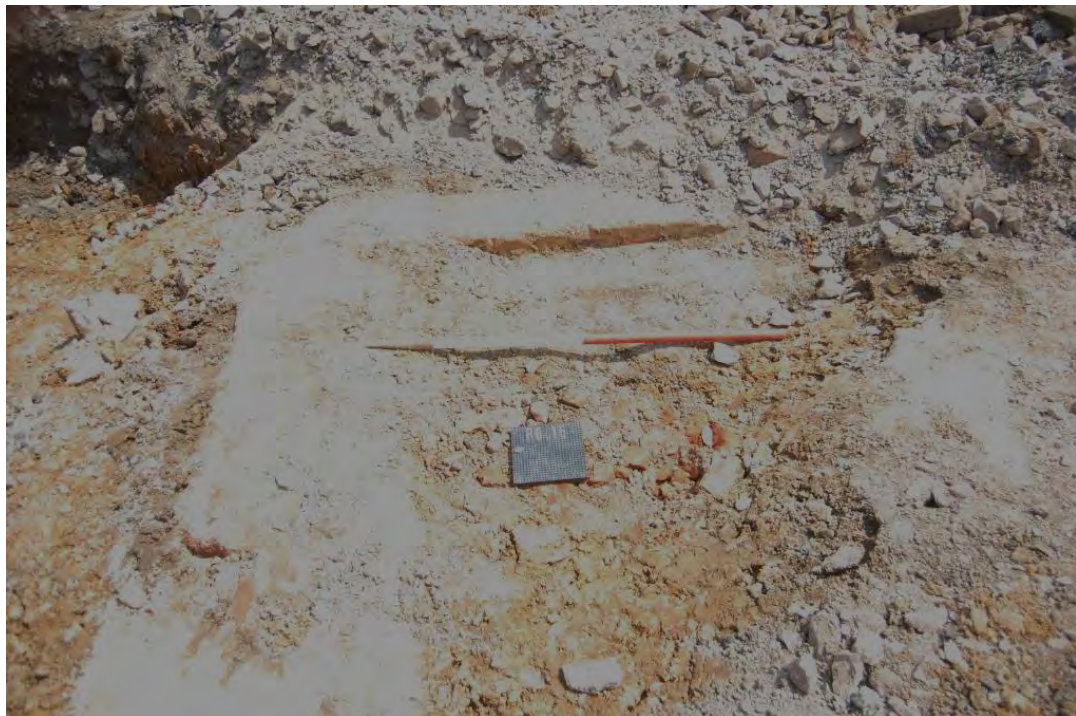
Photograph 4. Wall 10

5.9 At the southern end of the trench a 3.6m long brick wall (10) extended south-west to north-east across the trench. With a corner and return to the south. It was constructed on a concrete foundation and survived as a single, mortared, course. To the south of the wall was a small area of brick surface (12), possibly yard or floor. A brick wall (6) at the northern end of the trench was at least 1.4m long and comprised six courses of brick. These features are likely to be the structure shown on the First Edition map.

6.3 The wall foundations revealed in Trench 2 closely match the positions of buildings or boundaries shown on the Ordnance Survey First Edition map and these walls appear to be part of those structures. No evidence of associated deposits or finds was recovered during the evaluation.
