# Windy Hill, School Lane Priors Marston, Warwickshire

## Archaeological Watching Brief

Archaeology Warwickshire Report No 1405  
January 2014

**Project:** Conversion of Cattle Byre  
**Commissioned by:** Norman Yates  
**Project Report No.** 1405  
**Site Code:** PM13  
**Planning Reference:** 11/00762FUL  
**National Grid Reference:** SP 4905 5755  
**Staff:**  
**Project Manager:** Stuart Palmer  
**Fieldwork:** Caroline Rann  
**Author:** Caroline Rann  
**Illustrations:** Candy Stevens  
**Report checked by:** Stuart Palmer  
**Date:** 16/1/14  
**Report reference:** Rann, C, *Windy Hill, School Lane, Priors Marston, Warwickshire: Archaeological Watching Brief*, Archaeology Warwickshire Report 1405

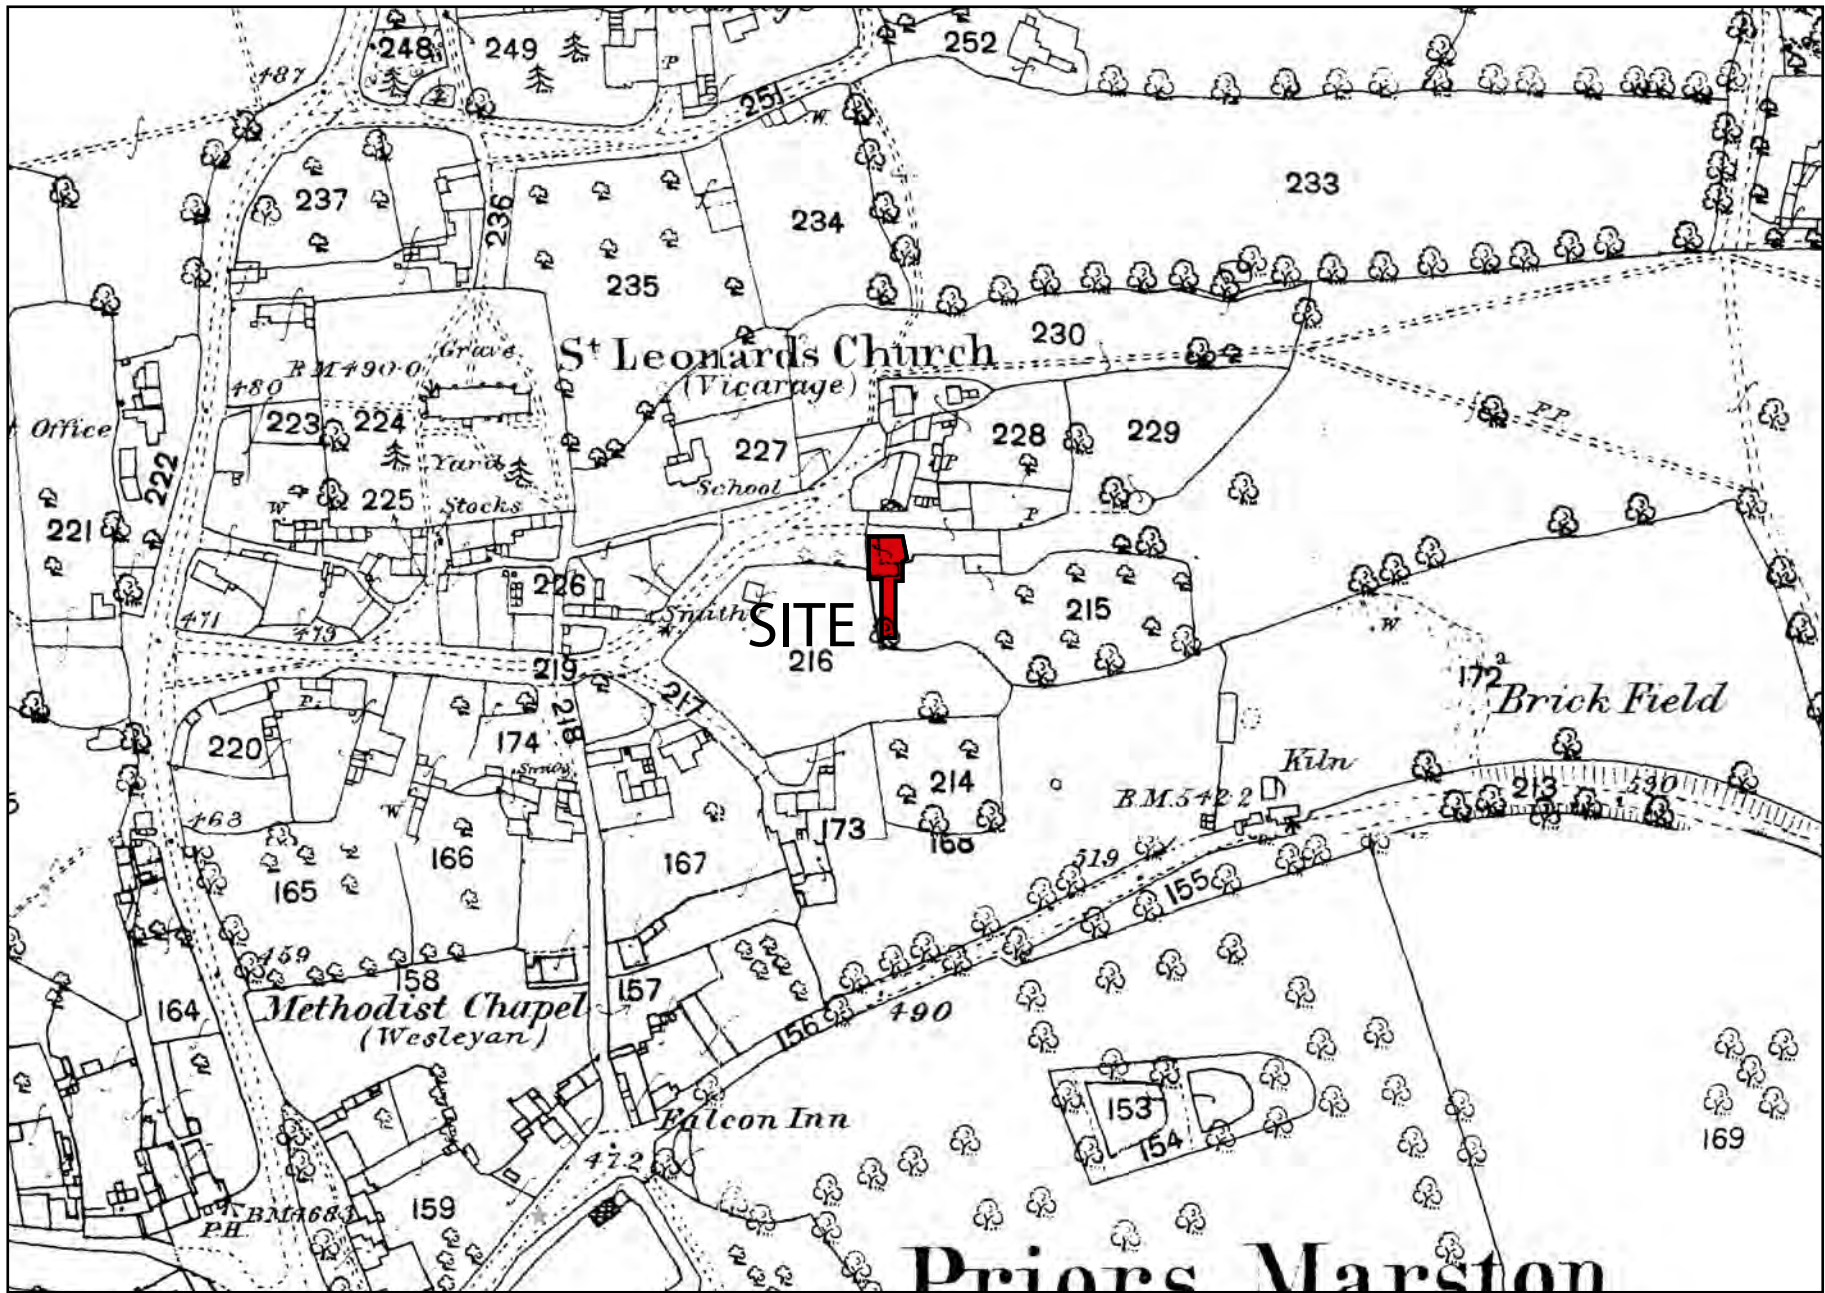
Fig 2: Detail from First Edition Ordnance Survey map of 1885

3.4 The medieval village of Priors Marston (HER MWA724) has never been examined in detail but the likely extent has been surmised with reference to the boundaries and roads and pathways extant on the First Edition of the Ordnance Survey (1885) at which time the cattle byre looks much the same as today (Figure 2).

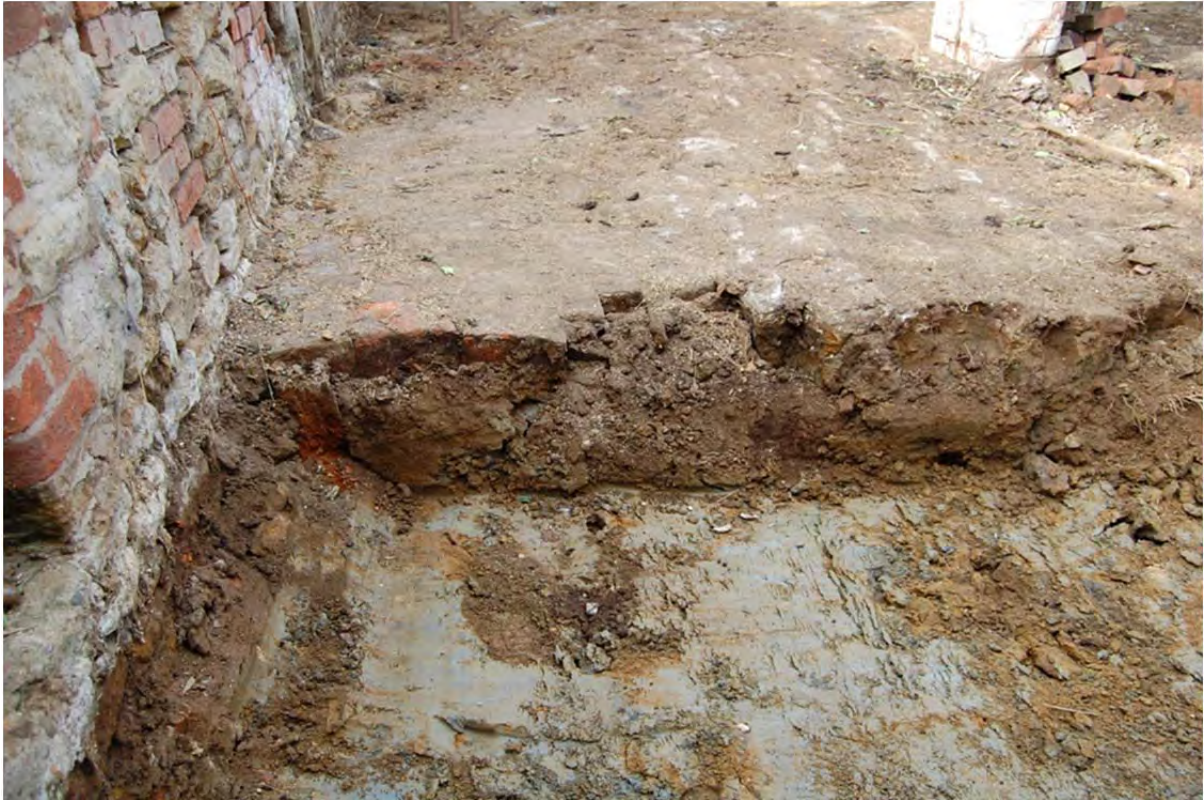
Fig 5: Floor make-up deposits

5.7 Overlying layer 10, was 0.28m of mixed grey and brown clay with siltstone fragments (3; Fig 5). A sherd of pearlware noted from this context provides an earliest possible date for this layer as late 18th-century, but it was still likely to have been a late 19th-century deposit, probably a bedding layer for the composite floor of the byre.

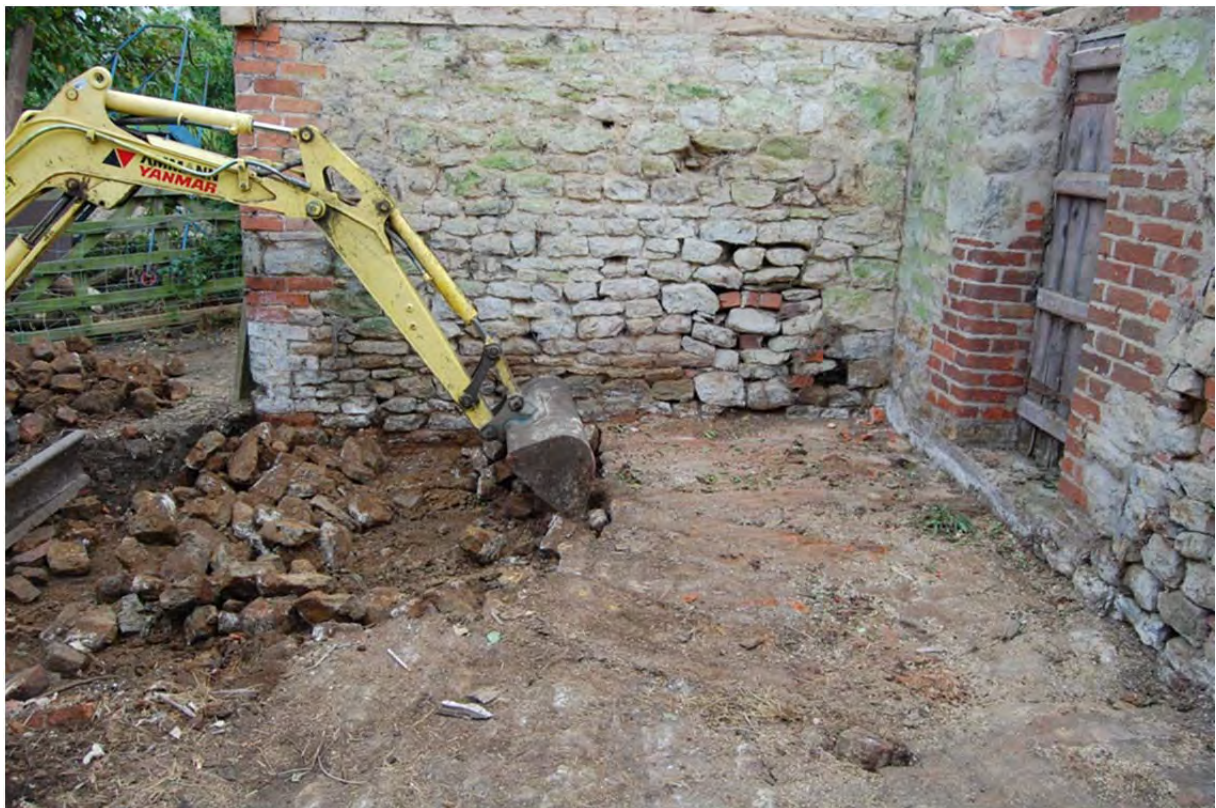
Fig 6: Removal of composite floor of barn

5.8 The composite floor consisted of up to four different materials; bricks were laid flat and lengthways (1), siltstone blocks laid lengthways and side upwards (2; Fig 6), a layer of reddish brown and very dark reddish brown clay loam with 19th/20th century pottery (5) and crushed white lime mortar (12). The latter context was also found below the bricks and may have been a bedding layer for them.

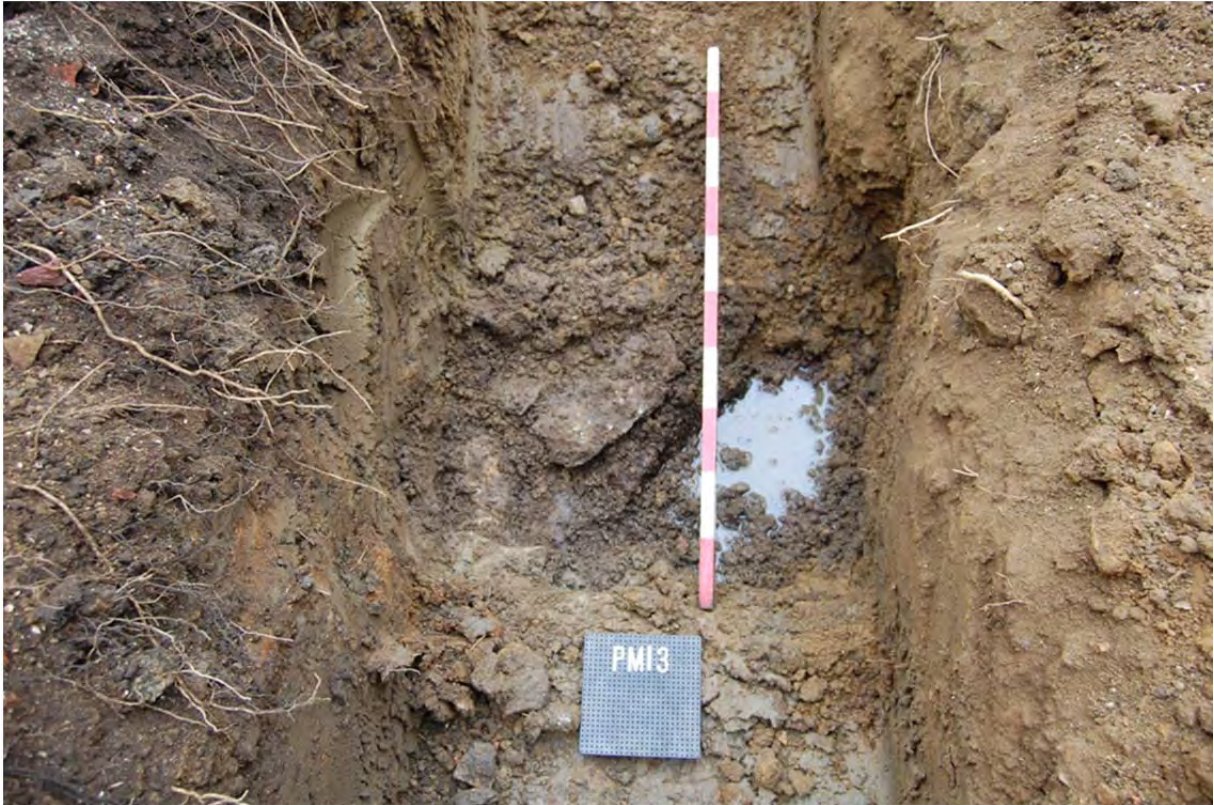
Fig 7: Siltstone layer 19

5.3 Geological natural greyish-blue clay (17) was observed in the northern part of the trench. At the lowest part of the trench, large siltstones (19), were aligned east to west, but these were probably natural and associated with the water table: no bonding material, construction cut or man-made artefacts were found around the stones (Fig 7).

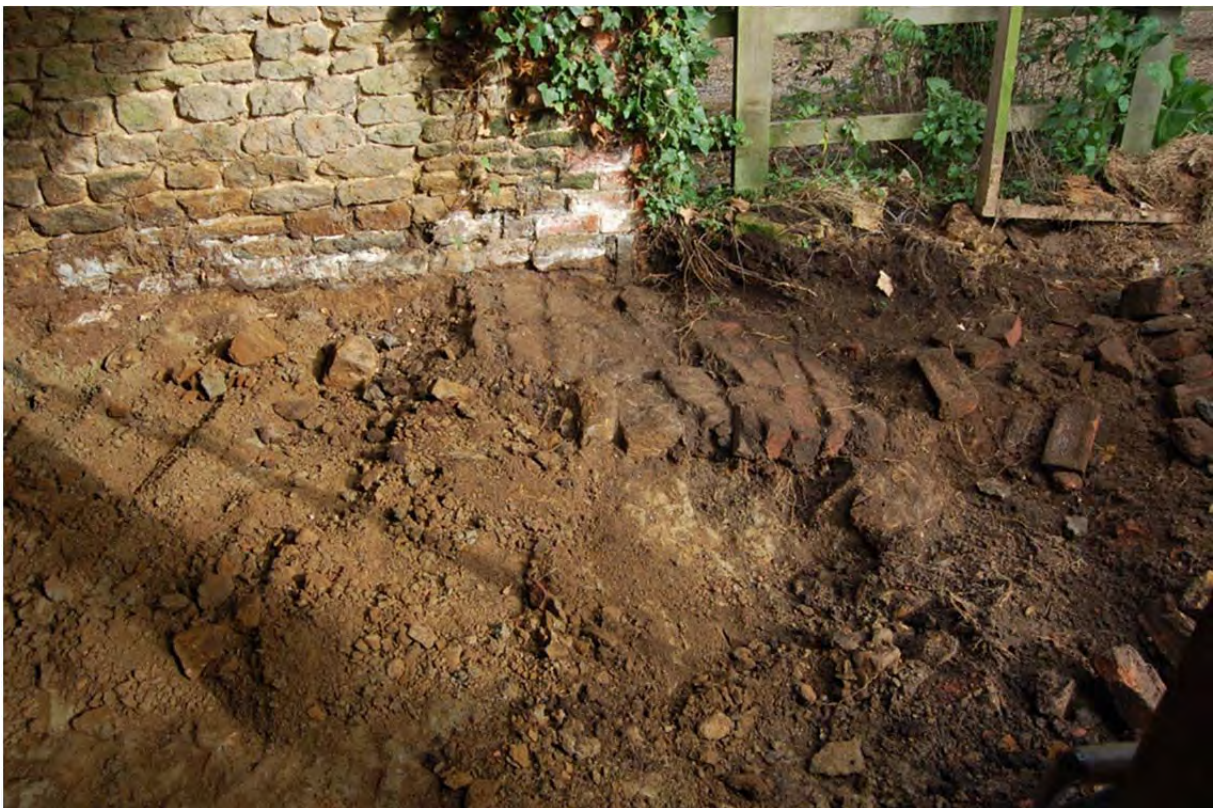
Fig 8: Floor of barn and brick yard surface

5.11 Overlying layer 8 was a more recent surface consisting of bricks laid longways on their side (7; Fig 8). The red frogged-bricks were manufactured by the Leamington Brick Company which made bricks until the middle of the 20th century.
