Archaeological Watching Brief on a water pipe trench at St John's House, Warwick

An archaeological watching brief was carried out on the trenches for the installation of a new water pipe at St John's House Museum, Warwick. Two trenches were observed; Trench 1 ran to the rear (south) of the house and west of the east wing; Trench 2 ran across the car park entrance to the north-east of the house.

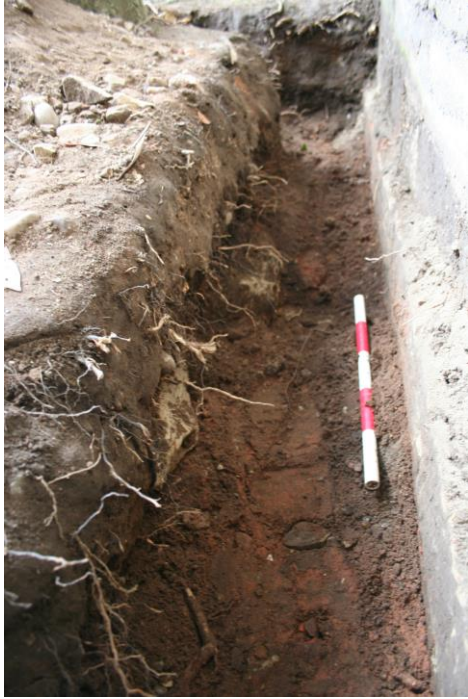
Fig. 2: Wall 8 looking south-west

To the north, along the southern wall of the existing building, a possible wall (8) ran roughly north-west to south-east across the trench (Figs. 2-3). This measured c.1m wide and was made of irregular or roughly squared sandstone blocks up to 0.20m thick by up to 0.40m across. Its top lay at 0.30-0.40m below the existing ground surface and it appeared to be bonded with reddish brown sandy silt. A patch of stone uncovered in the base of the trench appeared to form part of this wall and ran under the foundation for the existing building (12) which it pre-dated. This makes it possible that the wall formed part of the medieval or early post medieval structures that occupied the area before the existing mid 17th century building. A single squared sandstone block (10), 0.35m wide by 0.25m thick was recorded in the base of the trench further to the south-east. This may have belonged to an *in situ* wall but is just as likely to have been a random lump of stone from construction work.

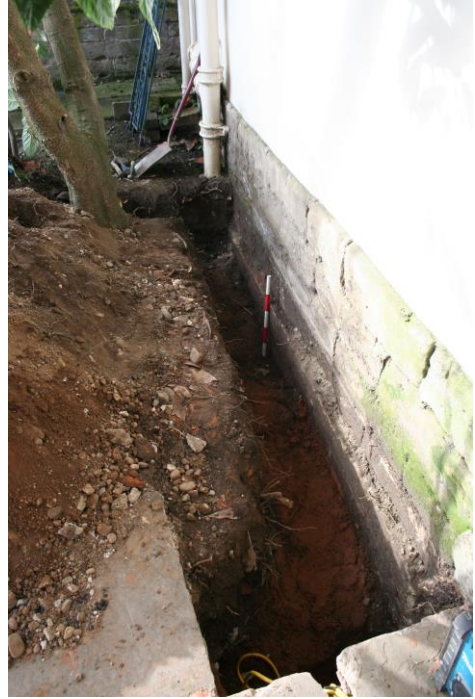
Fig. 3: Wall 8 location looking south-west

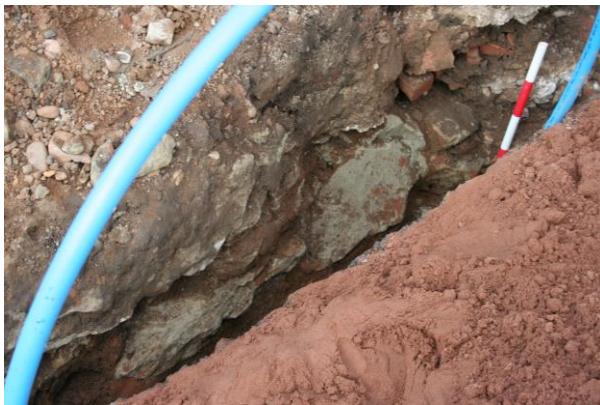
Fig. 4: Wall 9 looking north

Layer 6 appeared to be overlain by a wall of sandstone blocks up to 0.30m thick by over 0.40m long (9) that ran north-east to south-west along the line of the trench (Figs. 4-5). The base of the wall was at 0.40 below the current ground surface and the top of the wall at 0.65m below the current ground surface. Only the north-east end of the wall was observed due to the trench having been backfilled. It appears to have been a continuation of a medieval or early post medieval wall recorded in this area during the observation of a cable trench in 2008 (WJ08, context 34).

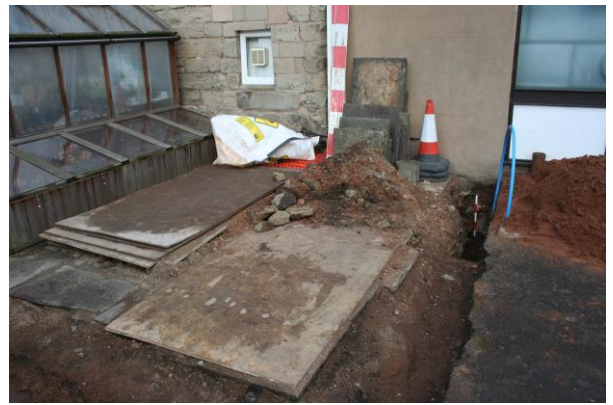
Fig. 5: Wall 9 location looking north-east

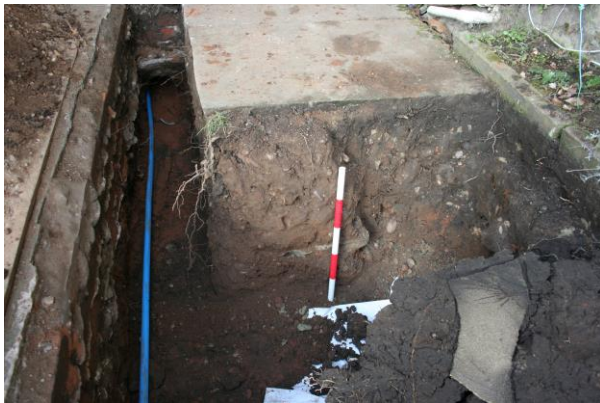
Fig. 6 ; Slab (path?) 7 looking north

Layer 5 was overlain by a single sandstone slab (7) that measured c.0.35m wide by 0.10m thick close to the east wing of the existing building (Figs. 6-7). The slab had been laid horizontally on the surface of garden soil 5 and may represent the remains of a former path.

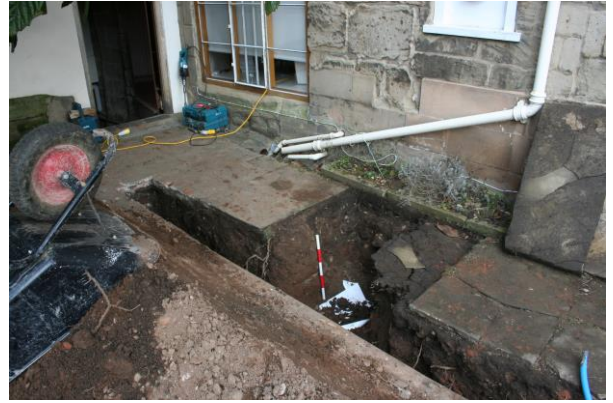
Fig. 6 ; Slab (path?) 7 location looking north-east

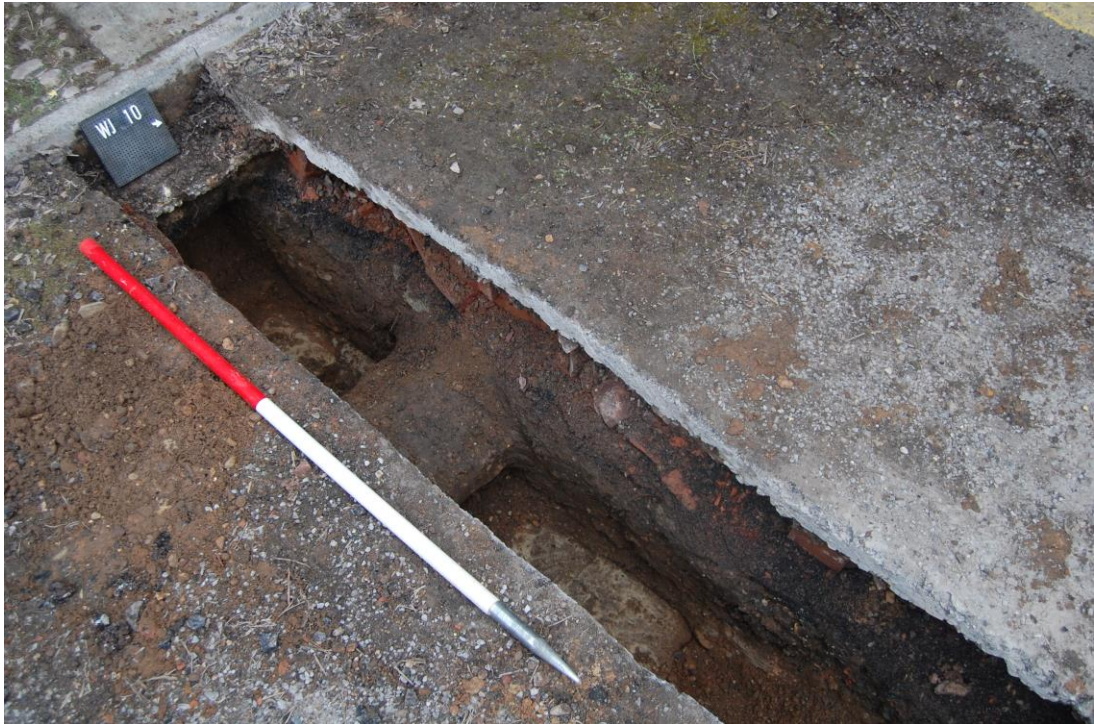
Fig. 7: Geological natural sandstone (21) south-west end of Trench 2, looking west

Trench 2 measured 0.35m-0.40m wide by c.0.75m deep and ran roughly south-west to north-east across the (inside of the) car park entrance north-east of St John's house. Geological natural sandstone (21, Fig. 7) was recorded at a depth of 0.55m-0.65m below the existing ground surface. Towards the north-east end of the trench natural 21 was cut by a vertical sided pit whose north-east edge was not uncovered (22, Fig. 8). Pit 22 was probably a quarry pit for the construction of the existing house or for earlier structures that once occupied the site. It was backfilled with brown sandy loam containing a few sandstone fragments (23). Fill 23 also contained a few fragments of hand-made ceramic roof tile and a fragment of human tibia. The find of a human bone fragment suggests that the pit had cut through, or at least been backfilled with material from, the medieval hospital cemetery that lay to the north-east of the existing house. This would imply that the pit was of post medieval rather than medieval origin.

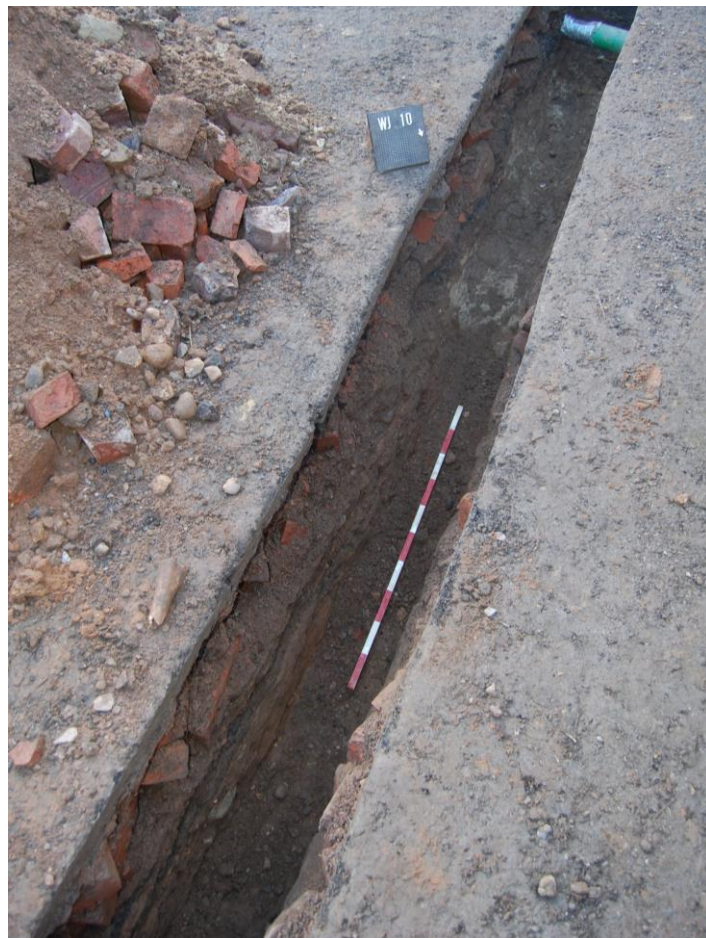
Fig. 8: Pit 22 looking south (edge against natural sandstone 21 below right of board)
