Kenilworth Castle Hedge Trench, Kenilworth, Warwickshire

ARCHAEOLOGICAL EXCAVATION AND RECORDING

Archaeology Warwickshire Report No 1627
MARCH 2015

Project: Excavation of a trench for a new hedge,
Kenilworth Castle

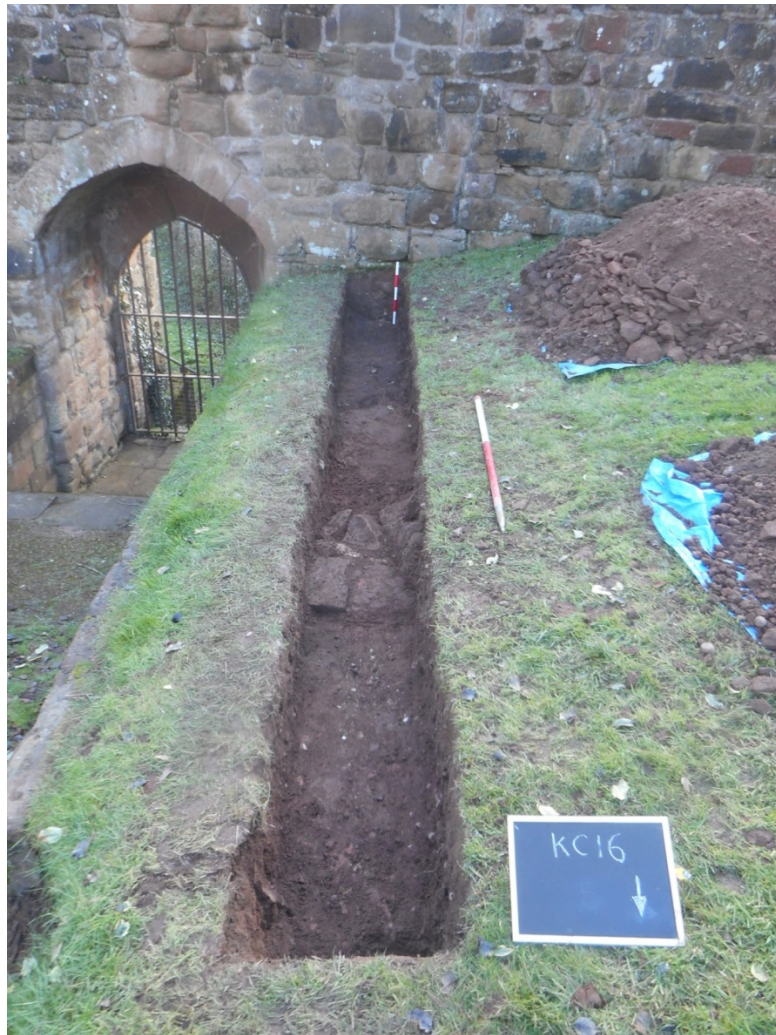
5.2 Sandstone wall 6 was aligned parallel to the curtain wall which was 3.40m to the south. It was 0.72m wide and was exposed as a single course 0.12m deep in the base of the c.0.50m deep trench. The northern face was dressed.

1. Excavated trench with wall 6 in the centre

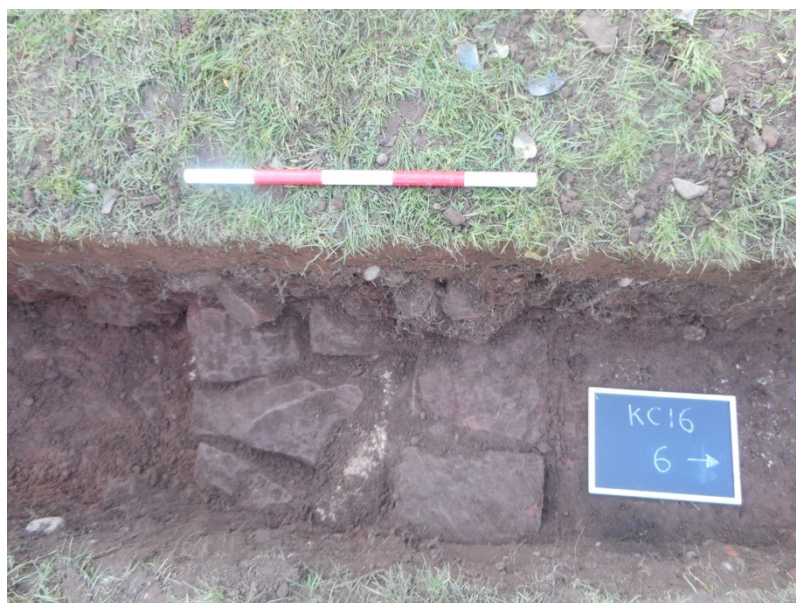
2. Detail of wall 6

6.1 The sandstone wall 6 seems likely to have belonged to a hitherto unknown building in this part of the site. It is tempting to posit a building backed up against the curtain wall but there is no evidence for scarring on the face of the curtain wall or any joist holes. At 0.72m wide the wall could have been stone-built to the eaves but a timber-frame on a plinth is also possible. The presence of a demolition layer over the foundation could suggest that its demise was late in the castle development, although the overlying deposit containing medieval debris could point to a medieval sequence.
