Hunningham Bridge, Hunningham, Warwickshire

ARCHAEOLOGICAL OBSERVATION AND RECORDING

Archaeology Warwickshire Report No 1604
FEBRUARY 2016

Project:	Hunningham Bridge duct installation
Commissioned by:	Les Williamson, WCC Design Services
Project Report No.	1604
Site Code:	HB15
Planning Reference:	N/A
National Grid Reference:	SP 3726 6852
Team:	
Project Manager:	Stuart Palmer MCIfA
Fieldwork:	Rob Jones and Kevin Wright
Author:	Dr Cathy Coutts
Illustrations:	Candy Stevens
Report checked by:	Stuart Palmer MCIfA
Date:	December 2015
Report reference:	Coutts, C M, 2015 <i>Hunningham Bridge, Hunningham, Warwickshire: Archaeological Observation and Recording</i> , Archaeology Warwickshire Report 1604.

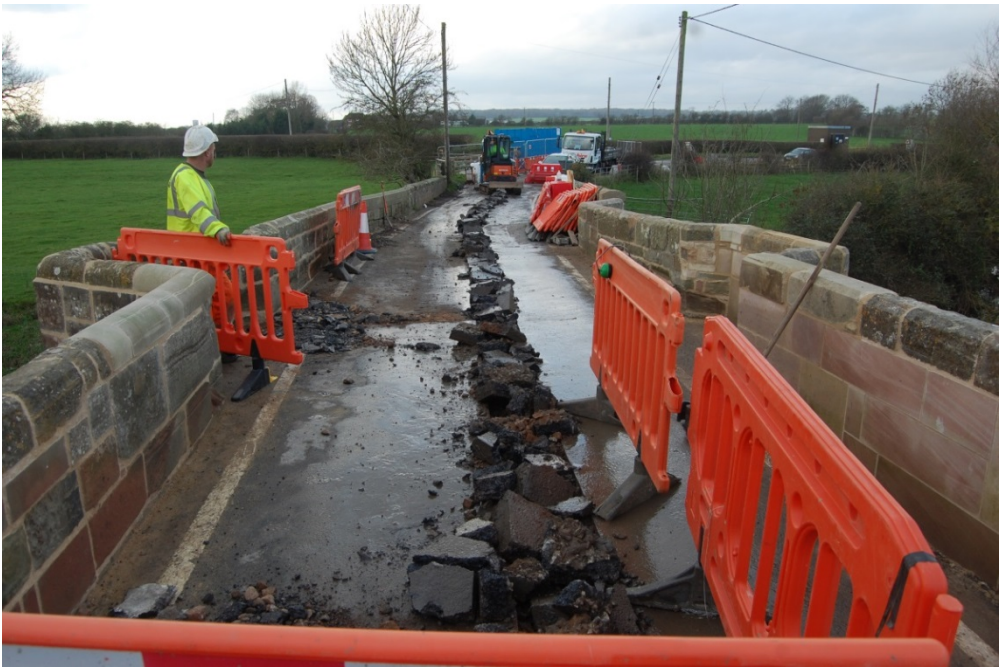
5.1 The tarmac that currently forms the upper surface of the bridge was cut by circular saw and the resulting channel of tarmac was pecked out using a breaker attached to a tracked excavator. Excavation then proceeded by hand. The service trench was 0.40-0.44m wide and 0.35-0.50m deep, being deepest on the lowest part of the bridge and shallowest at the apex. The lowest level achieved was a compacted layer of mixed Type 1 sub-base with reddish brown sandy loam (3), of which a depth of up to 0.30m was seen.

1. Breaking through the tarmac surface

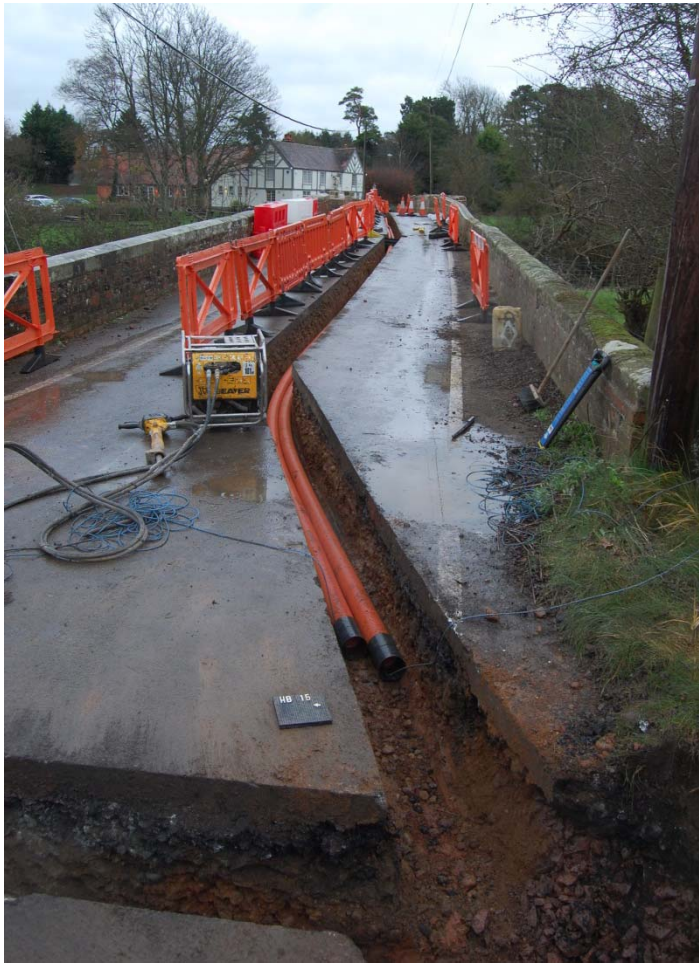
This was overlain by 0.10m of sub-base (2), overlaid by 0.10m tarmac road surfacing (1). No finds were recovered and the no part of the stone structure of the bridge was exposed in the service trench.

2. Service trench with conduits in place
