# Ilmington Community Shop, Grump Street, Ilmington Warwickshire

## ARCHAEOLOGICAL EVALUATION

Archaeology Warwickshire Report No 1520

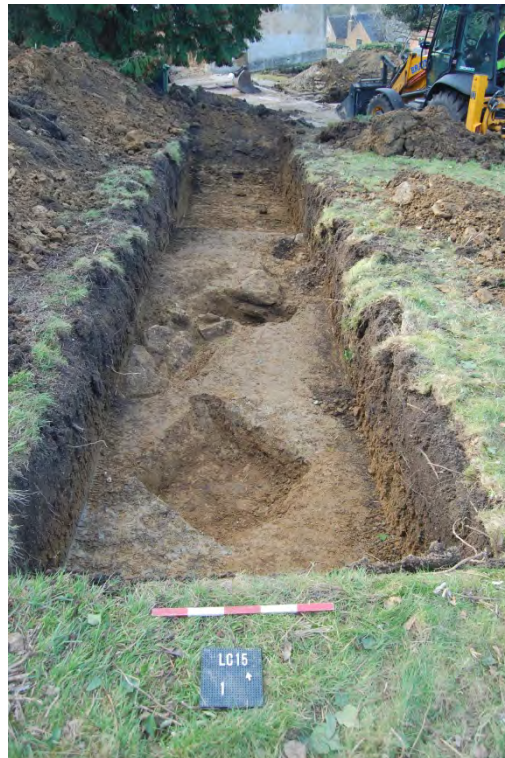
Photograph 1: Trench 1

5.2 Trench 1 was 8m long and located in the raised lawn area next to Foxcote Hill (Figs 3, 4 and Photograph 1). Geological natural yellowish brown clay with some fragments of mudstone (107) was revealed at a depth of 0.68m below the current ground level. It was overlain by a layer of dark yellowish brown clay loam (101) which was up to 0.4m deep. Post-medieval pottery and clay pipe were recovered from this layer. It also contained a line of irregular shaped stones (104). The stones were laid at a 45 degree angle rather than flat, suggesting that they were part of a revetment or bank (Photograph 2). Cutting layer 101 was a shallow ditch (102) filled with grey clay (103, Photograph 3). The feature was 0.08m deep and it may have been either a garden feature – as it followed the same alignment as revetment 104 or a trench intended for a service. The trench was covered with 0.3m of very dark greyish brown, sandy clay loam topsoil (100). A single small rectangular post-hole cut the topsoil (105) and was filled with very dark greyish brown sandy clay loam (106).

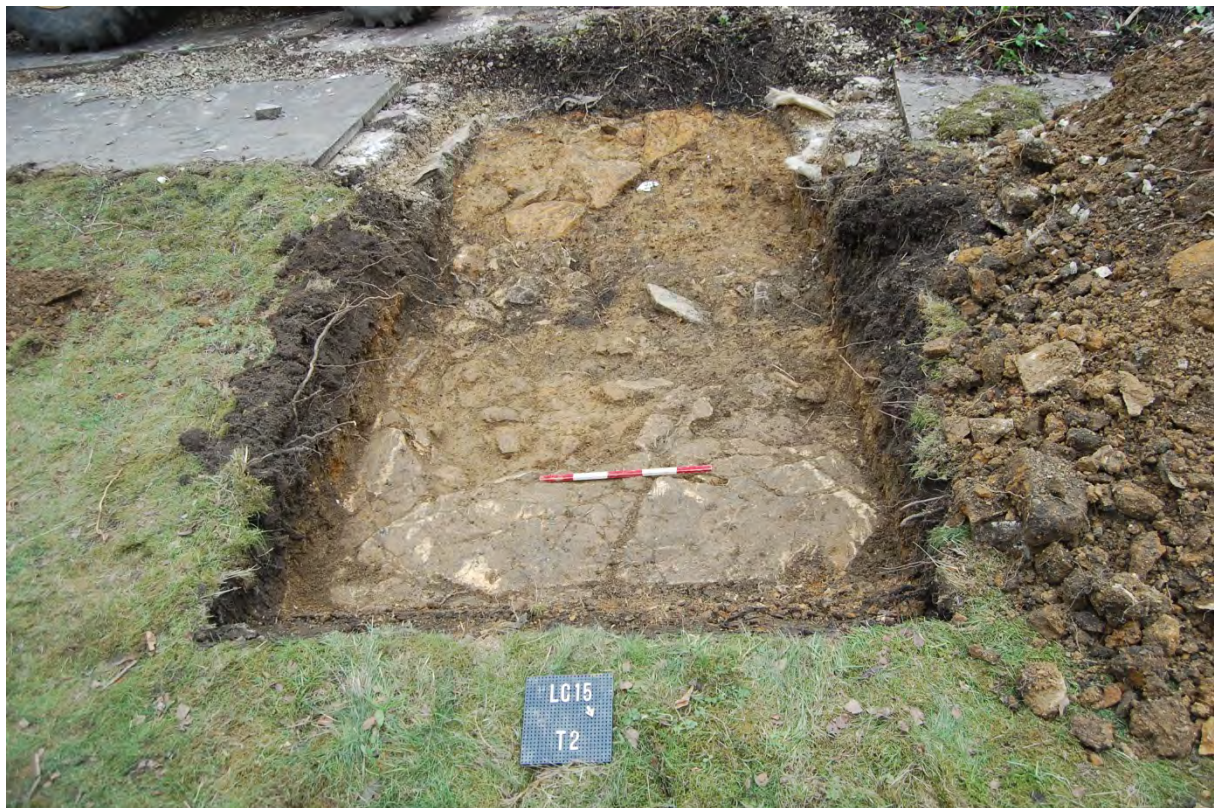
Photograph 4: Trench 2

5.3 Trench 2 was 3.25m long and aligned north/south. Geological natural yellowish brown clay with mudstone fragments (208) was reached at a depth of 0.58m below the current ground surface (Photograph 4). Sitting directly on the natural was a 0.78m wide Oolitic limestone wall (205) aligned SW-NE. Just a single course of the wall survived

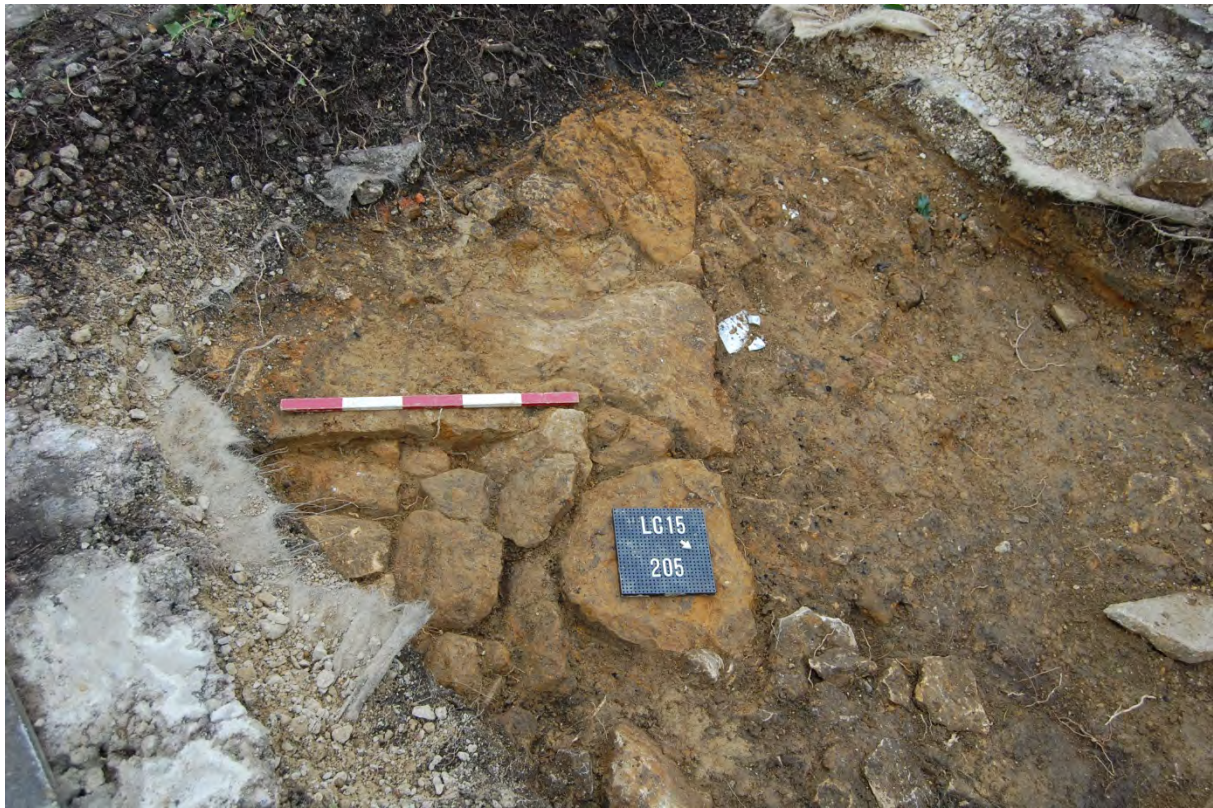
Photograph 5: Wall 205

(Photograph 5) and there was no evidence for bonding material. This wall belongs to the partly timber framed dwelling depicted on the 1781 map, which was demolished in the 20<sup>th</sup> century. At the northern end of the trench was a limestone surface constructed from large irregular slabs (203). It was likely to have been the yard for the house. It had been disturbed either during the demolition of the house or by the adjacent trench for the water main. Overlying wall 205 in the south-eastern corner of the trench was a layer of dark yellowish brown clay 0.07m deep (206). A c.0.48 deep demolition layer of stone rubble in a clay matrix covered the rest of the trench (204, 207). Slabs (201) or topsoil and grass (202) overlay the trench.

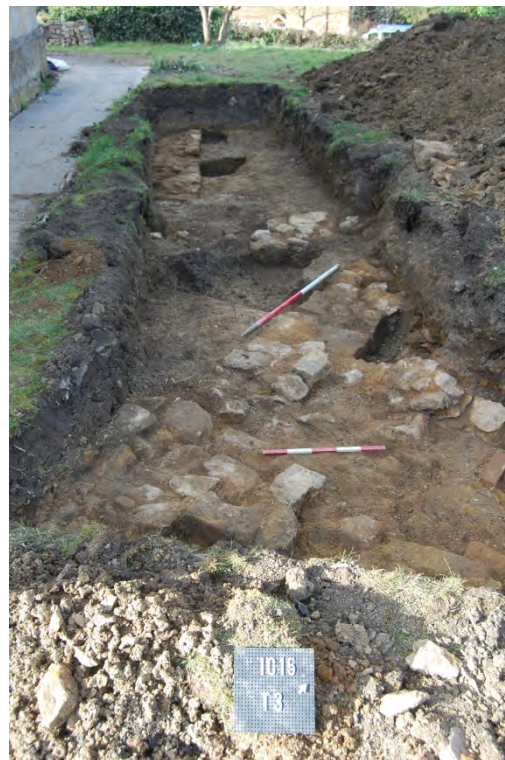
Photograph 6: Trench 3

5.4 Trench 3 was c.10m long and 'L' shaped (Figs 3, 4, Photographs 6, 7). Geological natural yellowish brown clay (317) was reached at a depth of 0.92m below the current ground level. Sitting on the natural was a NW-SE aligned Oolitic limestone wall 312 (Photograph 8). It was 0.5m wide and survived to 3 courses bonded with clay. This wall belongs to the building predating the School and the Presbytery depicted on the 1781 Inclosure map. A probable internal floor surface comprised of flat cobbles (318) survived on the west side of the wall. On the outside a spread of limestone rubble may have represented an external yard surface (313; Photograph 9).

5.10 A further series of Oolitic limestone walls (303, 304, 305, 307, 308, 309 and 310) were present in the southern part of the trench (Photographs 6, 7). These walls correspond to a building shown on the First Edition Ordnance map but not the inclosure map. The building shown is long and narrow which may indicate that it was for housing animals or was an outbuilding for the school. Between the walls was loose rubble associated with a drain (306) from which early 20<sup>th</sup> century finds were recovered.

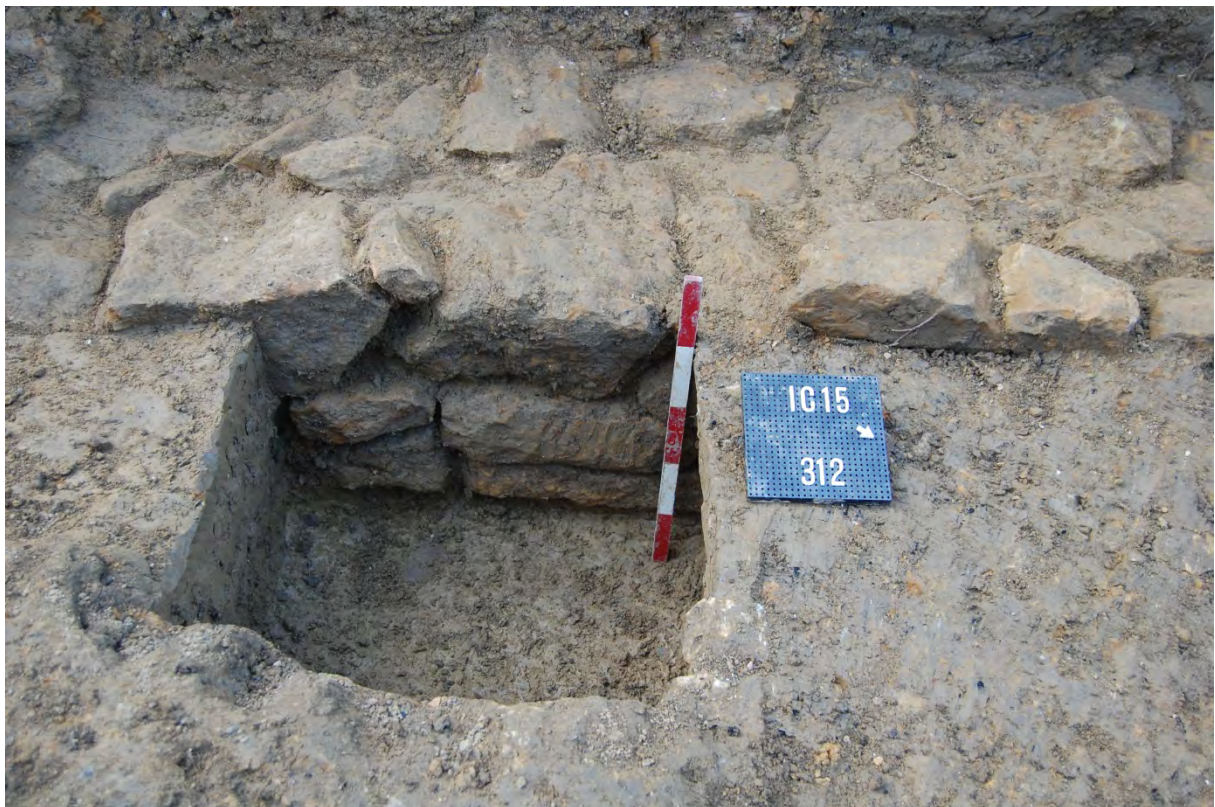
Photograph 8: Wall 312

6.1 Elements of buildings that can be identified on early maps were present in Trenches 2 and 3 (walls 205 and 312). These buildings predate the presbytery and were built before 1781 although no direct evidence for their construction and use dates was recovered.

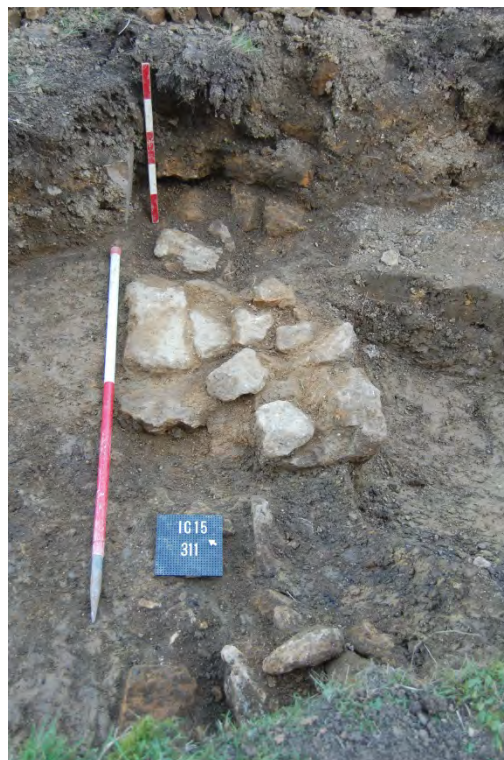
Photograph 10: Wall 311

5.9 Limestone wall 311 was aligned WSW-ESE (Photograph 10). No bonding material was apparent. The wall corresponds with a boundary shown on the First Edition Ordnance Survey map of 1885 (Fig 4). It was cut by truncated by services (Fig 3).
