# Brook Cottage, School Road, Snitterfield, Stratford-upon Avon, Warwickshire Archaeological Watching Brief

Archaeology Warwickshire Report No 1342  
August 2013

**Project:** Brook Cottage, Snitterfield

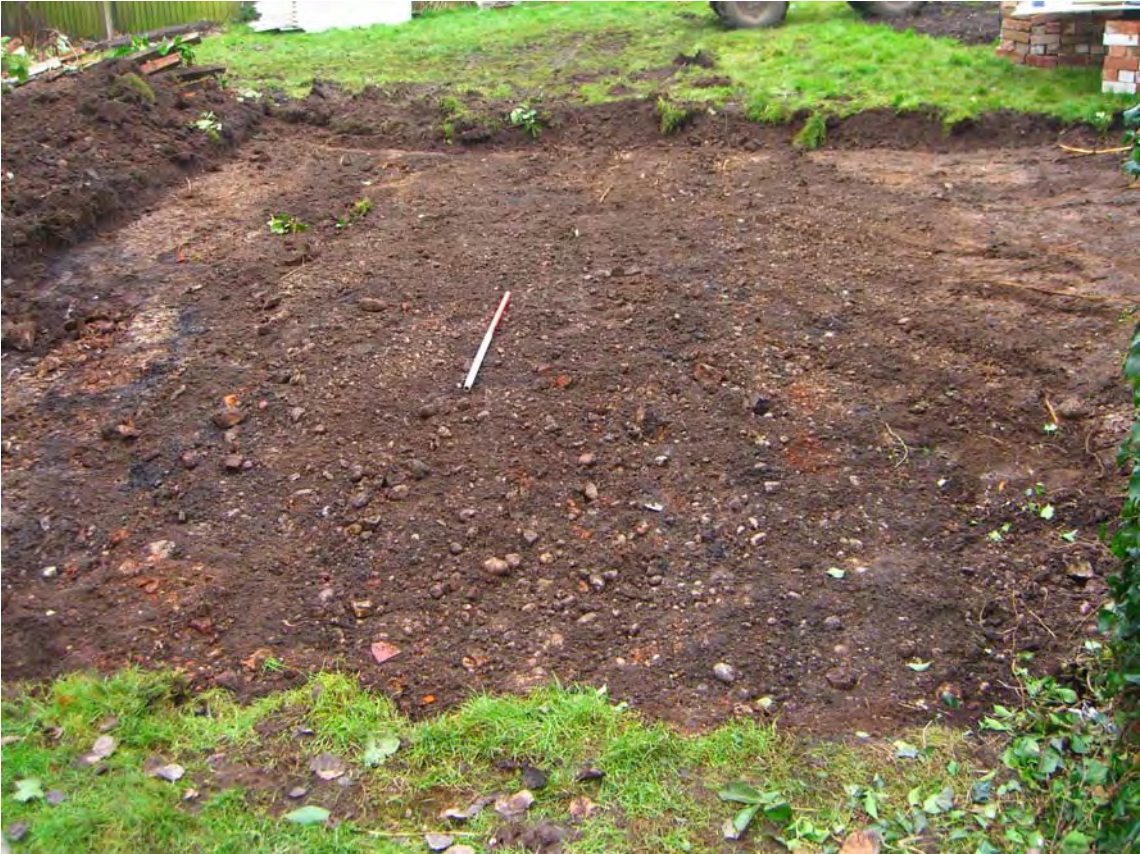
Fig. 5: Stripped area north of barn showing deposit 102, view north

5.3 Natural subsoil (101), a red brown clay with patches of sand and gravel, was recorded in two areas stripped to a greater depth. Close to a gate providing access to the Wolverton Road was a deposit of gravel and crushed brick (102, Figs. 3 and 5), 4m wide, this overlay natural subsoil 101. This was cut by the modern drain mentioned above and a sub-circular pit (108), 0.50m in diameter, which contained several sherds of 19th -20th century pottery (not retained). West of the gable end of the existing barn and abutting it were two parallel north-east to south-west aligned brick walls (109 and 110, Fig. 3), 2m apart, cutting the natural 101. Only a single course of brickwork survived and the walls extended beyond the limit of excavations. Walls 109 and 110 appeared to form a lean-to structure probably formerly housing livestock. Natural subsoil 101 and walls 109 and 110 were sealed by up to 0.50m of topsoil, west of the existing barn (Fig. 6).

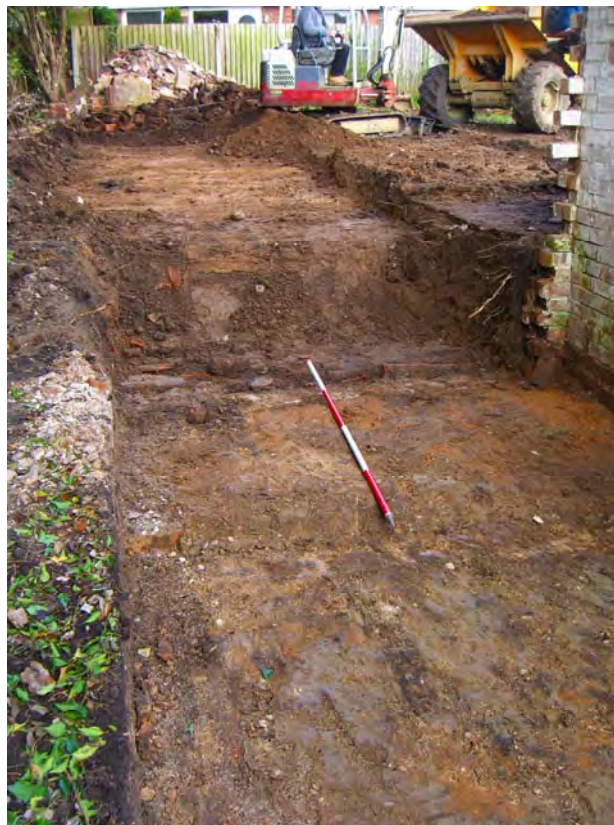
Fig. 6: Stripped area west of barn, view north

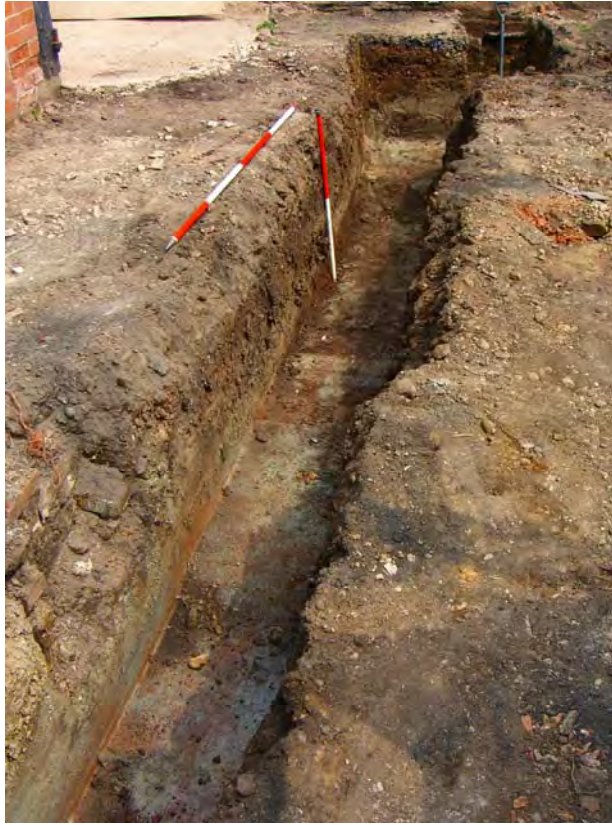
Fig. 7: Foundation trench south of barn, view north-east

5.5 South of the existing barn, in a foundation trench (Figs. 4 and 7), the natural subsoil was recorded at a depth of 0.25-0.45m. It was sealed, at the east end of the trench, by a

yellow sand and gravel (111), 0.40m deep. Layer 111 and natural subsoil 101 was sealed by a dark brown silty sand and gravel containing brick and concrete fragments (103), 0.40m deep. A brown sand and gravel layer (112), 0.40m below the current ground surface, sealed by layer 103, was recorded in a service trench excavated to a depth of 0.40m, to the south of this foundation trench (Fig. 3).

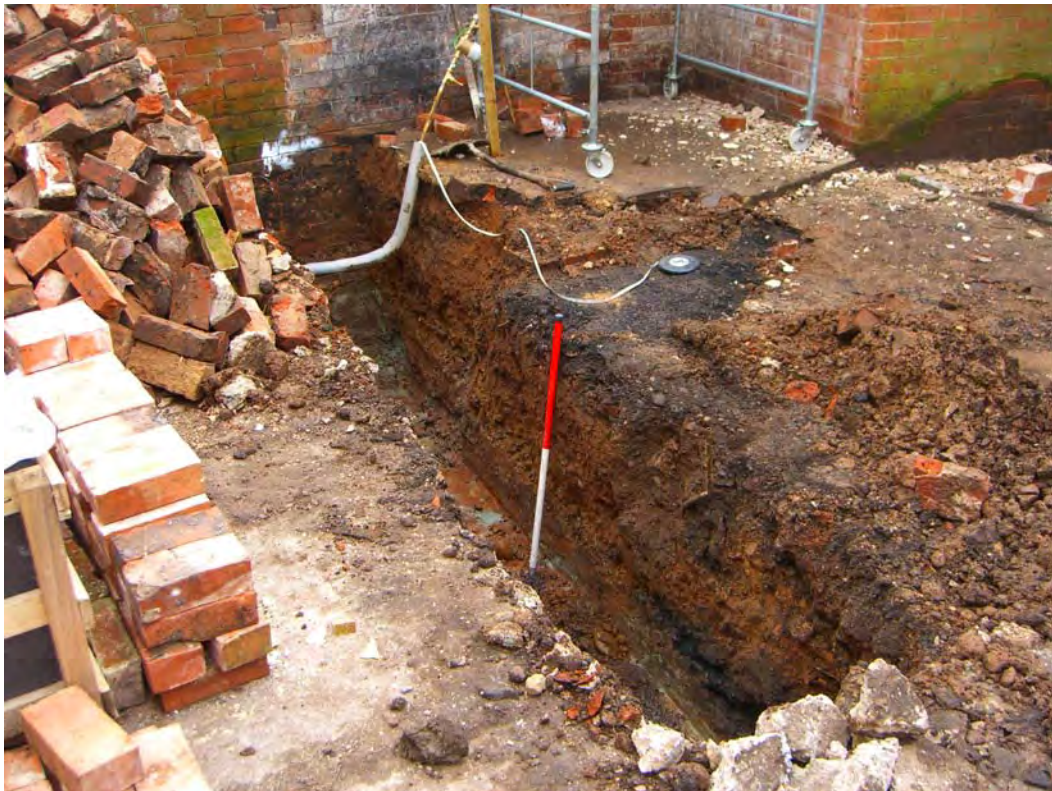
Fig. 8: Foundation trench east of Brook Cottage, view south

5.6 North-east of Brook Cottage, in a foundation trench (Figs. 3, 4 and 8), the natural subsoil was recorded at a depth of 0.60-0.80m below the present ground surface. This was overlain, at the east end of the trench, by a layer of dark brown sand and gravel (105) containing large quantities of clinker, 0.20m deep. At the west end of the trench the natural 101 was sealed by a layer of yellow sand and gravel (104), 0.20m deep. Above layer 104 were the brick foundations (106), 0.60m deep, for a demolished structure associated with Brook Cottage. These foundations were abutted by a dark brown sandy silt deposit (107), 0.60m deep. Deposit 107 and layer 104 were sealed by layer 103, a brown silty sand and gravel (103) containing crushed brick, 0.20-0.65m deep. This was overlain by a brick yard surface, 0.08m deep.
