Chadshunt House Stables Access Road, Chadshunt, Warwickshire

ARCHAEOLOGICAL OBSERVATION AND RECORDING

Archaeology Warwickshire Report No 1637
MAY 2016

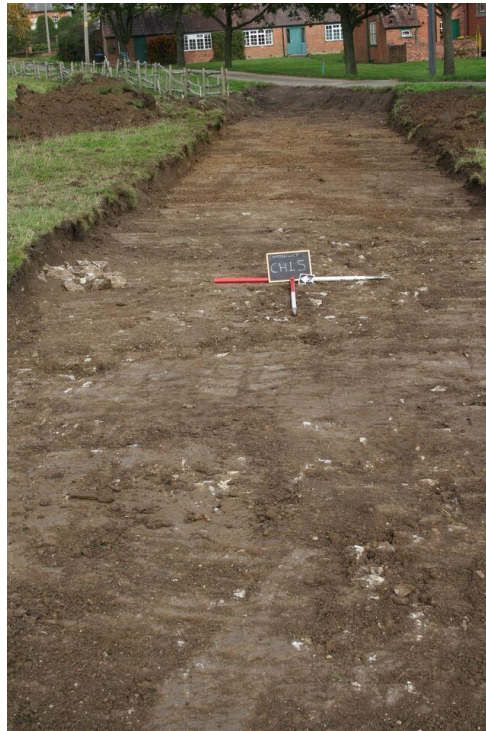
1 New road stripped

5.1 The new access road was stripped using a tracked excavator equipped with a toothless ditching bucket, to a depth of c.0.40m. The new road was stripped to between 3.5m and 4m wide. An area of limestone rubble was recorded on the northern side of the stripped drive (3). This area of stones may be the remnant of demolition rubble from a wall footing, or the result of stone clearance from the field. However, no finds were recorded associated with the stones. A small pit was also recorded (5). The pit fill was a reddish brown gritty silty sand (4) which did not produce any finds.

5.2 Geological natural was not reached during the road strip. The lowest level reached was a subsoil or ploughsoil layer of dark brown silty clay (2), of which 0.27-0.30m was removed. This was overlaid by a dark brown topsoil layer, 0.09-0.13m deep (1). No finds were recovered during the stripping.

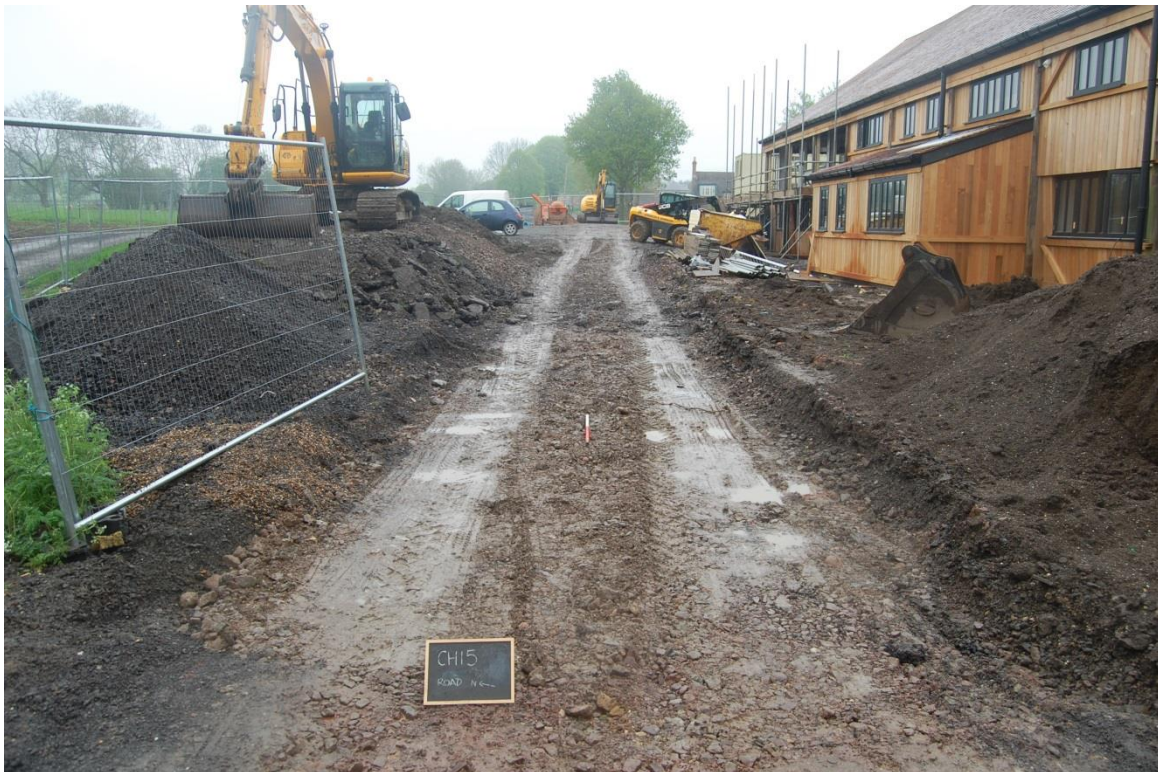
4 Grubbed out old road

5.3 The former road was grubbed out using a tracked excavator to a maximum depth of 0.50m. The underlying soil (9) was reached; this was a layer of light grey brown sandy silt mixed with hardcore. Layer 9 was overlain by two layers of hardcore (0.20m of large sized gravel – 8, overlain by 0.10m of medium gravel – 7) and 0.10m of tarmac (6). No finds were recorded and no archaeological features exposed. The full length of the road was not grubbed out as the middle area was being used as hardstanding for the existing compound. The access spur between the new road and the old road area was being used as hardstanding and was covered with gravelly tarmac. No stripping was observed in this area, however, we were informed that only topsoil was removed prior to the surface material being laid.
