# Stapenhall Farm, Deppers Bridge, Harbury Warwickshire

## ARCHAEOLOGICAL EVALUATION

Archaeology Warwickshire Report No 1567

OCTOBER 2015

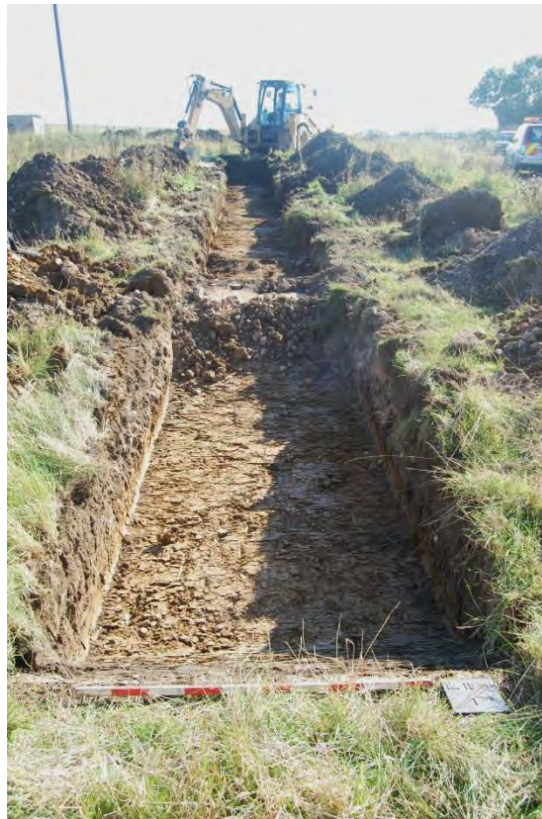
1. Trench 1 looking south

5.2 Trench 1 contained no significant archaeological features, but the deposit sequence was truncated by a 0.7m wide service trench and by a water main supply pipe.

5.3 Geological natural yellowish brown clay (103) was sealed by a 0.12m to 0.18m thick layer of greyish brown silty clay (102). A 0.15m to 0.2m thick layer of demolition rubble (101) including brick and concrete was present across much of the trench. A greyish brown silty clay loam topsoil deposit (100) was recorded across the trench.

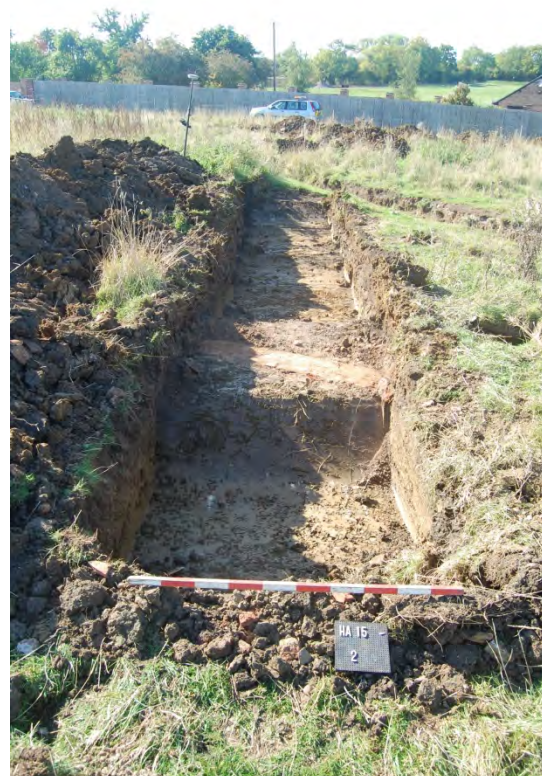
2. Trench 2 looking south-west

5.4 Trench 2 contained a single brick wall foundation but no other significant archaeological features. The trench was truncated by a modern drainage channel.

5.5 Geological natural (204) was sealed by a 0.12m to 0.18m thick layer of greyish brown silty clay (203). A 0.3m to 0.35m thick layer of demolition rubble (201) including brick, large pebbles and some Tarmac was present across much of the trench. Adjacent to the demolition rubble was a 0.37m wide brick wall. A single course was recorded and bricks were bonded with yellowish brown mortar.

5.6 A topsoil deposit (200) extended across the trench and sealed the wall foundation and rubble.

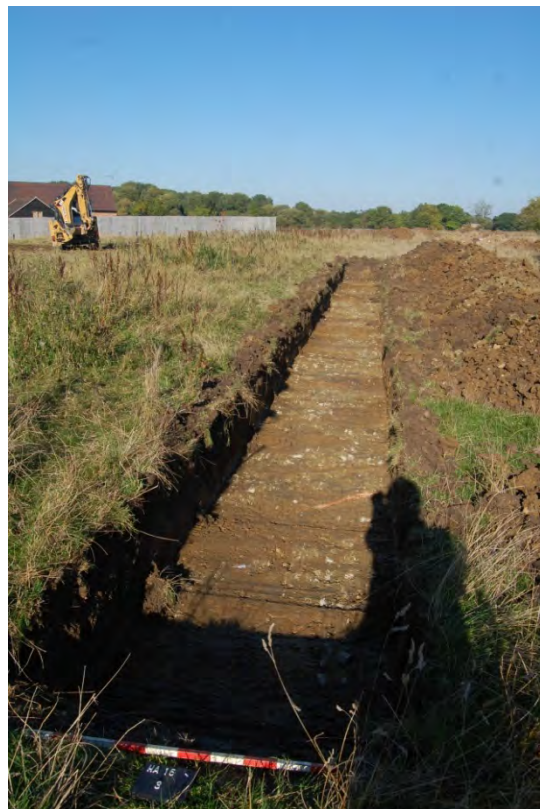
4. Trench 3 looking north-east

5.7 Trench 3 contained a single pit for a dog burial, but no other archaeological features or remains were revealed.

5.8 The layer of geological natural (302) included patches of reddish brown sand and frequent limestone fragments. This was sealed by a 0.2m thick layer of greyish brown silty clay (301). A single, 0.6m wide pit (305) was at least 0.4m deep contained the skeleton of dog (304) and was cut through ploughsoil deposits.

5.9 A topsoil deposit (300) extended across the trench. Two ceramic land drains (303) also extended across the trench.

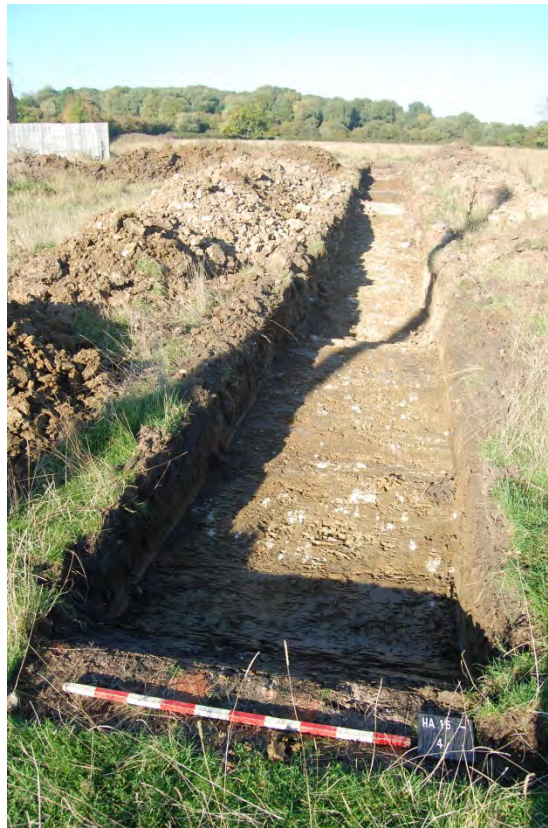
5. Trench 4 looking north

5.10 Trench 4 contained a single brick wall foundation, however no other significant archaeological features or remains were revealed.

5.11 Geological natural (404) was sealed by a 0.2m thick layer of greyish brown silty clay (403). A 0.4m to 0.45m thick layer of demolition rubble (401) including a variety of bricks, concrete and other 20th century debris was present across a large part of the trench. At the northern limit of the demolition rubble 401 was a 0.5m wide brick wall foundation (402). A single course of bricks survived and were bonded by a light yellowish brown mortar.

5.12 A topsoil deposit (400) extended over the trench and sealed the wall foundation and rubble.
