# Quinavon, Upper Quinton, Warwickshire

## ARCHAEOLOGICAL INVESTIGATIONS

Archaeology Warwickshire Report No 1527

**Project:** Evaluation and Strip, map and sample  
**Commissioned by:** Mark Palmer@ Palmer Developments  
**Project Report No.** 1527  
**Site Code:** QA15  
**Planning Reference:** 14/02843/FUL  
**Planning Authority:** Stratford-upon-Avon, Warwickshire  
**Planning Archaeologist:** Anna Stocks, Warwickshire  
**National Grid Reference:** SP 1777 4633  
**Team:**  
**Project Manager:** Stuart Palmer MCIfA  
**Fieldwork:** Bryn Gethin BA Kevin Wright, Stuart Palmer,  
Caroline Rann BA  
**Author:** Stuart Palmer MCIfA and Caroline Rann BA  
**Illustrations:** Candy Stevens  
**Report checked by:** Dr Cathy Coutts  
**Date:** May 2015  
**Report reference:** Palmer, S, and Rann, C, 2015 *Quinavon, Upper Quinton, Warwickshire: Archaeological Investigations*, Archaeology Warwickshire Report 1527.

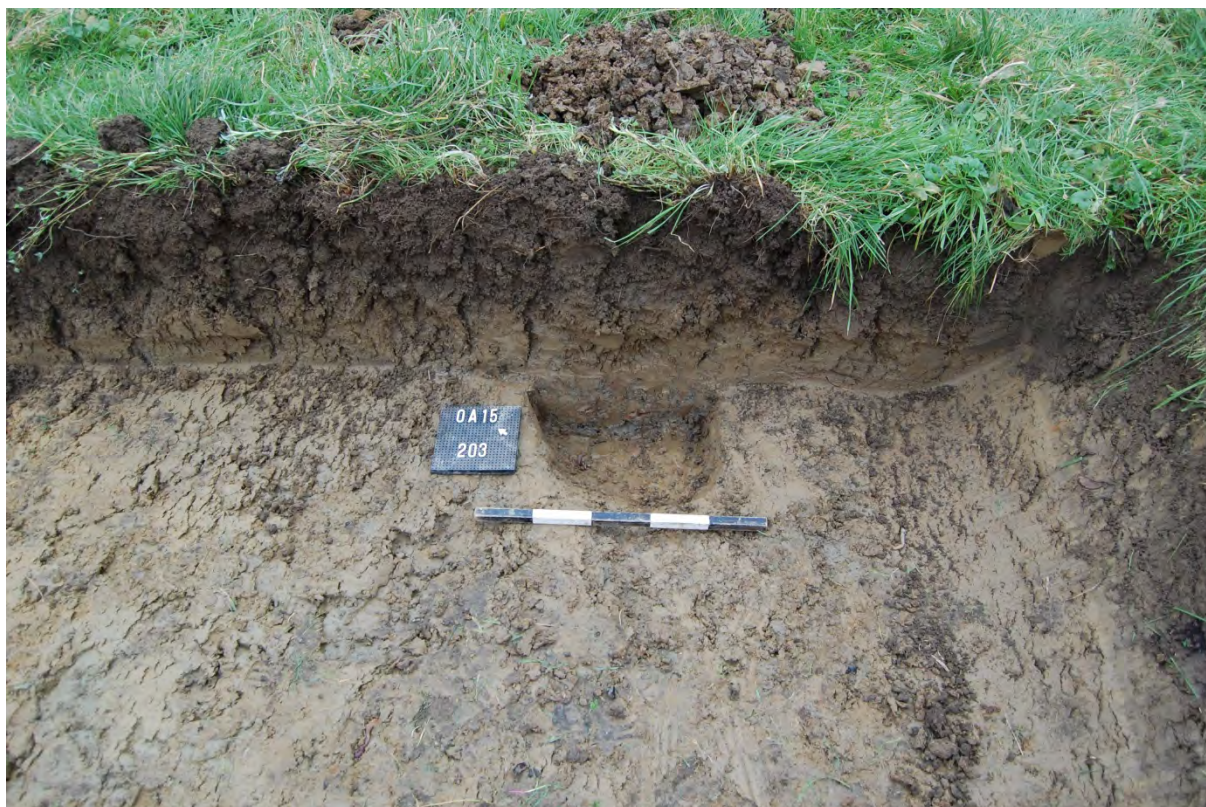
Photograph 1. Iron Age pit in Trench 2

5.2 Trench 2 was located in the footprint of the southern house plot. Geological natural clay (205) was reached at a depth of c.0.50m. The clay was cut by a small, steep-sided pit 203, only partially within the limits of the trench. The fill of the pit was a grey clay loam with brown mottling (204) which contained 95 sherds of pottery, probably deriving from a single pot. The pit fill and natural clay were overlain by a layer of yellowish brown clay loam (202), 0.15m deep in the southern part of the trench and 0.25m deep in the northern part. Layer 202 was overlain by 0.15-0.20m of brownish grey clay loam (201) which was sealed by brown clay loam topsoil (200). No finds were recovered from the layers above the natural clay.

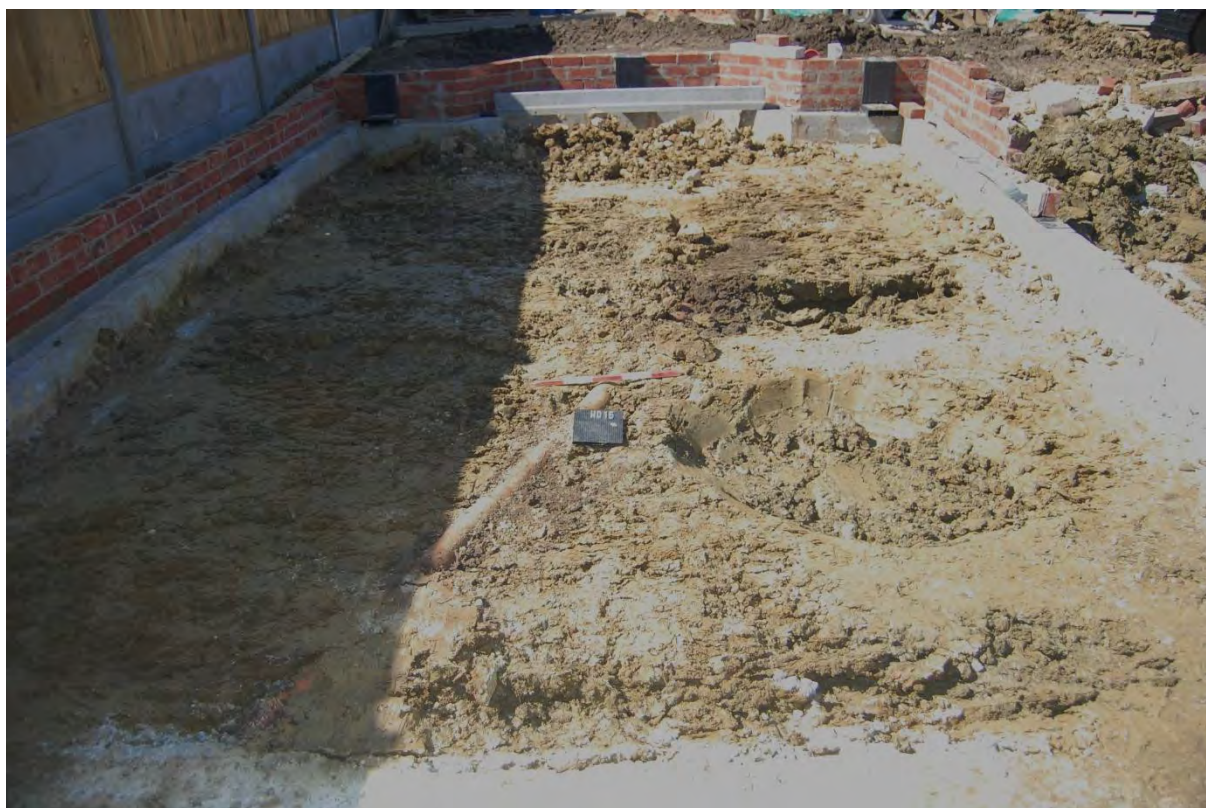
Photograph 2. Area of pit examined (Iron Age pit would have been under foreground)

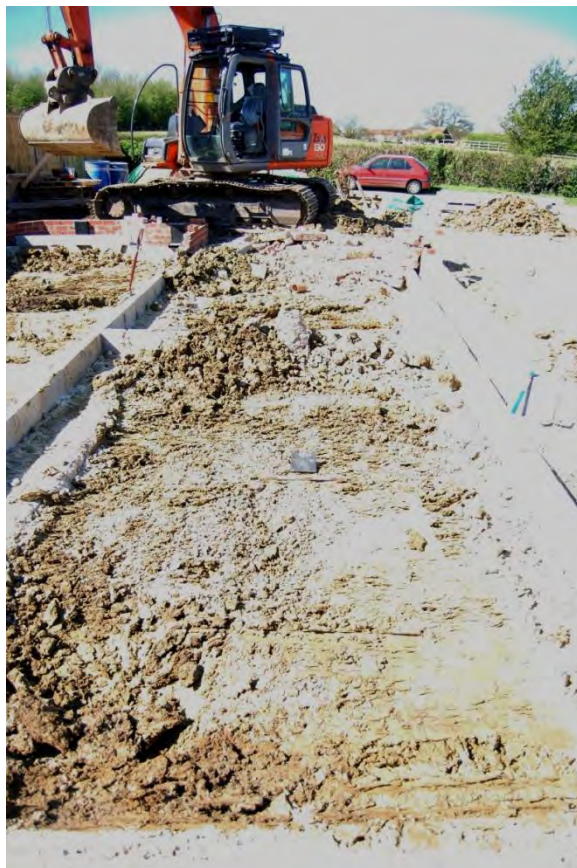
Photograph 3. Cleaning between foundations

5.6 Around 0.05m of soil was removed in order to clean the exposed clay between the foundations in the southern house plot. No archaeological features were evident and no finds were recovered on the site, although several natural tree root holes were examined.. The level of the exposed clay was a minimum of 0.15m below the level of the top of the natural observed in the trial trenches. The reduced level ground reductions in the northern house plot were deeper than the southern plot so it was concluded that further cleaning in this area would have no archaeological value.

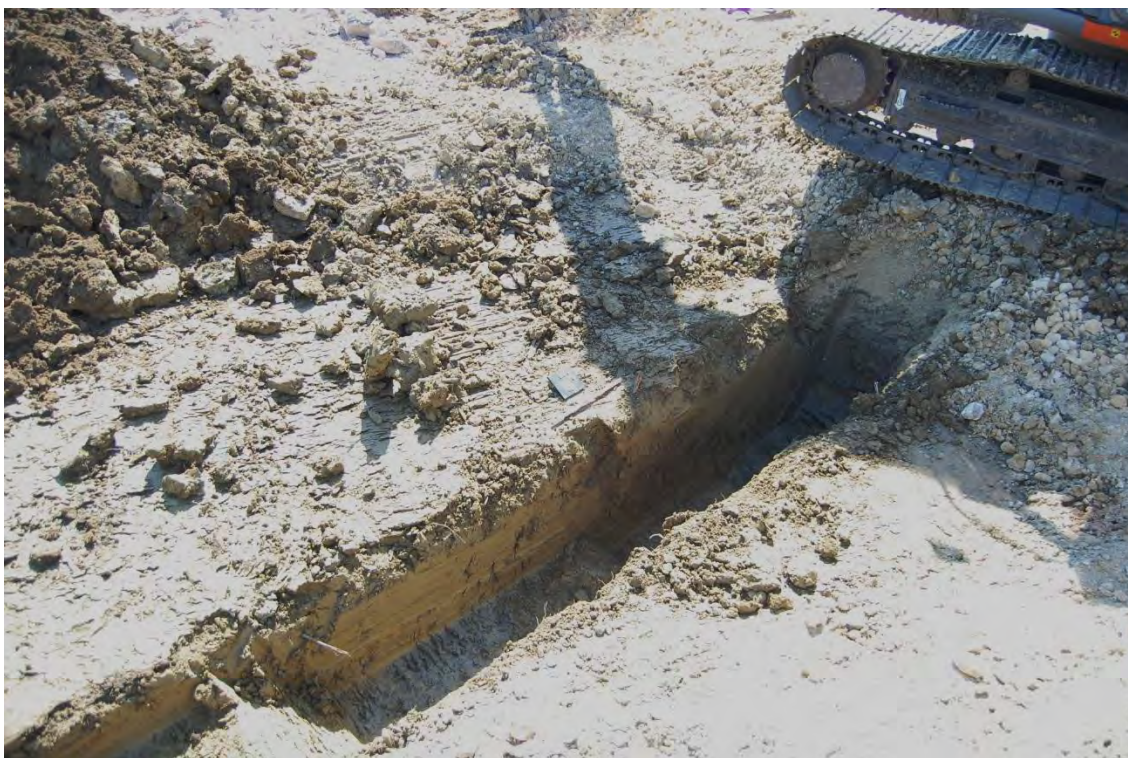
Photograph 4. Slot through medieval ditch

5.7 An area at the front of the site was stripped to the geological natural of yellowish brown clay (405). A continuation of ditch 303 was noted (403). In addition, a large possibly linear feature was recorded towards the street frontage (401). A full profile of the feature was not possible due to its depth of around 1.5m. A sherd of medieval pottery and an animal bone fragment was recovered from the dark yellowish brown clay fill (402).

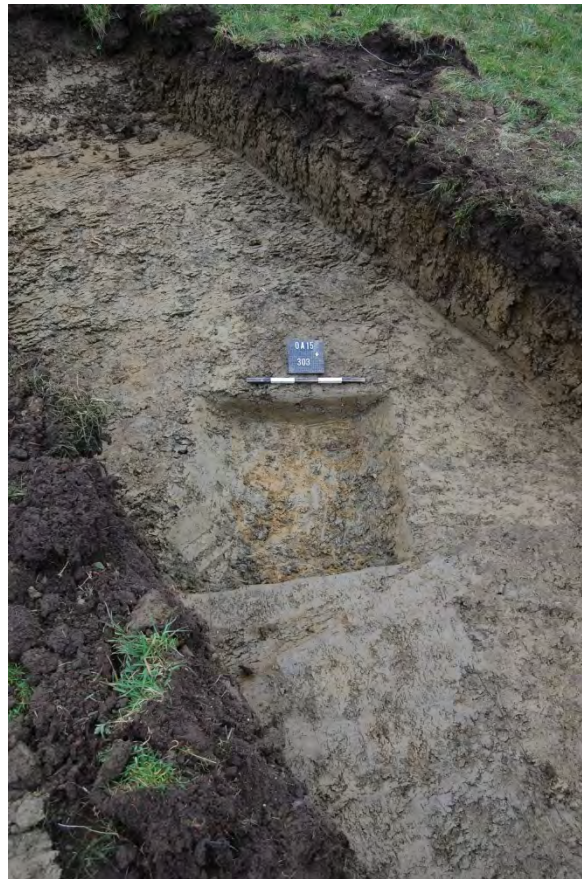
Photograph 5. Ditch 303 in the evaluation Trench 3

5.3 Trench 3 was located near the street frontage, in the area of the proposed drive. Geological natural clay (305) was reached at a depth of c.0.40m. It was cut by a 0.80m wide ditch with moderately steep sides and a flattish base 0.34m deep (303). The ditch was filled with a brownish grey clay loam (304), from which three small sherds of pottery were recovered. Overlying the ditch fill and the geological natural was 0.35m of yellowish brown clay loam (302). This was covered by between 0.15 and 0.2m of brownish grey clay loam (301) from which three sherds of pottery were recovered. It was sealed by 0.08m of turf (300).

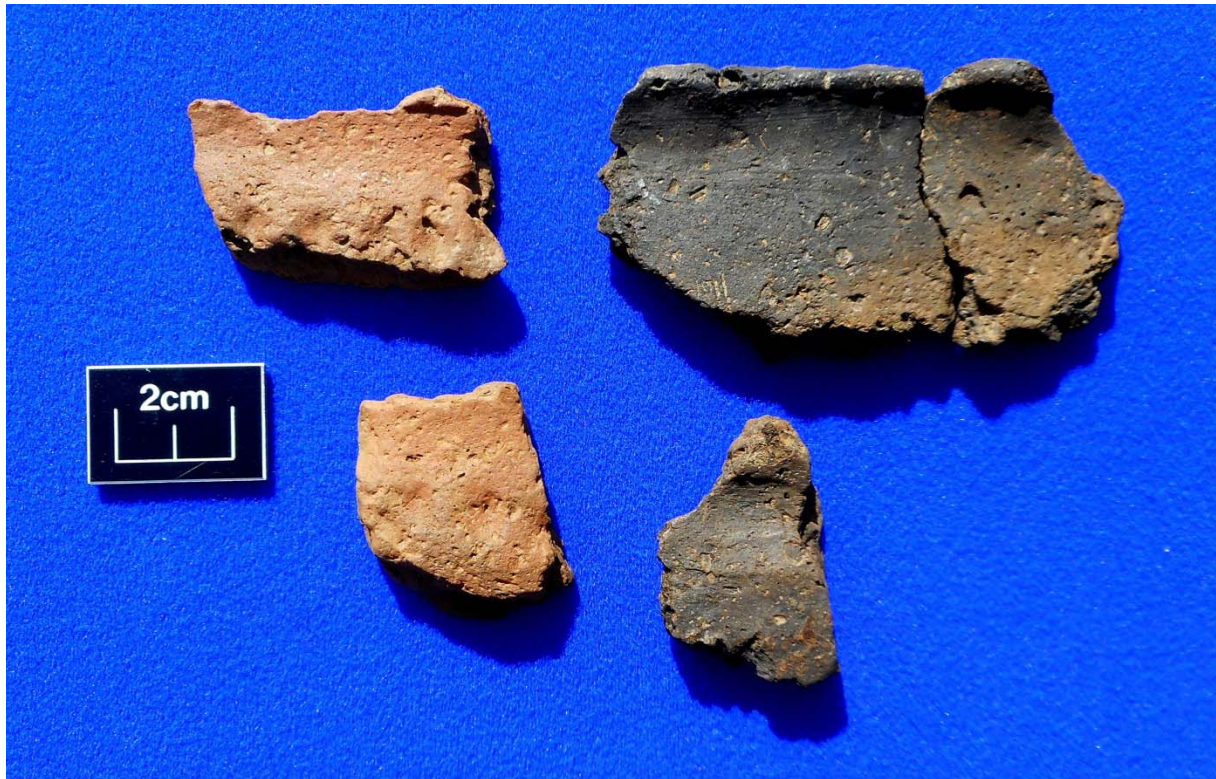
Photograph 7. Iron Age pottery

5.4 There were 95 sherds, weighing 583g from a single deposit (204). They are probably from the same vessel, in a handmade poorly levigated fabric with yellowish red (5YR 5/6) surfaces on the body and base and black neck and rim. The fabric is soft with a hackly break and a soapy feel. It has inclusions of abundant fossil shell and other calcareous inclusions, common coarse organic voids and some sub rounded quartz and fine silver mica. The vessel is a large (with mouth of 300mm diameter and a base of 110 mm diameter) bowl or jar with an everted rim squared at the tip, with a simple flat base. There is slight finger-tip decoration around the rim and the suggestion of a further band at the shoulder of the vessel. There is no evidence of internal wear or sooting.

5.5 The dating of this vessel is problematical as the diagnostic criteria are common to both Iron Age and Saxon pottery. However finger tipping decoration is more commonly noted on Iron Age pottery than Saxon pottery, Saxon pottery tends to be of smaller jars, Saxon pottery tends to have more rounded bases than the one noted here. Furthermore, whilst calcareous inclusions are possible in Saxon pottery, nearby Saxon assemblage have tended to have quartz or granadiorite inclusions (e.g. Evans 2009; Evans and Mills 2008), whilst the

site is located in a zone of Iron Age calcareous tempered pottery supply (Evans and Mills 2013). The vessel is probably therefore of early to mid-Iron Age date. The size and large quantity from a single vessel suggests that this may have been a structured deposition.
