National Grid Car Park, Technology Park, Warwick, Warwickshire

ARCHAEOLOGICAL WATCHING BRIEF

Archaeology Warwickshire Report No 1502
January 2015

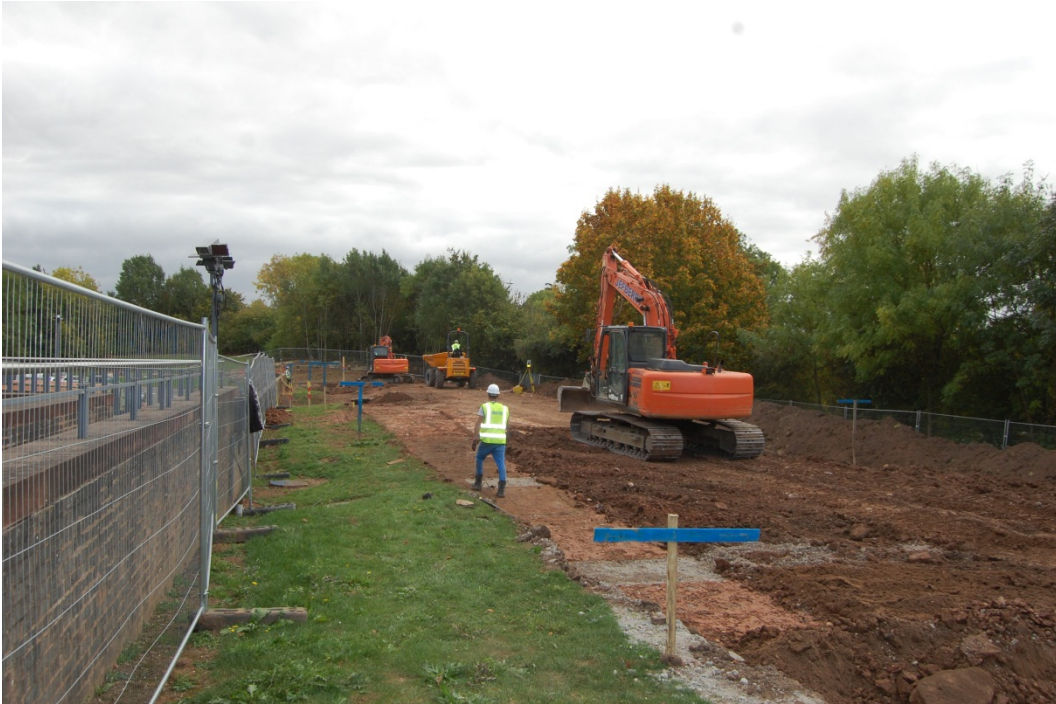
Fig 3: Ground reduction for Car Park in progress

4.6 Material from the access road was added to the modern made ground in the vicinity of the proposed carpark in order to provide the base for the lower deck. Foundation trenches were cut through this level. Given the inherent instability of the made ground and the fact that the trenches were in excess of 2.0m deep, it was deemed not possible to safely inspect the trenches.

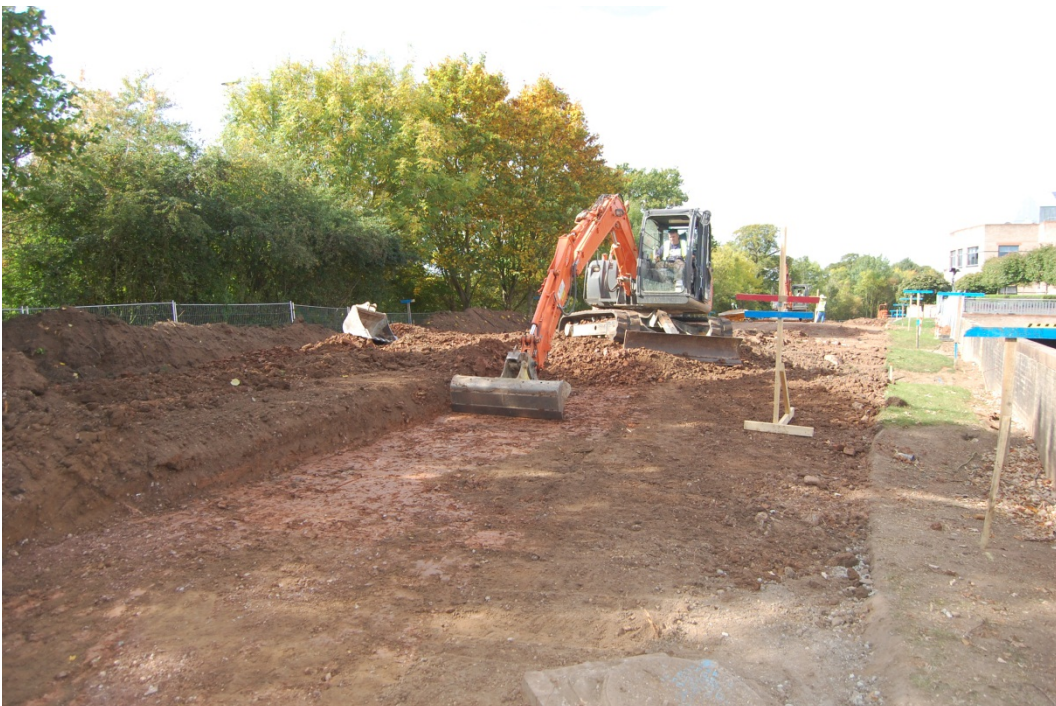
Fig 4: Ground reduction for road

4.2 Ground reduction to a depth of 0.45m took place across the area and several trees were grubbed out (Fig 2). The lowest and therefore earliest layer reached was greyish brown pebbly silt (4): Some 0.15m of this layer was removed during the groundworks. It seems likely this was an older (medieval/post-medieval) plough soil with no indication that it had been re-deposited. Layer 4 was overlain by a 0.15m deep layer of dark greyish brown silty loam (5). This appeared to be buried topsoil and no finds were recovered from it.

4.3 The topsoil was overlain by modern deposits consisting of 0.1m of hardcore (3), 0.1m of reddish clay (2) and modern topsoil up to 0.22m deep which covered the site.

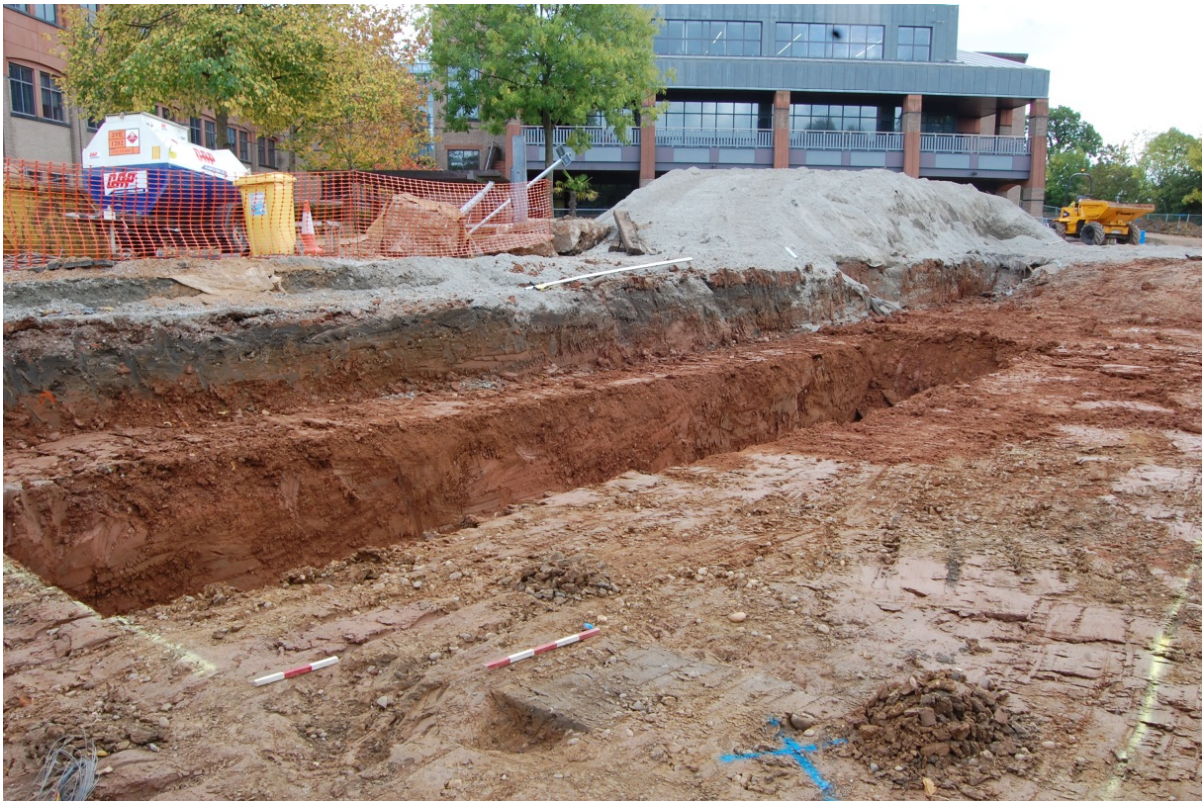
Fig 5: Tank excavations in progress

4.4 Geological natural reddish brown clay with sand and gravel patches (24) was observed at a depth of 1.2m below the current ground surface. Cutting the natural were two small pits (20 and 23). Pit 20 was sub-oval with a shallow U-shaped profile. It was 0.7m x 0.5m at its widest points and 0.07m deep. No finds were recovered from the greyish brown clay loam fill (21). Pit 23 was sub-oval and filled with greyish brown clay loam (22). It was 1.2m x 0.85m at its widest points and 0.1m deep with a U-shaped profile. There was no evidence to suggest a function for the pits.

4.5 Overlying the pits was a sterile layer of light yellowish brown sand and gravel (18) which was 0.2m deep. Layers above this were the result of recent landscaping; firstly layer 17 was 0.5m of dark grey silty clay with modern brick fragments. It was overlain by 0.5m of red clay with modern brick fragments (16) and 0.25m of light grey aggregates (25).
