# St Michael's Church, Stoke, Coventry

## Archaeological Watching Brief

Archaeology Warwickshire Report No 1375  
November 2013

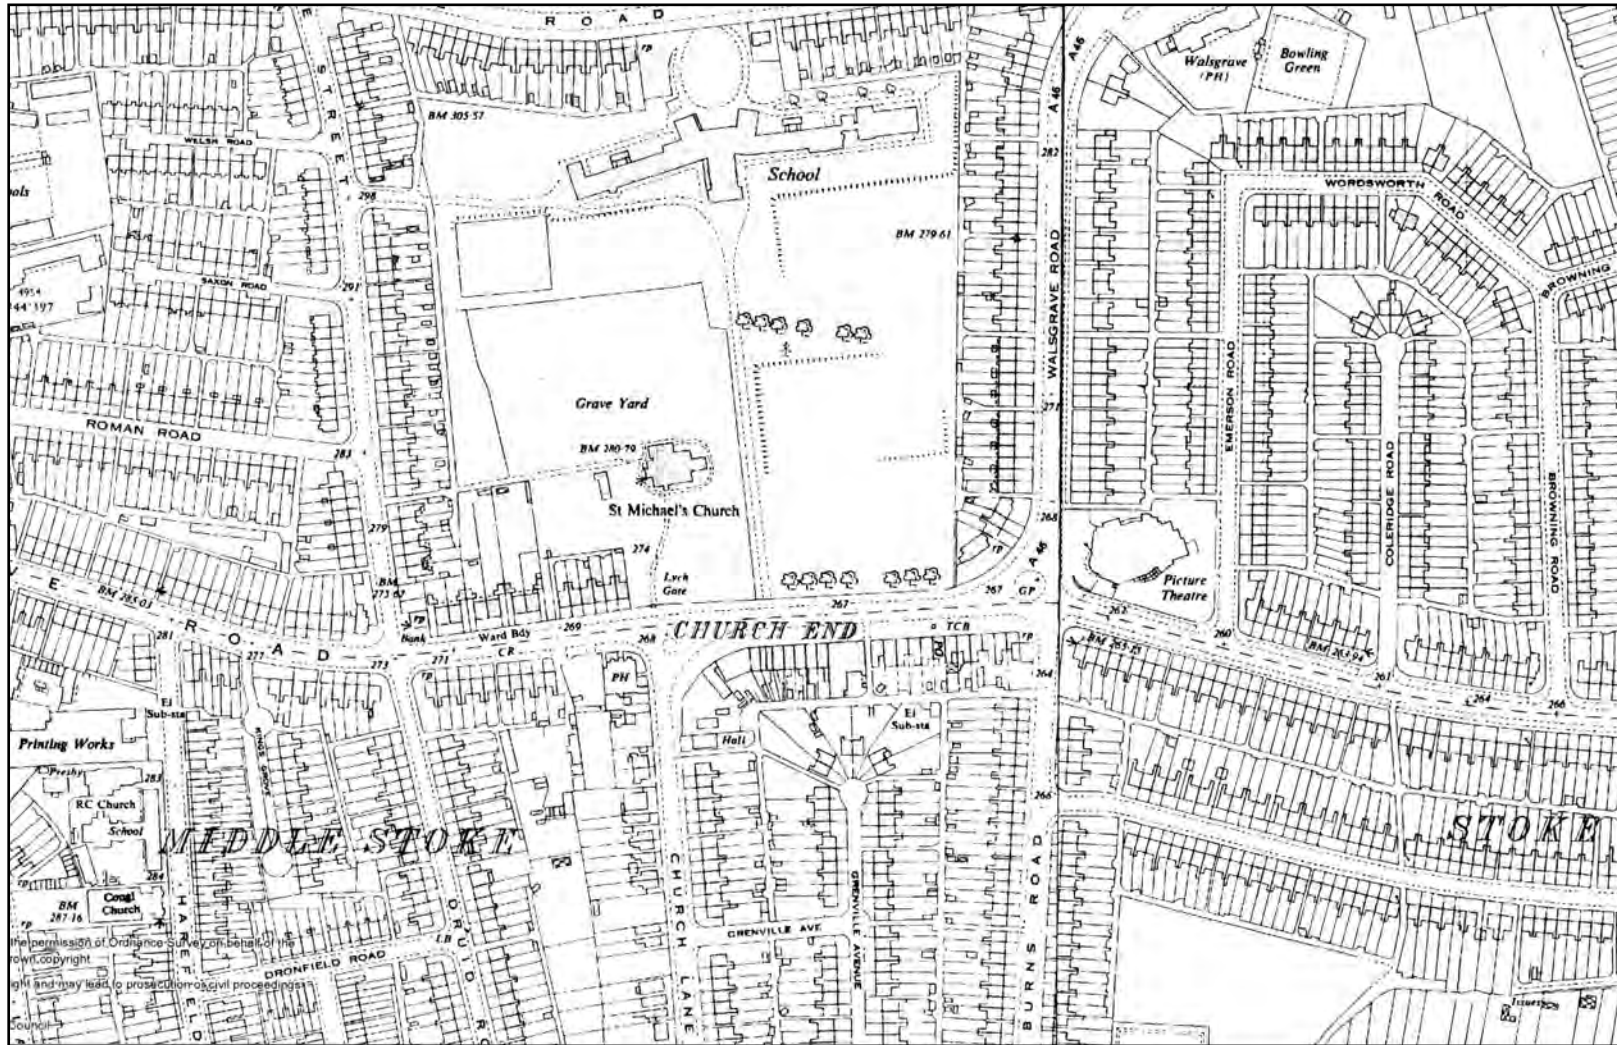
Fig 5: Detail from Post War Ordnance Survey map of 1949

4.4 By the late 19th century pockets of housing development had begun in Stoke (Ordnance Survey 1888). Little further development had taken place by the time of the Second Edition Ordnance Survey map of 1905, but by 1925 'Middle Stoke' was heavily developed with terraced houses and by 1949 the whole of the area surrounding the church and churchyard had been built up, with the school to the north of the church (Fig 5).

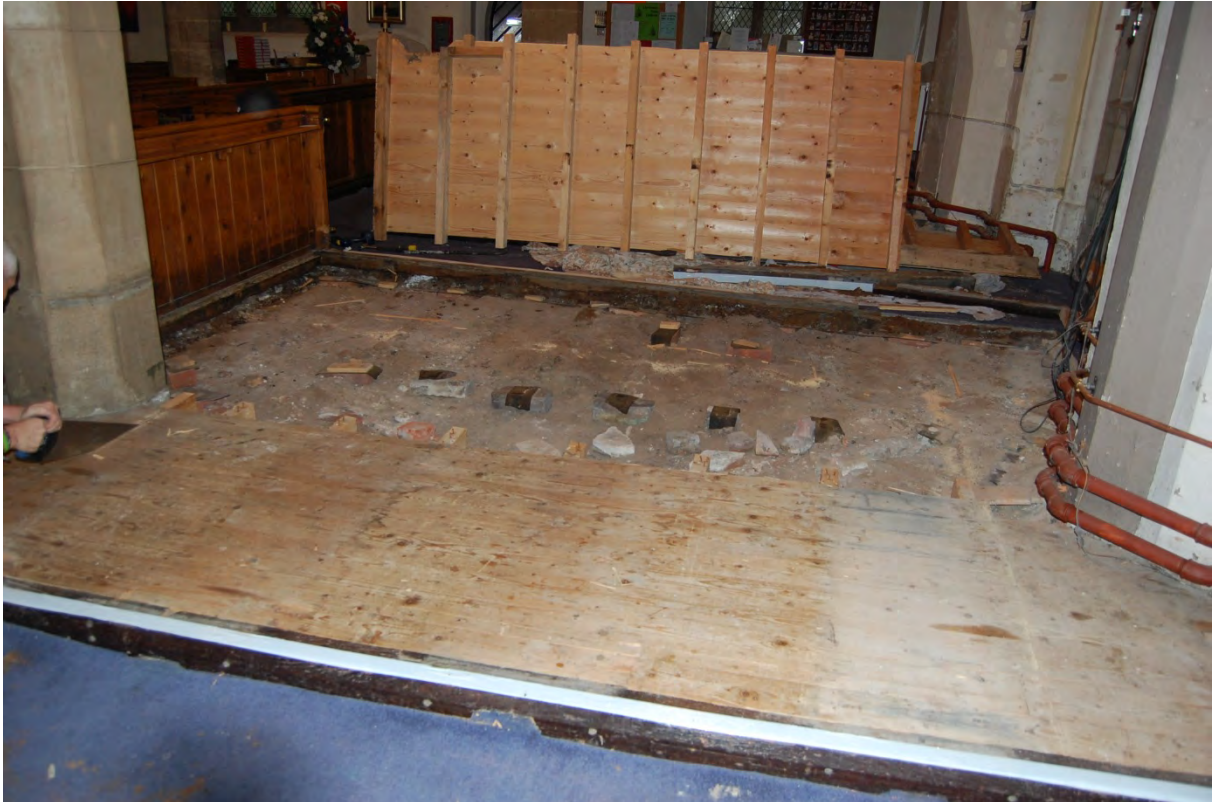
Fig 8: View of sub-floor material and joist supports

5.2 The floor-boards themselves were modern, and measured 0.12m (5 inches) wide (1). This was an area of 20th-century replacement flooring, much of which was due to be re-used in the new floor. The joists on which they rested (2) measured 90mm x 100mm and significant parts of these were rotten. These joists, and the *ad hoc* joist supports (brick, overlaid with a small piece of roofing felt with a sliver of wood on top – 3; Fig 8) were removed prior to the sub-floor area being cleaned and lowered slightly.

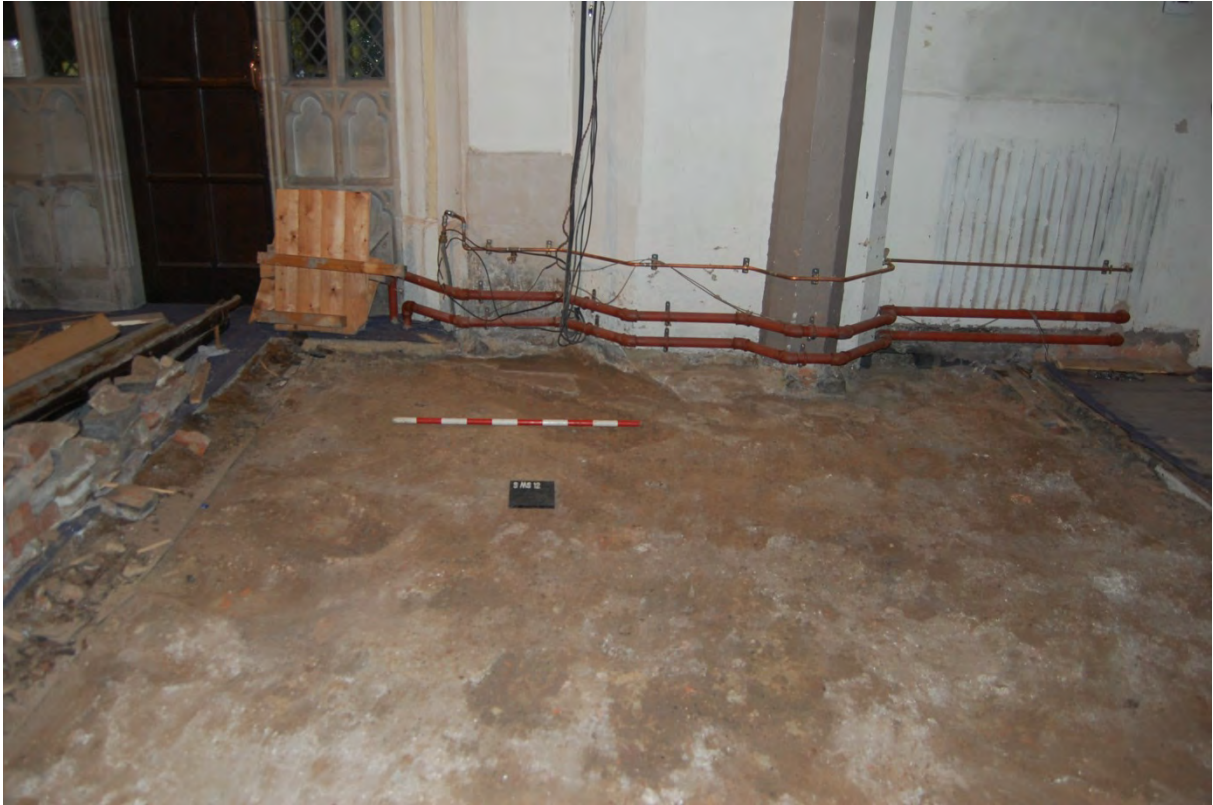
Fig 10: View of pier with stone slabs (5) below

5.5 Clearance around the western pier uncovered the remains of an 80mm thick flagstone floor (5) that had been covered by layer 7. This had been cut (6) presumably to facilitate the removal of the floor itself, but leaving the floor intact below the pier.

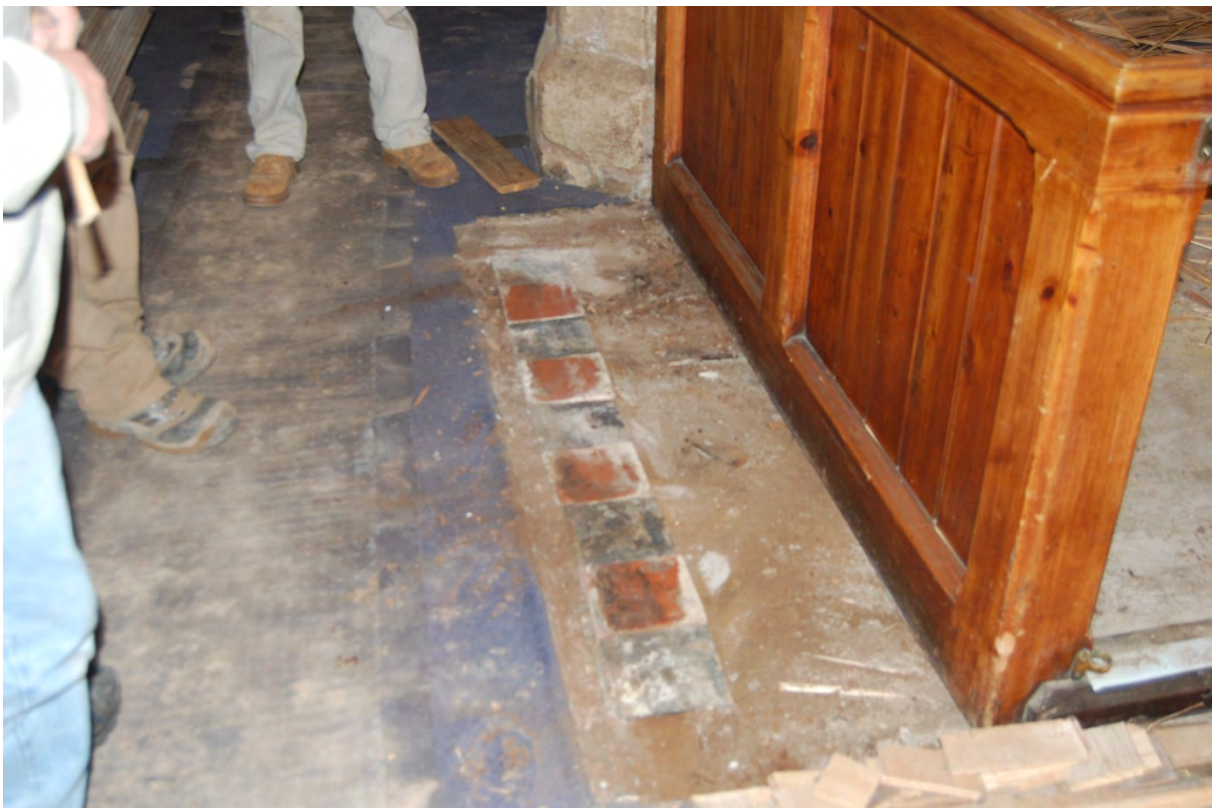
Fig 11: Victorian quarry tile floor (8)

5.6 The hexagonal pier in the north-west part of the area (9) rested on brick footings (10), suggesting these were part of the 1860s rebuild. The Victorian quarry tile floor (8), still intact in places under the carpeted floor, will also date to this time (Fig 11).

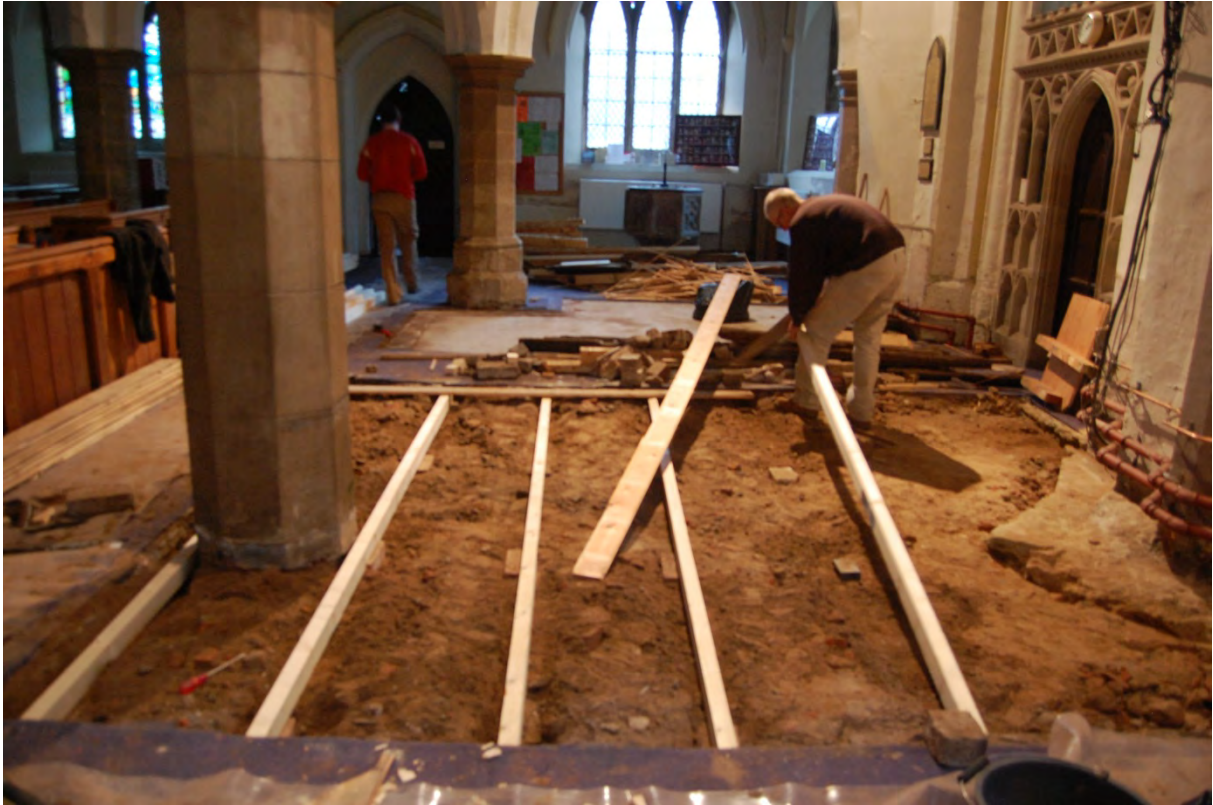
Fig 12: New joists being laid
