Flood Alleviation, Gog and Fishers Brook, Stratford Road, Warwick

ARCHAEOLOGICAL WATCHING BRIEF

Archaeology Warwickshire Report No 1602
January 2016

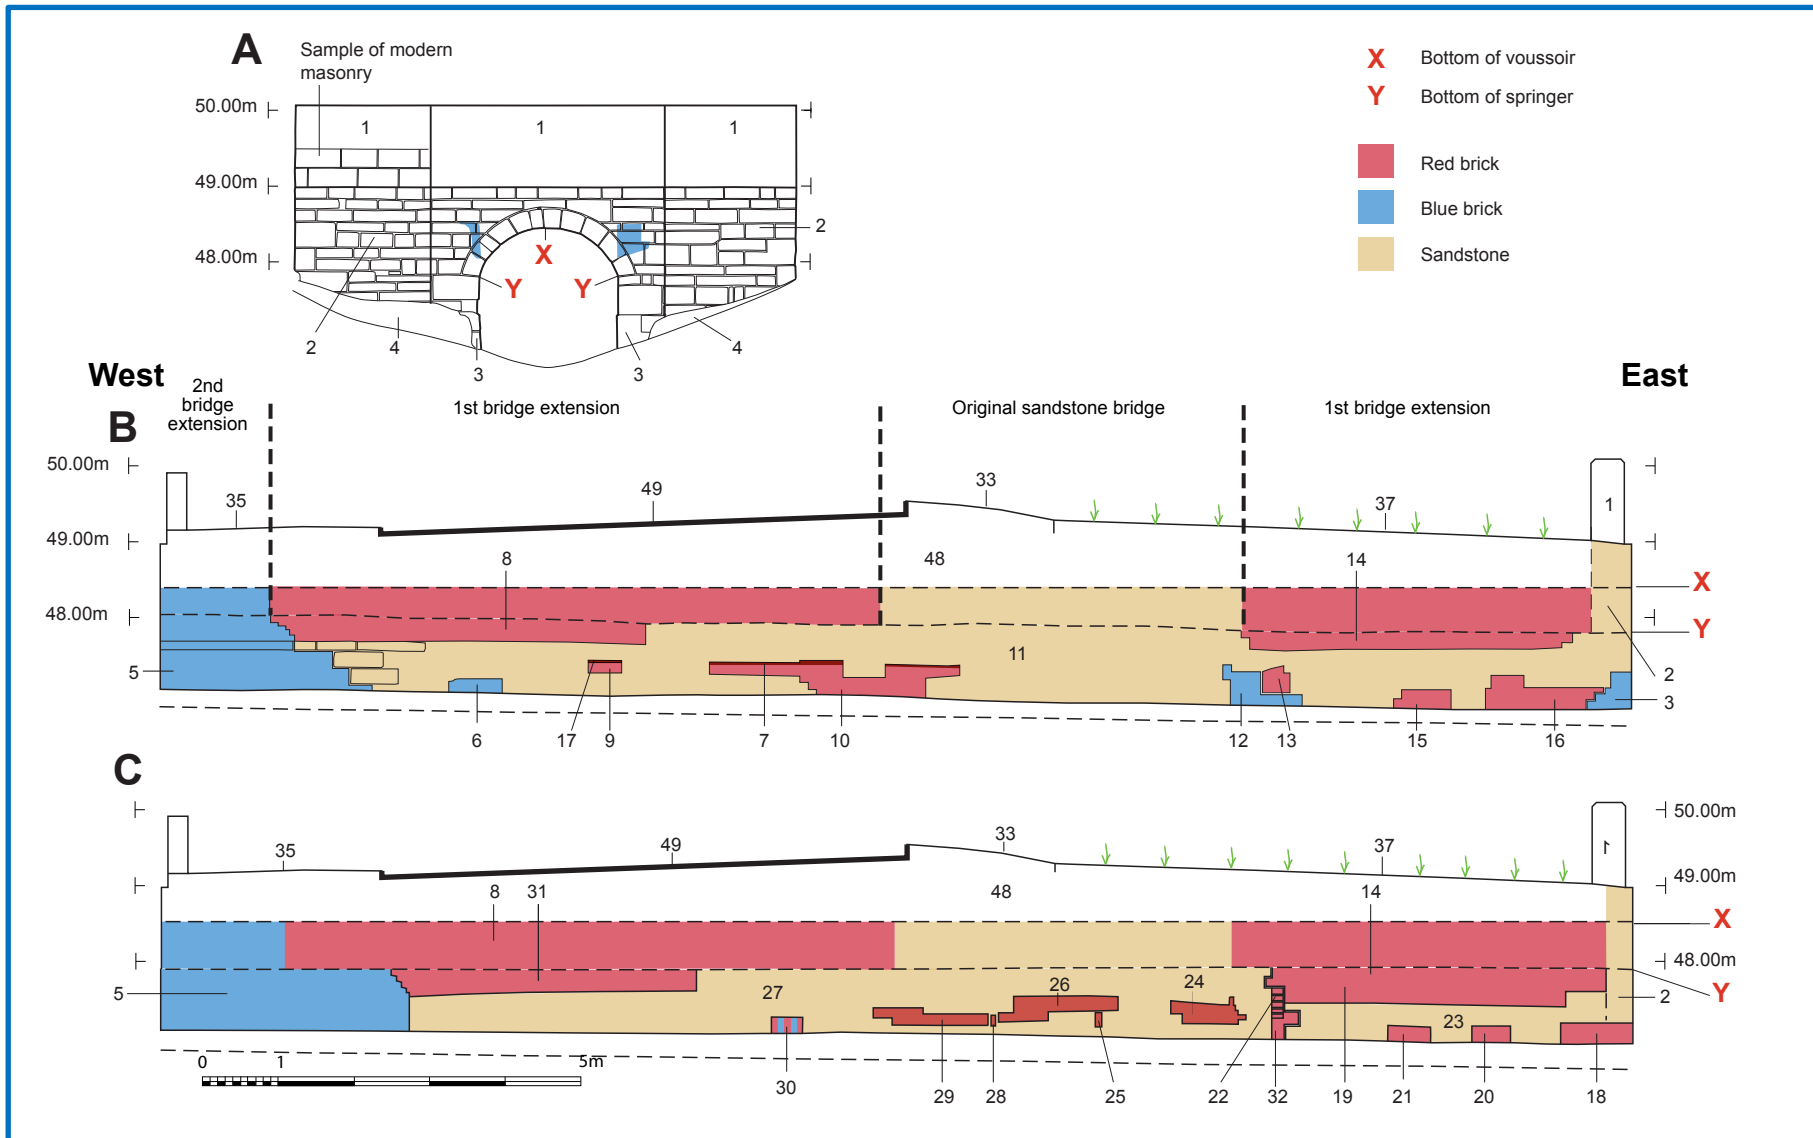
Fig 2: Bridge Phasing

5.3 The bridge measured 19.5m E-W and 7m N-S (Fig 2). The earliest phase of construction was identified in the centre of the Bridge (Fig 2, Section B, C). Sandstone blocks had been used (11, 23, 27) in the 1.5m high, arched structure (Fig 4). The sandstone blocks had been painted at some time with white paint or plaster (Fig 5). A later phase of bridge was evidenced by the use of red brick (8, 14, 31 figs, 2, 6) and an extension to the western end took place using blue engineering bricks which were manufactured from 1832 but became common towards the later 19th century (5, Figs 2, 7).

5.5 The parapet (1) and face of the bridge (2) were constructed of sandstone blocks (Figs 2, 9).

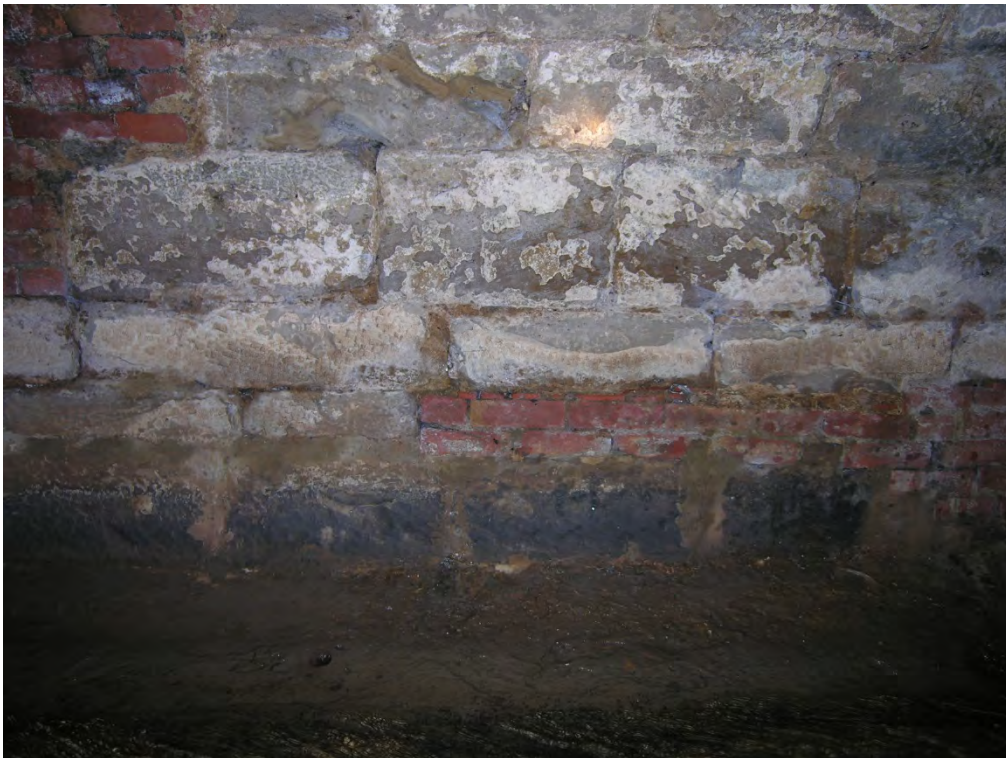
Fig 8: Tile used in repair

5.4 Numerous repairs to the inside of the bridge arch were apparent, mostly in red brick (9, 10, 13, 15, 16, 18, 20, 19, 21, 32, 22, 24, 25, 26, 28, 29 and 30). although some were of blue bricks (3, 6, 12 and 30) and there was occasional use of tile (7, 17, Fig 8).

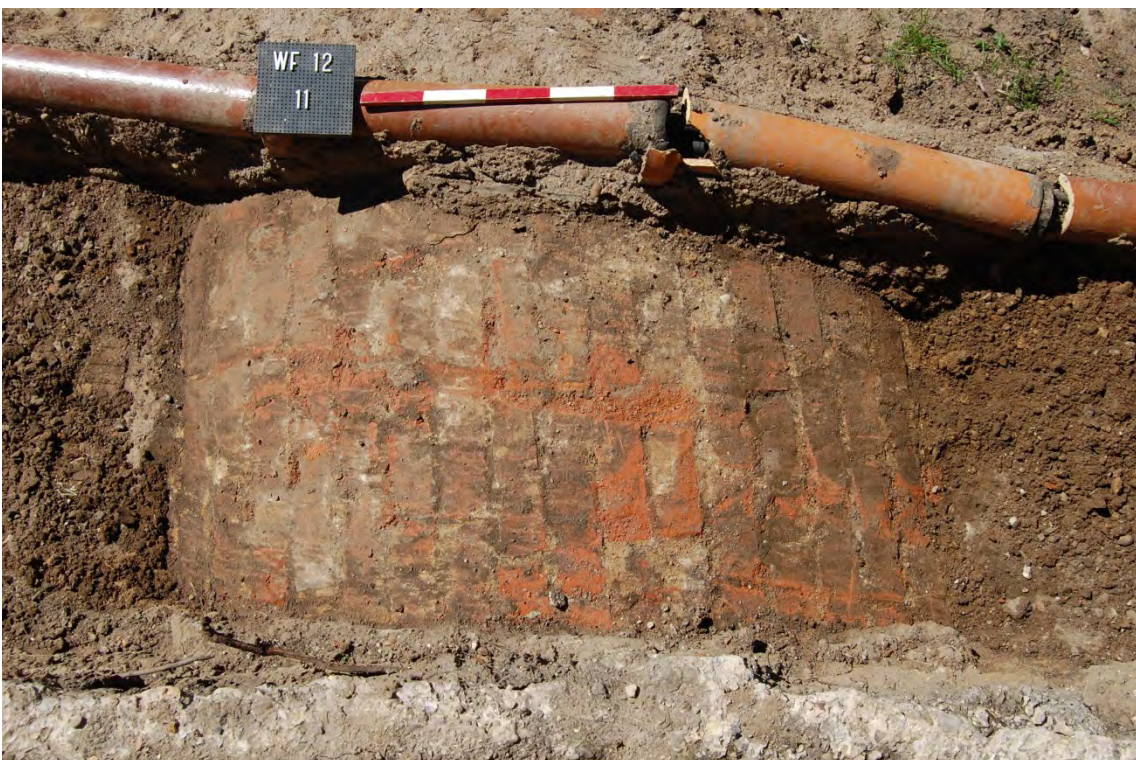
Fig 12: Exposed bridge arch (context 8)

5.7 Excavations within the road revealed the arched red brick structure of the bridge, context 43 which was the same as 8, not 11 as shown (Fig 12). It was covered with aggregates (48) and tarmac (49). Similarly the footpaths (33, 35) were constructed of a less substantial depth of make-up (34, 36).

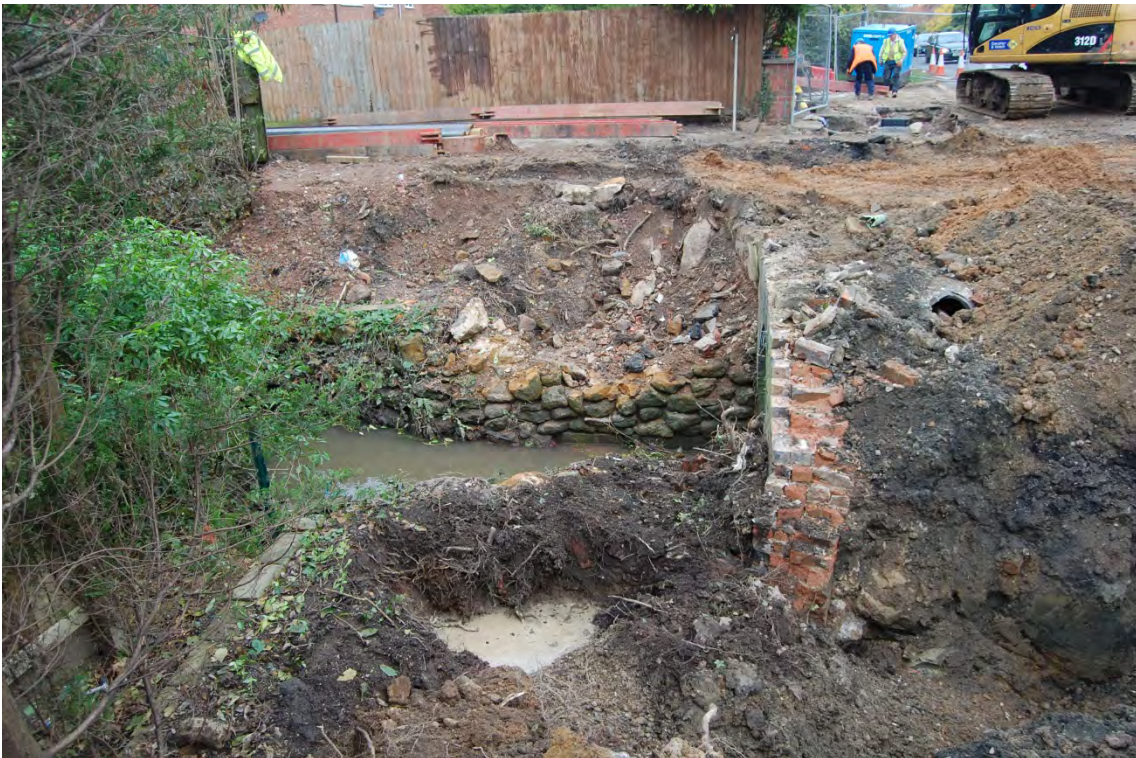
Fig 13: Western edge of bridge during excavations

5.8 The northern bank of the brook on the western side was revetted with unbonded sandstone blocks (47). Ground reductions alongside the bridge structure revealed the sandy natural (44) overlain by greyish brown sandy loam (46) and road construction layers (48, 49, Fig 13)
