Barton Farm Barn, Barton, Bidford-on-Avon, Warwickshire

Building Recording and Archaeological Watching Brief

Archaeology Warwickshire Report No 1607
JANUARY 2016

Project: Barton Farm Barn, Building Recording and
Watching Brief

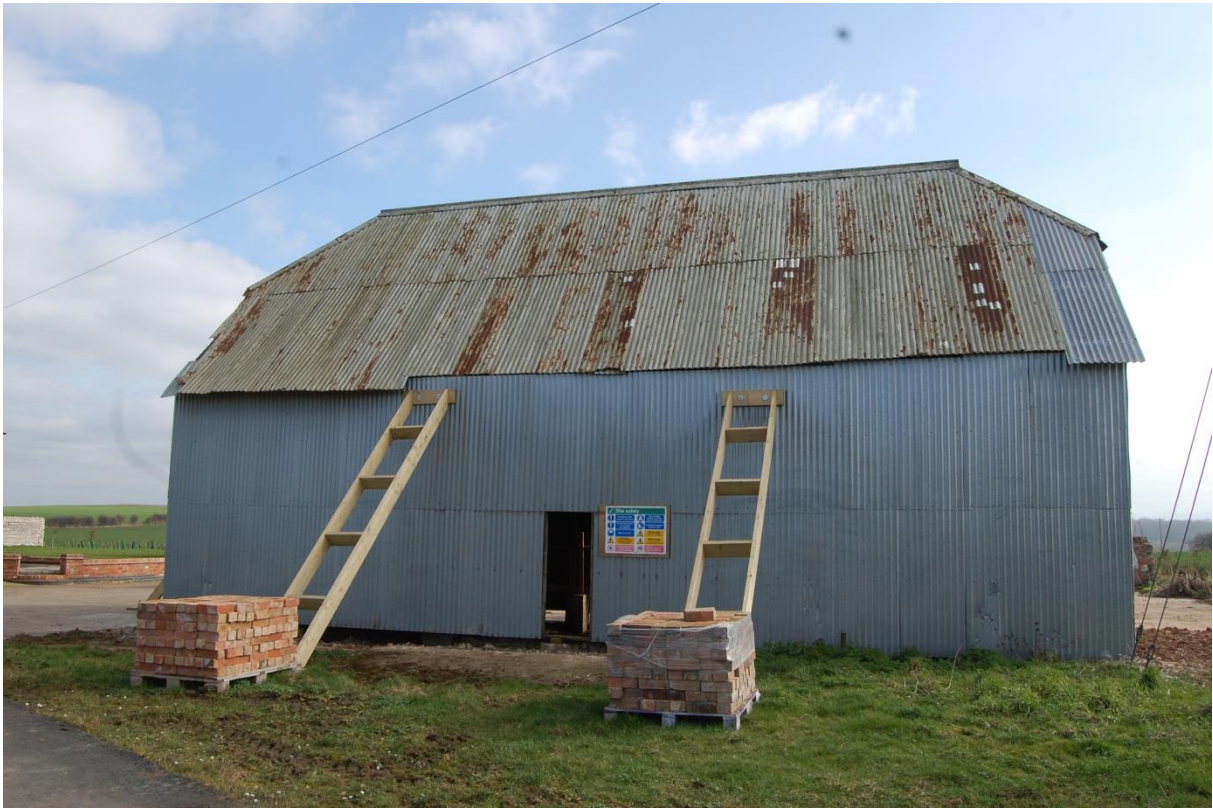
1: The barn with its corrugated iron cladding and roof cover

5.1 Building recording was carried out before any groundworks associated with this phase of the development were carried out, but after the removal of the floors of the barn, and much of the limestone plinth, which had been removed much earlier. The barn has been clad in corrugated iron since 1984 (D. Turner pers. comm., see Photos 1 and 2), although the roof had been replaced by corrugated iron much earlier and is mentioned in the Listing, which was also carried out in 1984. At that time the barn had plank doors and weatherboarding – these were stripped out prior to the barn being clad in metal sheeting.

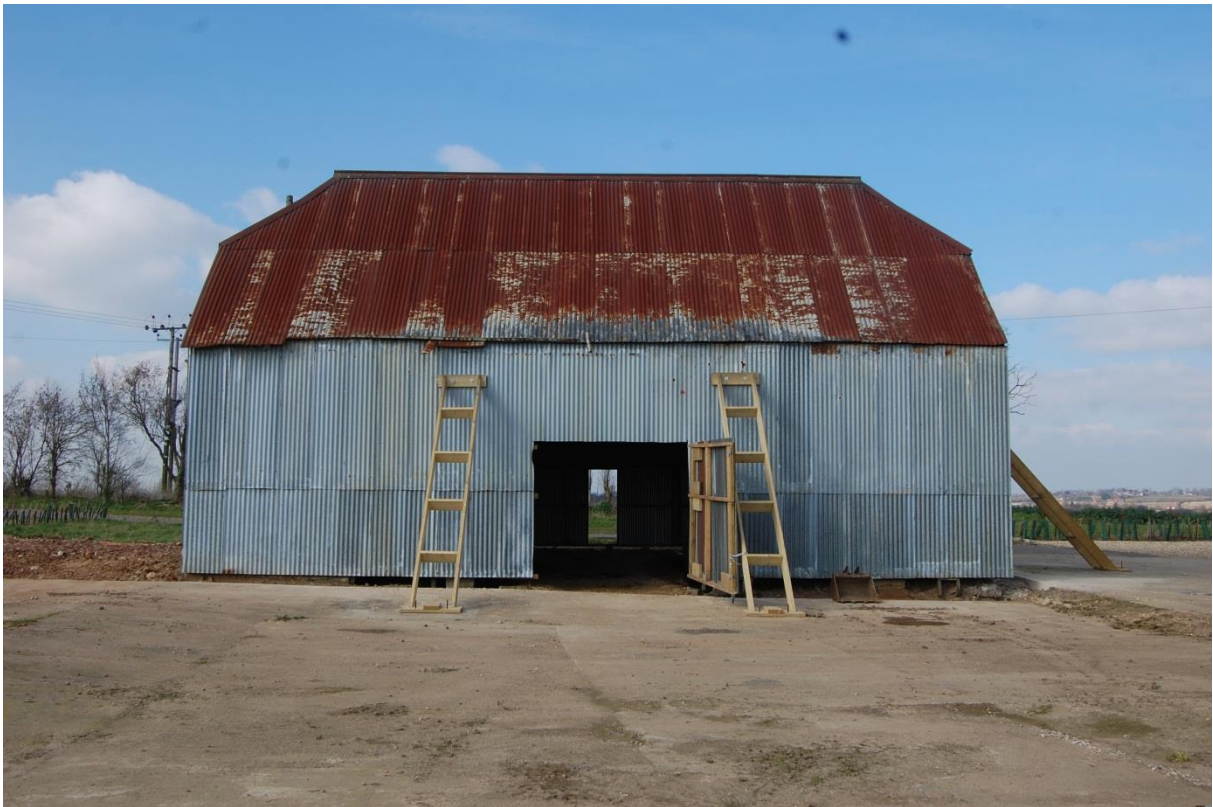
2: The barn from the south-east

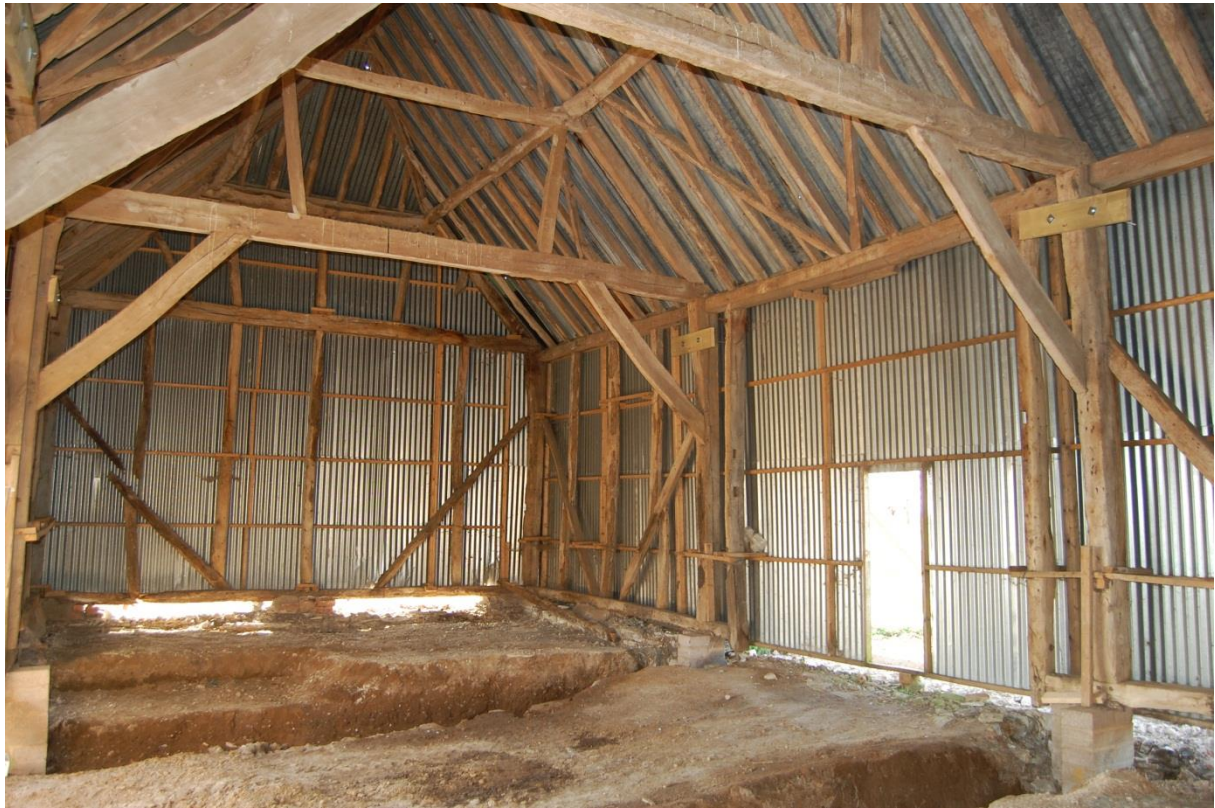
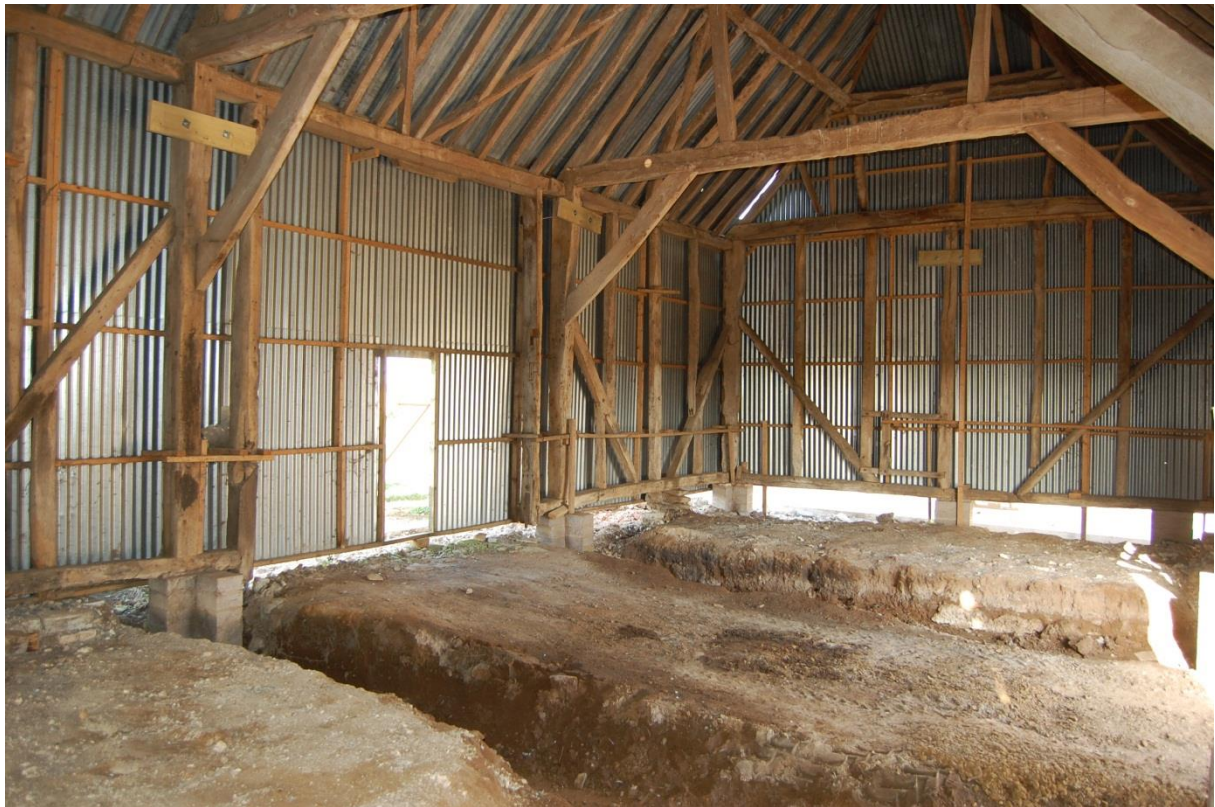
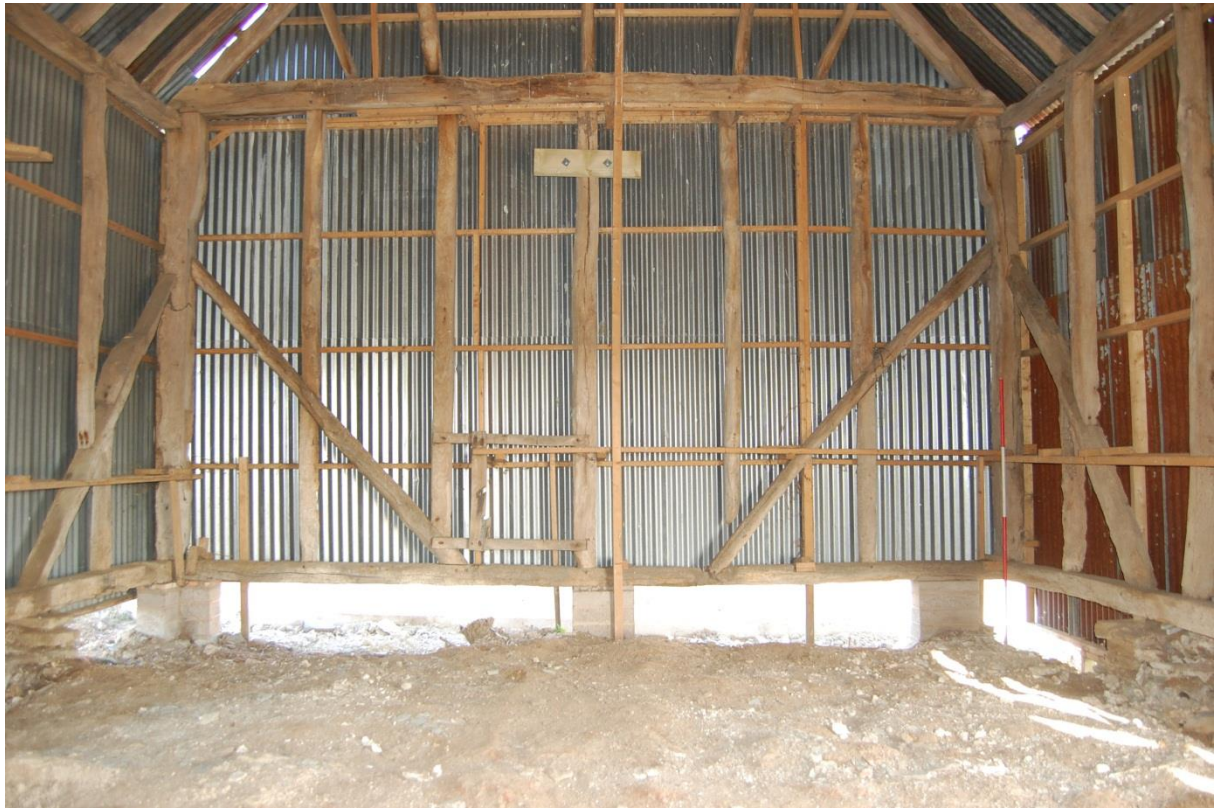
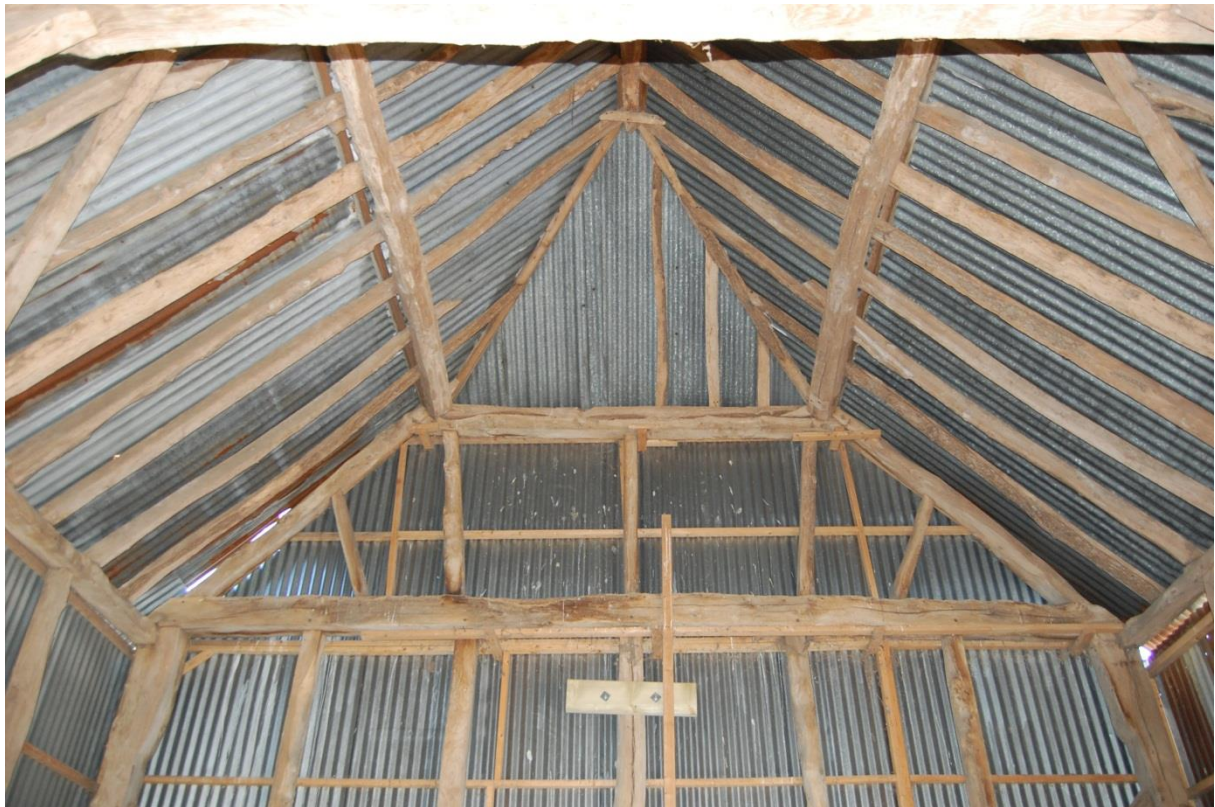
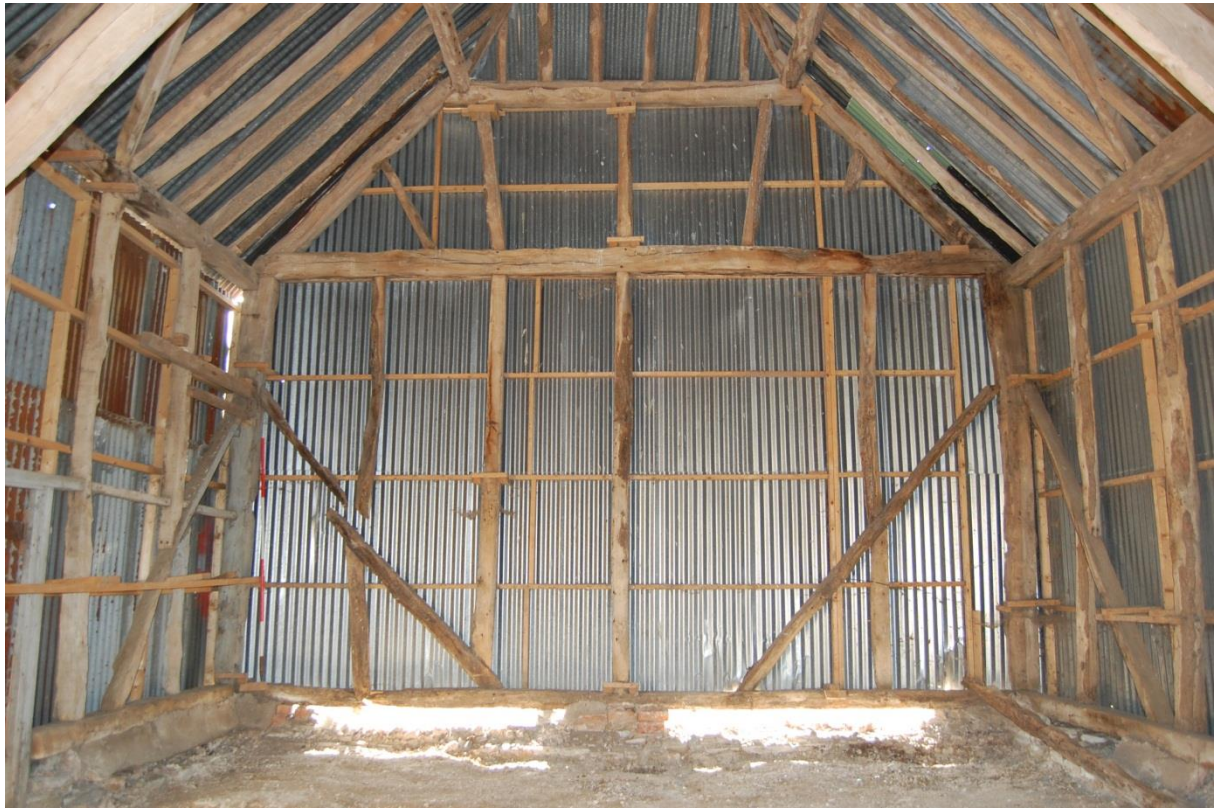
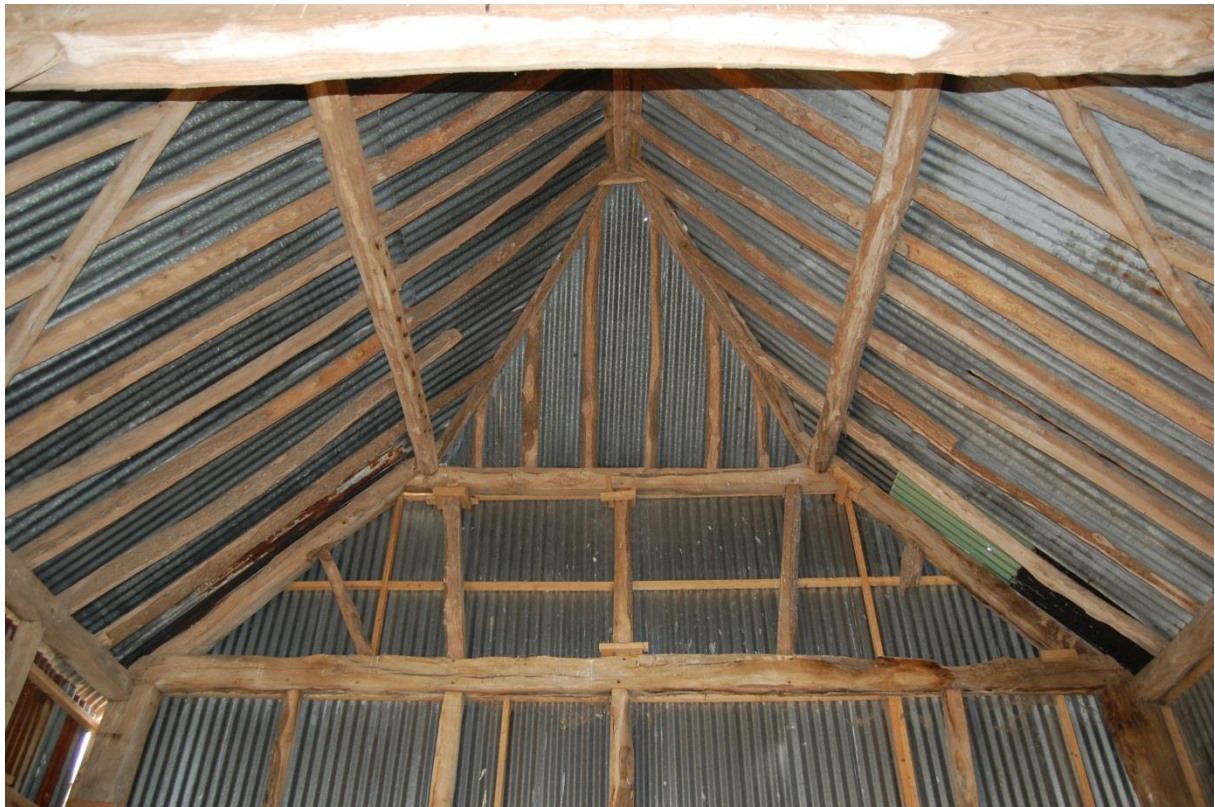
5.4 The timber framing consists of upright timbers and diagonal braces on all walls (Photos 3-8). There is no indication of horizontal timberwork between the uprights, suggesting that the barn was weather-boarded from the outset and did not previously have box-framing or panel infill, whether of wattle and daub, wattle and staves or brick nogging. The upright timbers average between 0.16m and 0.18m wide with the corner posts being

3: General view of the interior, looking west

4: General view of the interior, looking north-east

5: North-east wall

6: North-east half-hipped gable

7: South-west wall

8: South-west half-hipped gable

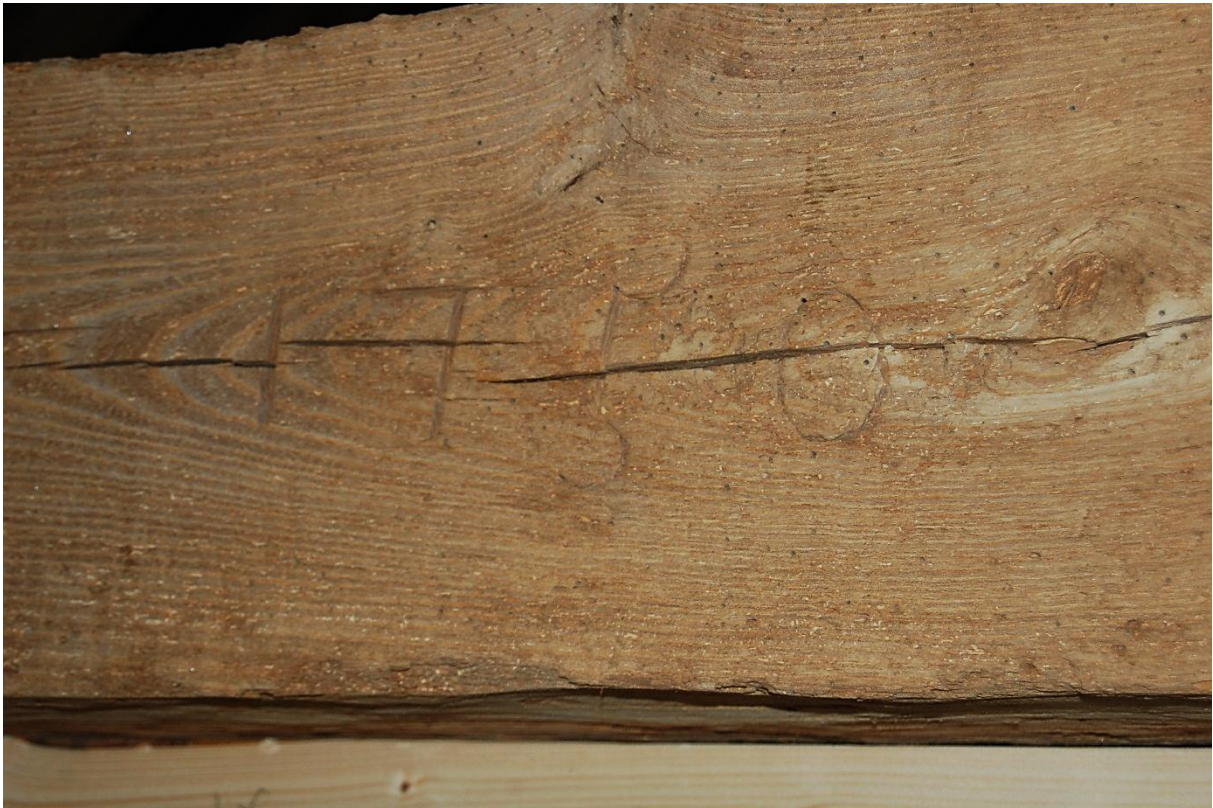
6.1 The building recording showed that the barn did not contain any re-used timber from earlier buildings, as for example indicated by redundant mortice joints. This shows that the barn was purpose-built for this site, presumably in around 1750, a date carved into one of the beams (Photo 9). It was a fine barn and would have been a relatively costly structure at that time. The barn had remained largely unaltered except for the gradual degradations of age such as rotting of the timbers and the replacement of the original tile roof and weatherboarding with corrugated tin.

9: Date of 1750 carved into the cross beam

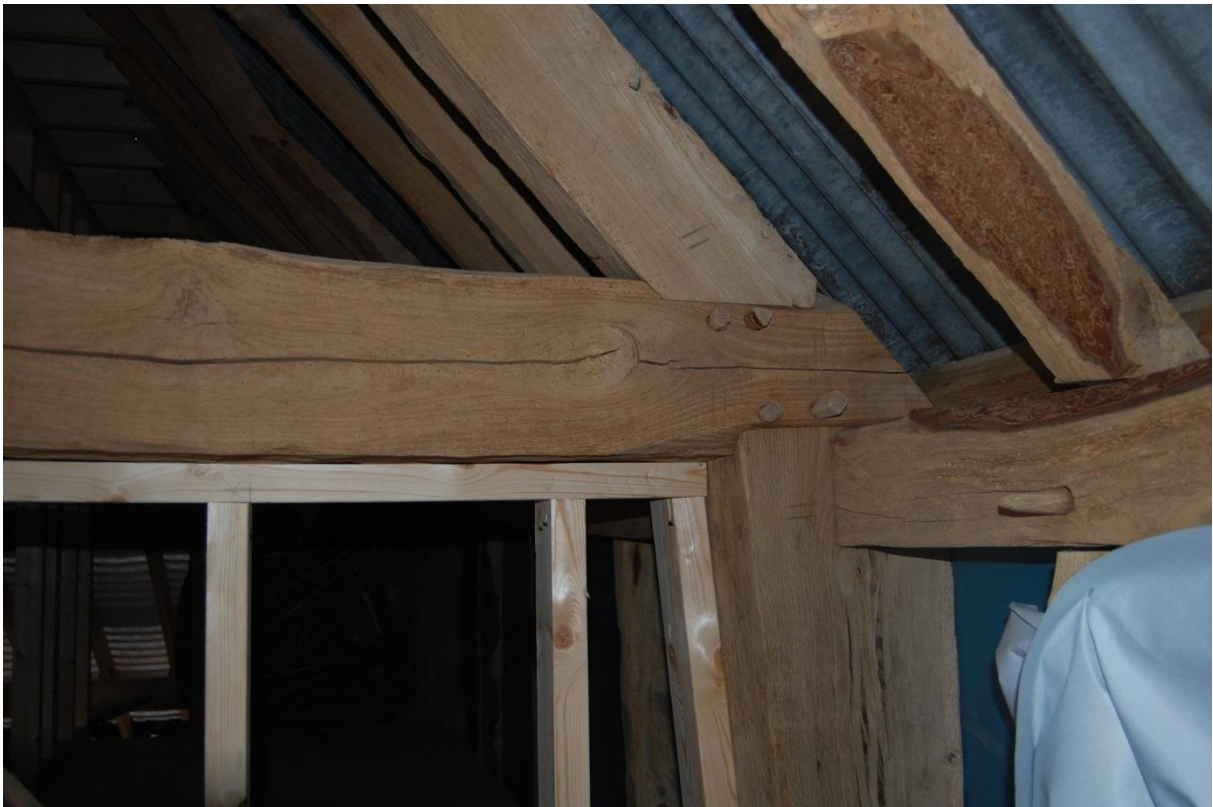
c.0.20m wide. Carpentry marks are visible on the roof trusses facing the threshing floor (Photo 10). The major joints are held with three pegs and the smaller joints with two pegs. There is no sign of timber re-use on any of the barn's timbers. The majority of the timbers are in good condition, with the exception of those on the western frame, which had been subject to the prevailing wind. The wooden sill rests on the remains of a low wall of Lias limestone, most of which has been removed to ground level and replaced by a series of breeze block pillars. Only at the south-west end of the building did the majority of the wall still support the timber frame (Photo 13). Here it was measured as 0.50m wide and with approximately 0.30-0.40m height visible externally, with the ground 0.10-0.20m lower internally.

5.6 The roof timbers are fairly slender and some have bark on them, as does one of the purlins and some of the wall timbers.

10: Carpentry marks and bark on timbers

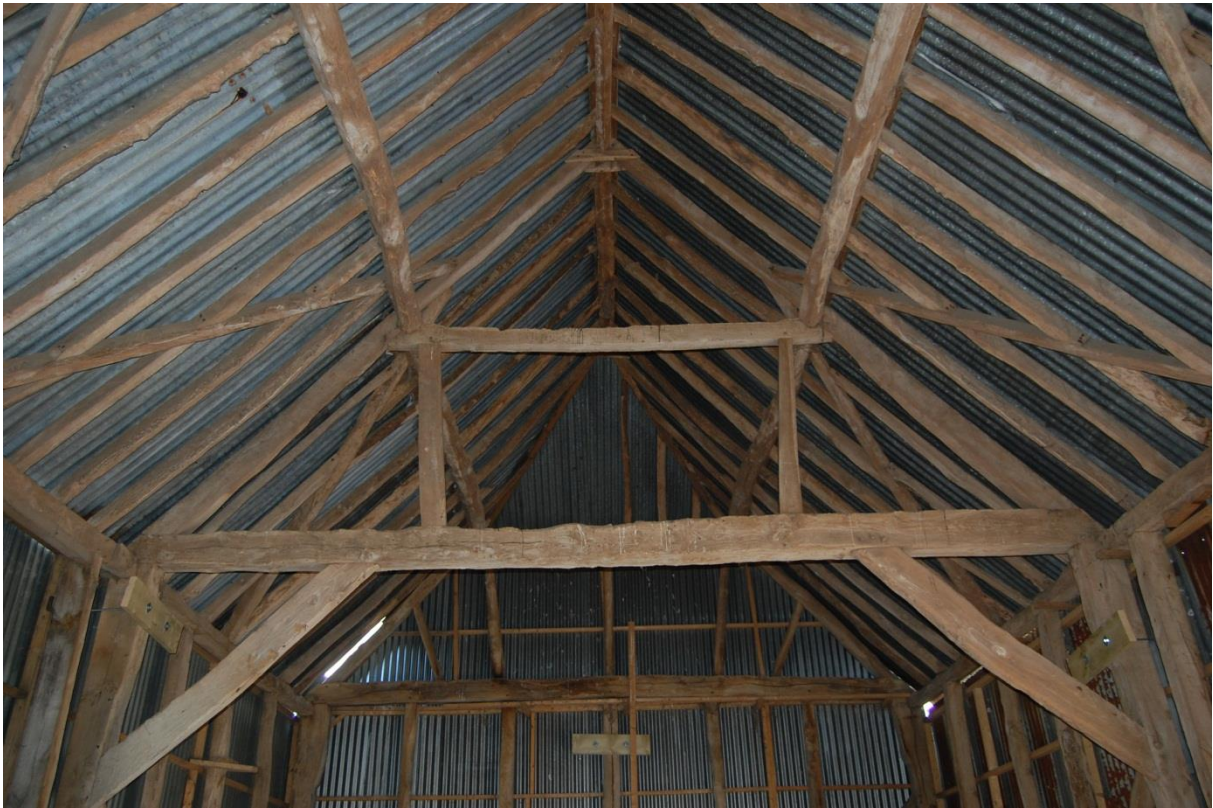
11: Roof structure

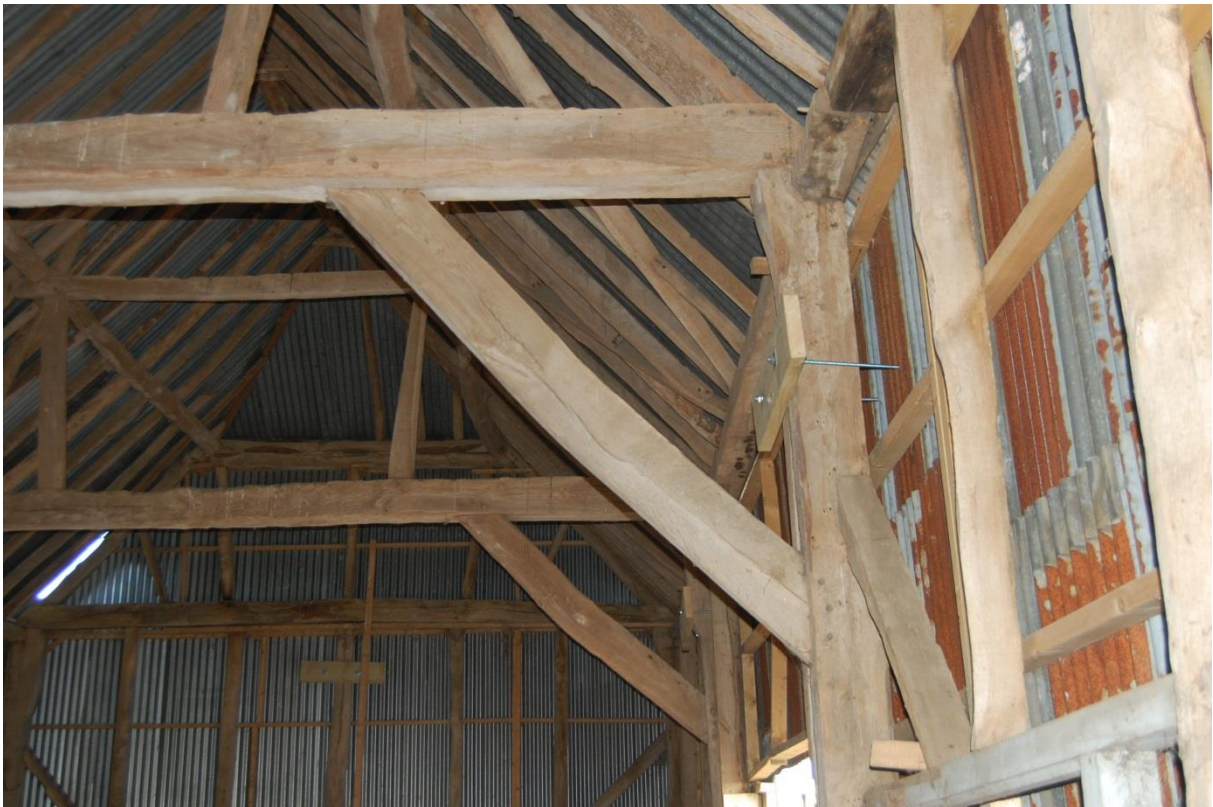
12: Diagonal bracing

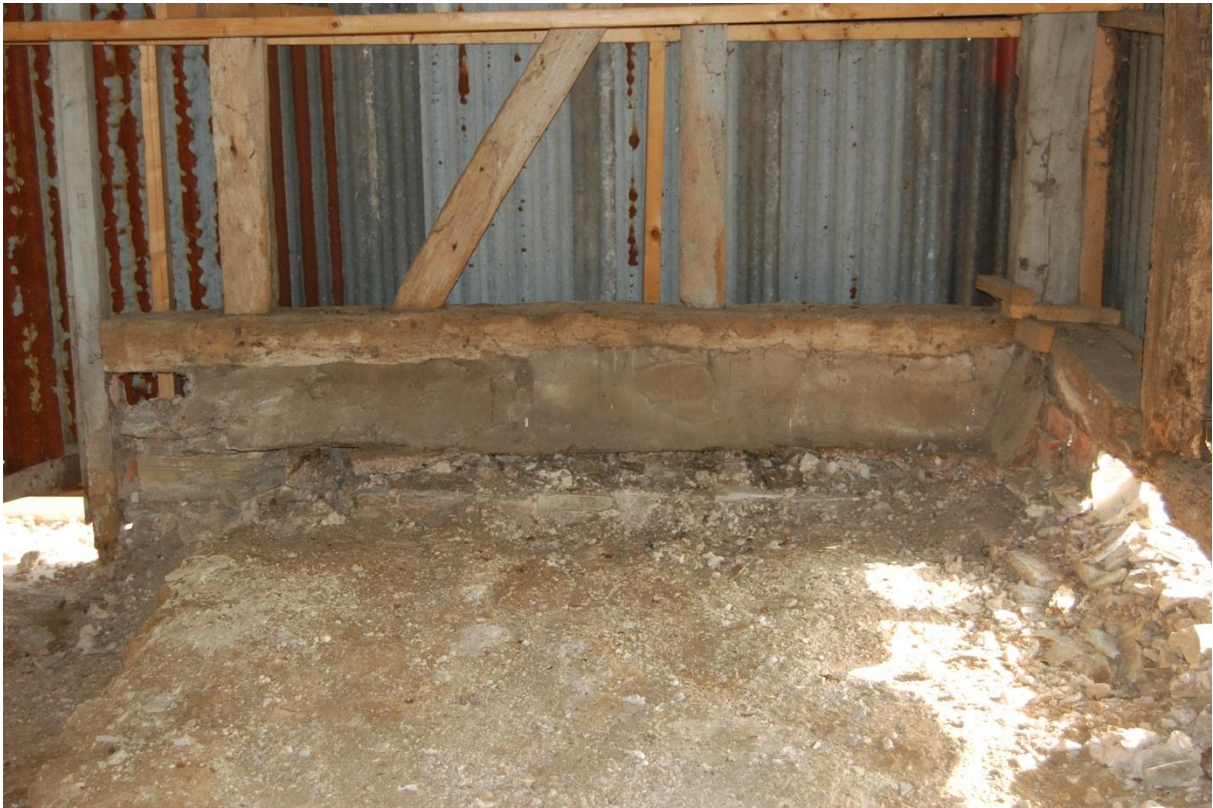
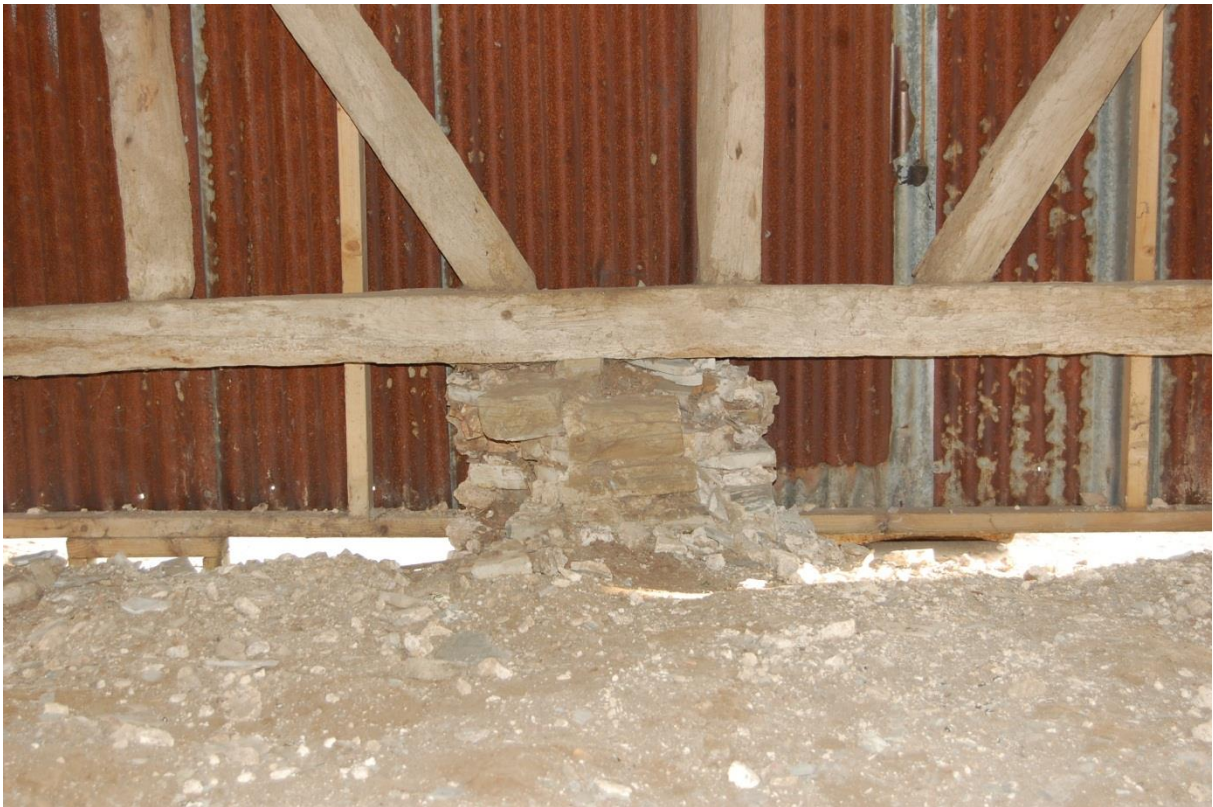
13: Remnant of wall plinth

14: Remnant of wall plinth

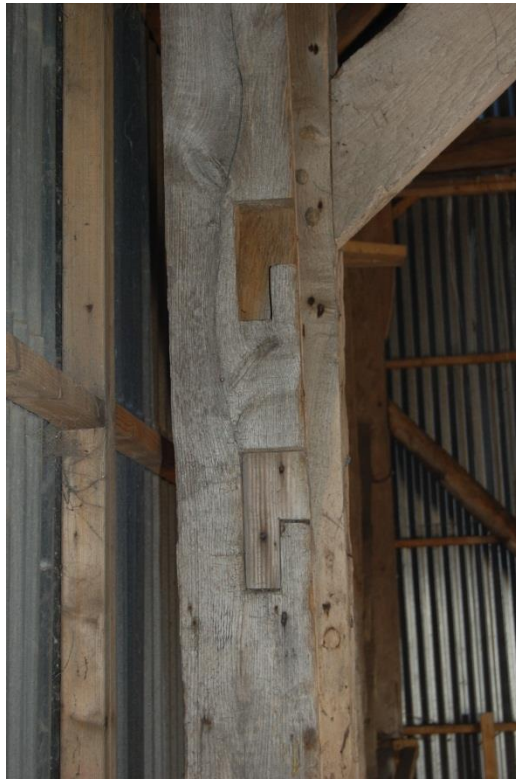
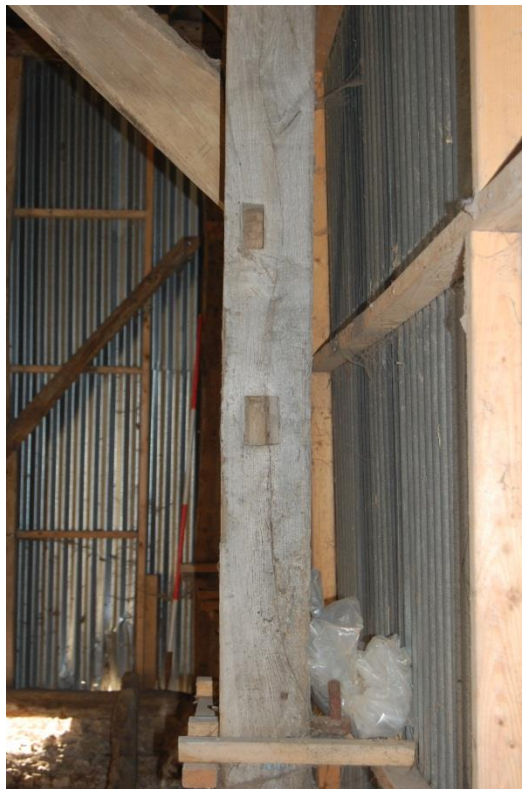
5.5 The barn has three bays, in common with many other similar threshing barns. The central threshing floor would have been paved and there is evidence from spalled limestone fragments, that the other two bays (for threshed straw and corn sheaves respectively) were also once paved. The posts either side of the north-western barn doors have two recesses cut into each of them (Photos 15 and 16), rectangular on the northwest side and measuring 90mm x 45mm and 45mm deep, and L-shaped on the other side, with a gap of 0.29m between them. These would have held cross-bars to stop the barn doors blowing inward when the doors were shut. The south-eastern doors had single recesses; this door would generally have been subject to less pressure from the wind. The door posts have the original iron pintles at top and bottom, although the north-west post has one c.1m up from floor level, suggesting this side may have had a split-door. There are mortises with sawn-off tenons in them in the low parts of the southern doorposts.

15: Slots for cross-bars on north-west door frame

16: Slots for cross-bars on south-east door frame

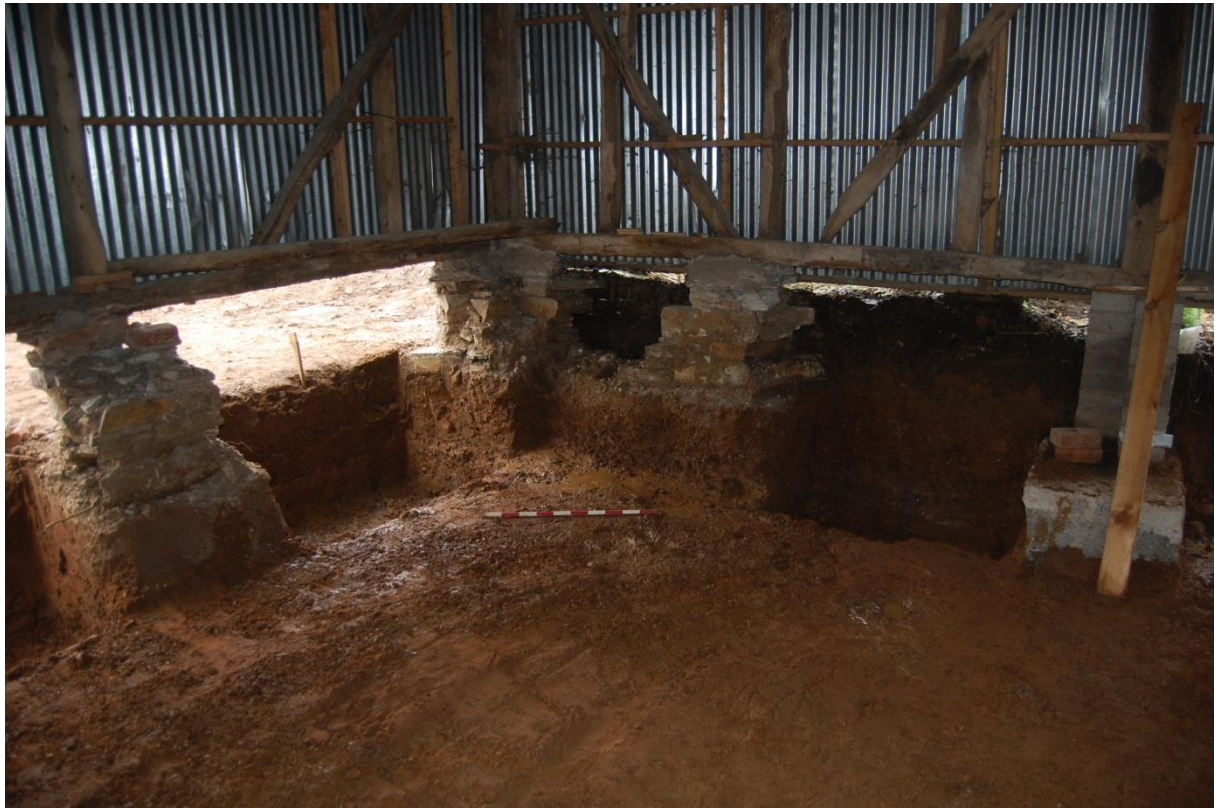
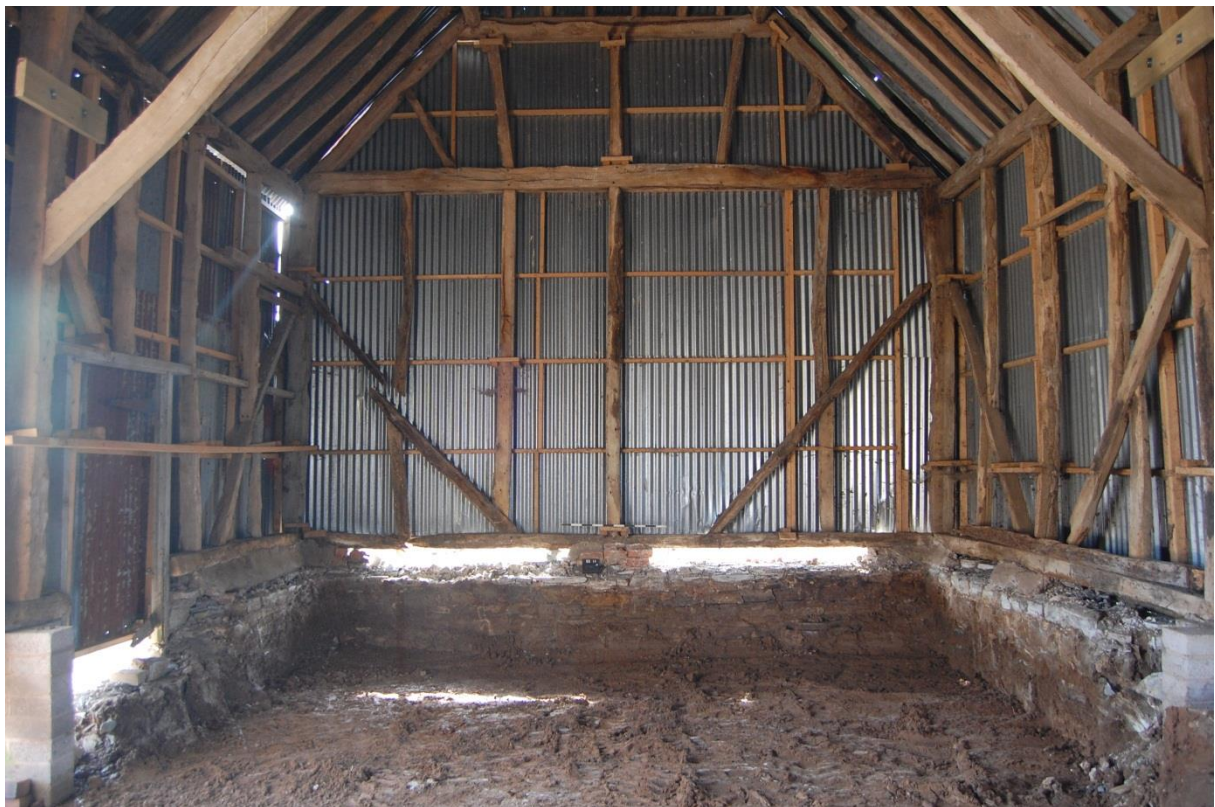
5.8 Ground reduction within the barn took place using a mini-excavator with a toothless bucket to a depth of 0.90m below the previous level (Photos 17-18). Geological natural brownish yellow sand with occasional gravel (6) was up to 0.6m below the current ground surface. It was overlaid by 0.40-0.50m of brown sandy loam (5). This layer was overlain by 0.10m of hard-packed dark greyish brown sandy loam (4), presumably either an old floor layer, or the old topsoil layer compacted by flooring above. No finds were recovered from ground reduction within the barn.

17: Ground reduction in the barn and on the line of the plinth wall

18: Ground reduction showing below-ground extent of plinth wall at south-west end of barn

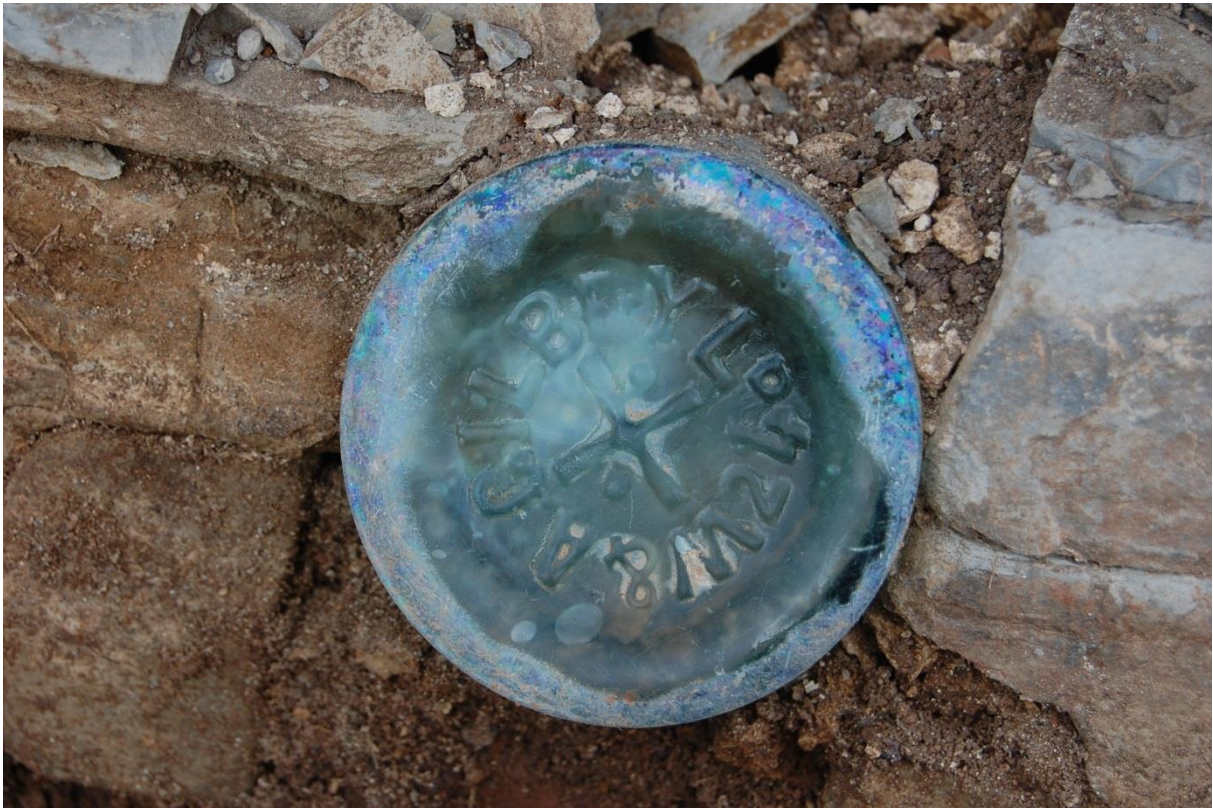
5.9 To the south-west of the barn an area measuring 5.5m x 6.5m was stripped to a depth of 0.54m. Geological natural sand was not reached and the lowest level encountered was the same brown sandy loam encountered in the barn (5). A 0.35m wide brick wall (7) was recorded running off the western corner of the barn, to the south-west, on the same alignment as the long side of the barn. The bricks of this wall measured 240mm x 110mm x 70mm and appeared to be 19th-century in date. The two courses of extant brick rested on a Lias limestone foundation, bonded with off-white lime mortar (8). The base of an old Gilbey's gin bottle was recorded embedded in soil between stones in the lower part of the external barn wall (Photo 19).

19: Base of Gilbey's Gin bottle embedded in barn wall

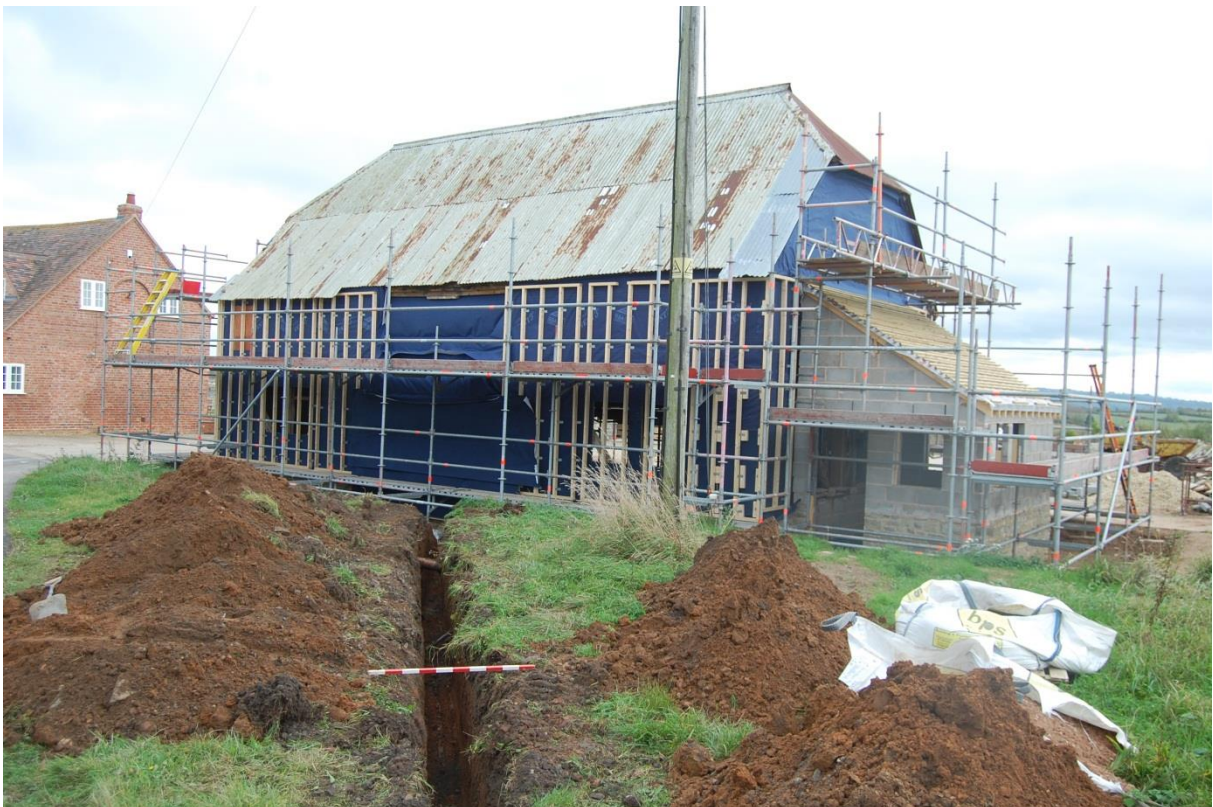
5.11 A service trench for an electricity cable was excavated in October 2014, from the barn to the telegraph pole to the north-west (Photo 20). The trench was 0.30m wide and between 1.04m and 1.16m deep. Natural reddish brown sandy clay (12) was reached below 0.23m of topsoil (10) or 0.25m of modern road make-up (11). A wider area was opened up north of the road to look for a water pipe.

20: Service trench to the north-west of the barn

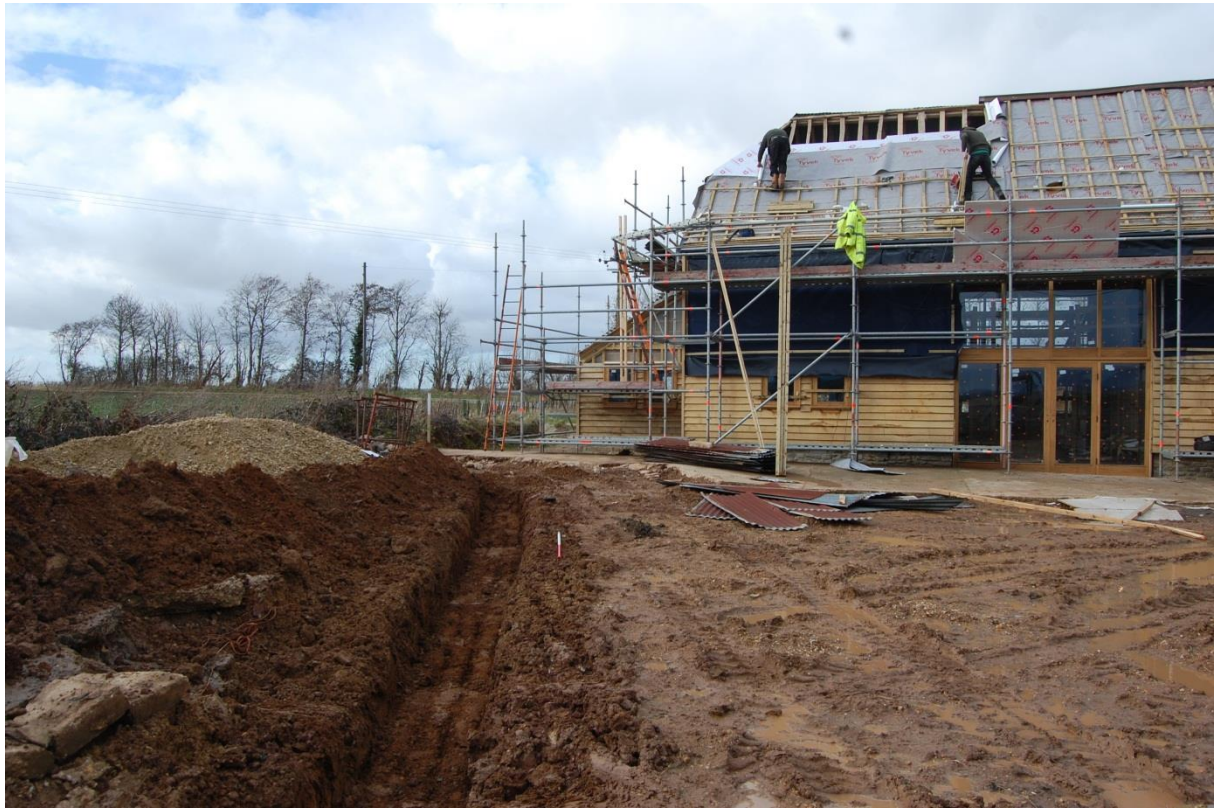
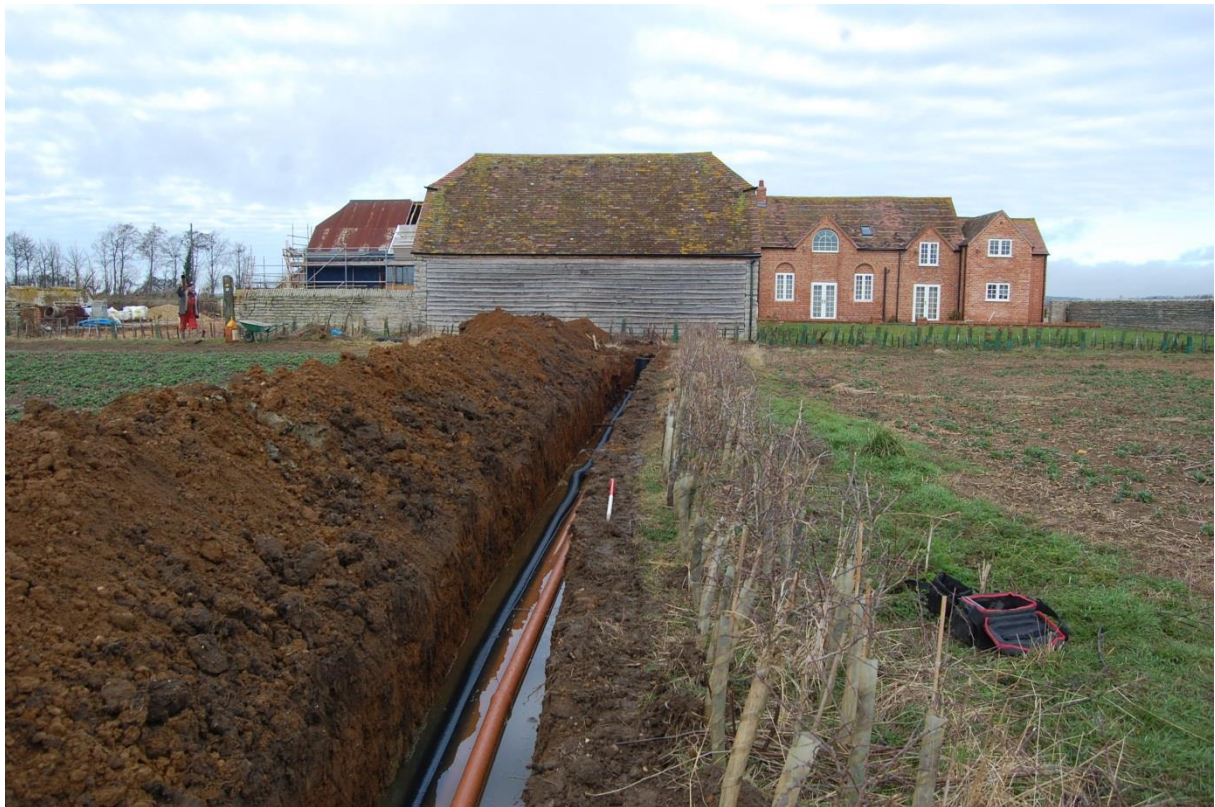
5.13 A further service trench was observed running south from the barn, across the farmyard and into the field to the south (Photos 21-22). It was 0.75m wide and sloped downwards to the south, being 0.45m deep at the north end and 1.1m deep at the south end. The trench exposed geological natural deposits along its entire length and no archaeological features were exposed in it. In the majority of the trench this was geological natural reddish brown sand and gravel (15). Outside of the farmyard this was overlain by 0.4m of brown sandy loam (14), an old plough-soil, which was covered by between 0.3 and 0.35m of greyish brown sandy loam plough-soil. Just outside the farmyard the geological natural was overlain by a layer of greenish grey clay (16). This was 0.3m deep and ran in to the area of the farmyard itself and was either a variation in the geological natural or perhaps more likely a deliberately dumped layer used to build the ground up for part of the farmyard. No dating evidence was recovered from it. It was overlaid by 0.2m of topsoil (13). The concrete yard surface had previously been stripped from the site.

21: Service trench across courtyard

22: Service trench out into field
