St Michael's Cathedral Ruins, Coventry

ARCHAEOLOGICAL OBSERVATION AND RECORDING

Archaeology Warwickshire Report No 16123
DECEMBER 2016

Project: St Michael's Cathedral Ruins, new drain
Commissioned by: Tony Auty, Director of Property and Fabric,
Coventry Cathedral
Project Report No. 16123
Site Code: CSM16
Planning Reference: N/A
National Grid Reference: SP 3360 7899
Team:
Project Manager: Dr Cathy Coutts
Fieldwork: Rob Jones and Dr Cathy Coutts
Author: Dr Cathy Coutts
Illustrations: Candy Stevens
Report checked by: Pete Thompson BA
Date: December 2016
Report reference: Coutts, C. M. 2016 *Coventry Cathedral Ruins
new drainage, Archaeological Observation
and Recording*, Archaeology Warwickshire
Report 16123.

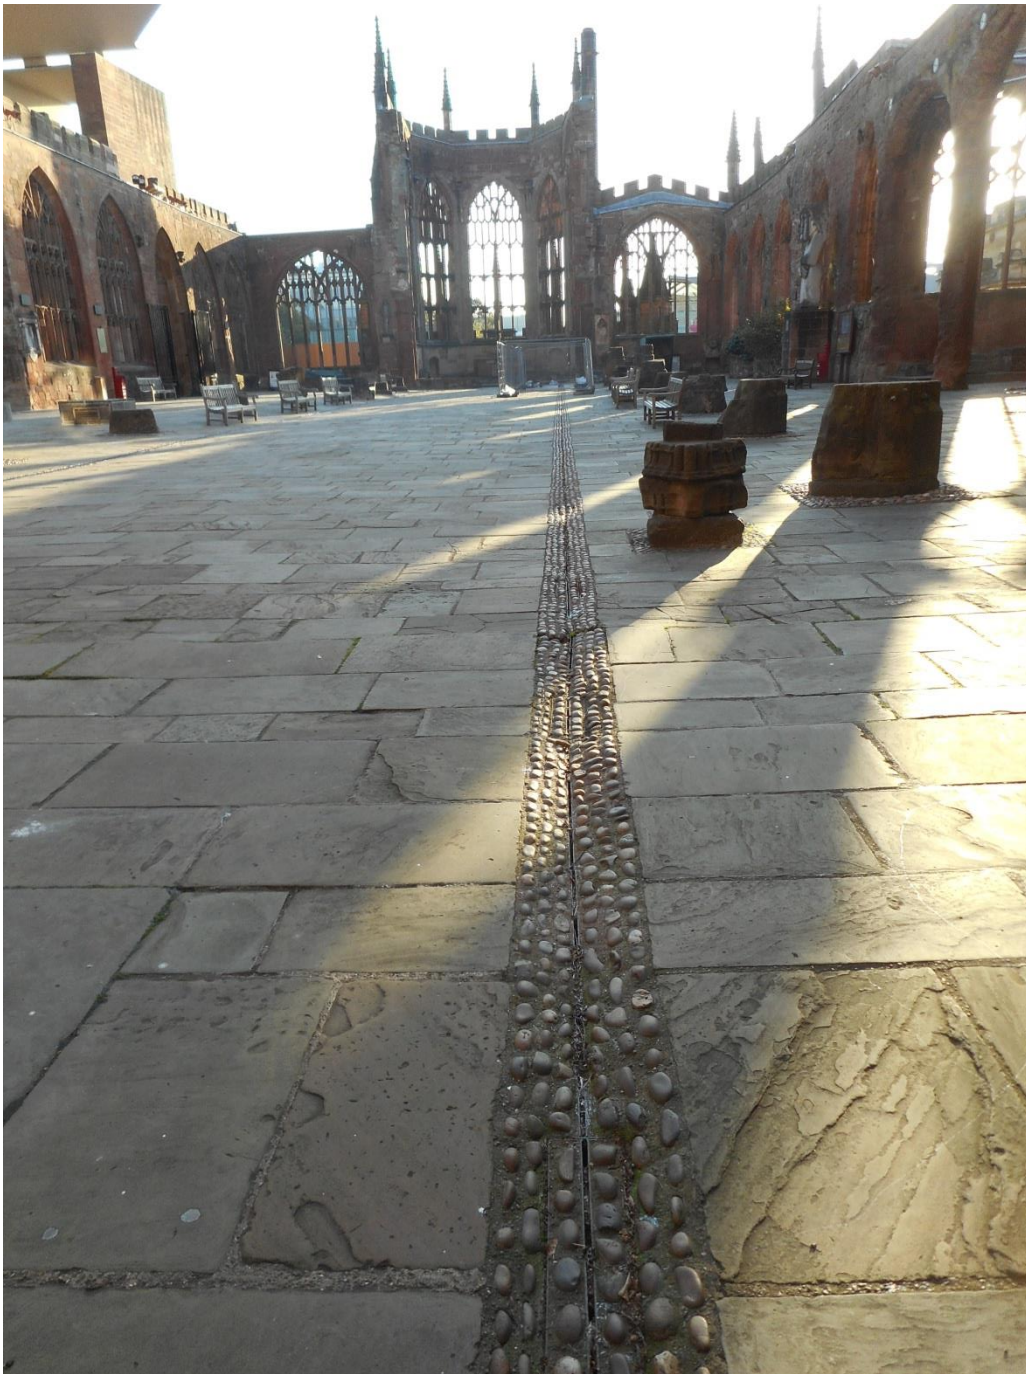
1: Slot drain prior to replacement

- 5.2 The material either side of the old metal slot drain was strong mortar with rows of decorative pebbles embedded onto the surface either side (Fig 1). This material was taken out using a *Kango Hammer* and its removal allowed the sections of metal slot drains (3) to be removed. The maximum depth excavated was 0.17m, revealing the 1m long sections of the old ceramic drain channel, which were laid in a 0.30m wide cut between the stone flagstones (1) that make up the present flooring of the cathedral ruins. This drain was bedded in a sandy mortar (2), the upper 70mm of which was removed.

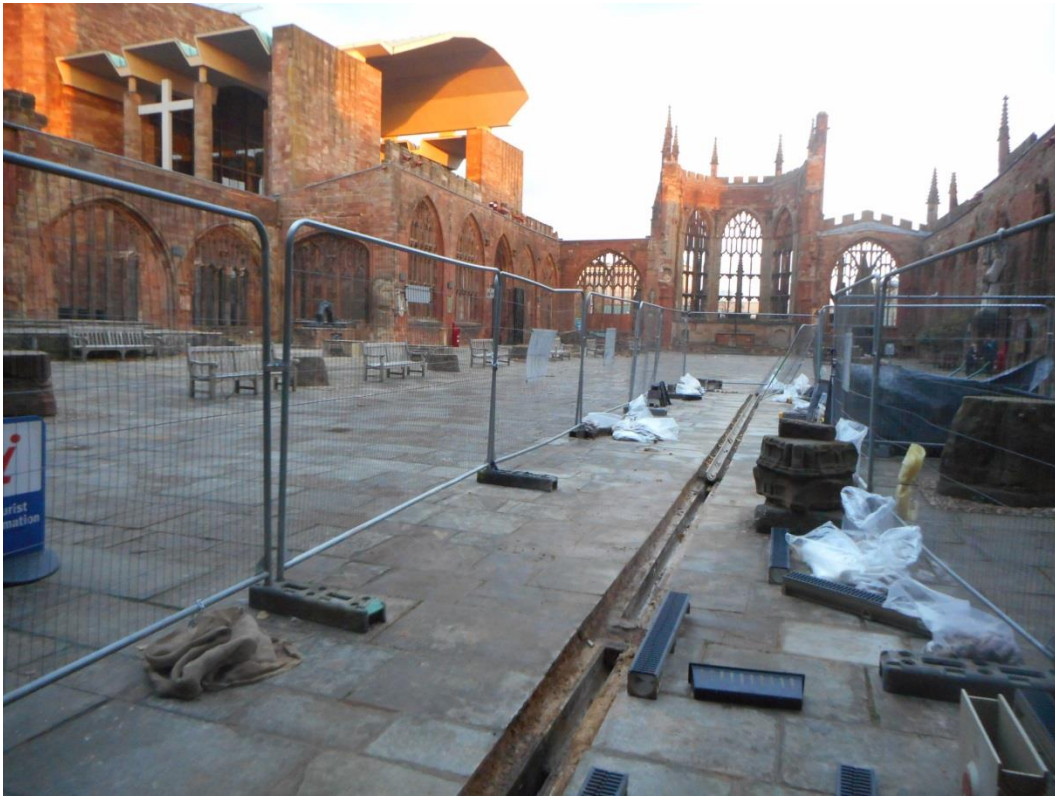
2: Old drain removed and new drain being installed

- 5.3 The new drain channel was installed on top of the old channel and the void either side re-filled with concrete into which two rows of pebbles were bedded. The initial stretch of new concrete had to be removed and re-set with more frequent pebbles to be more in keeping with the new drain channel in the northern side of the church. This re-excavation was not observed.

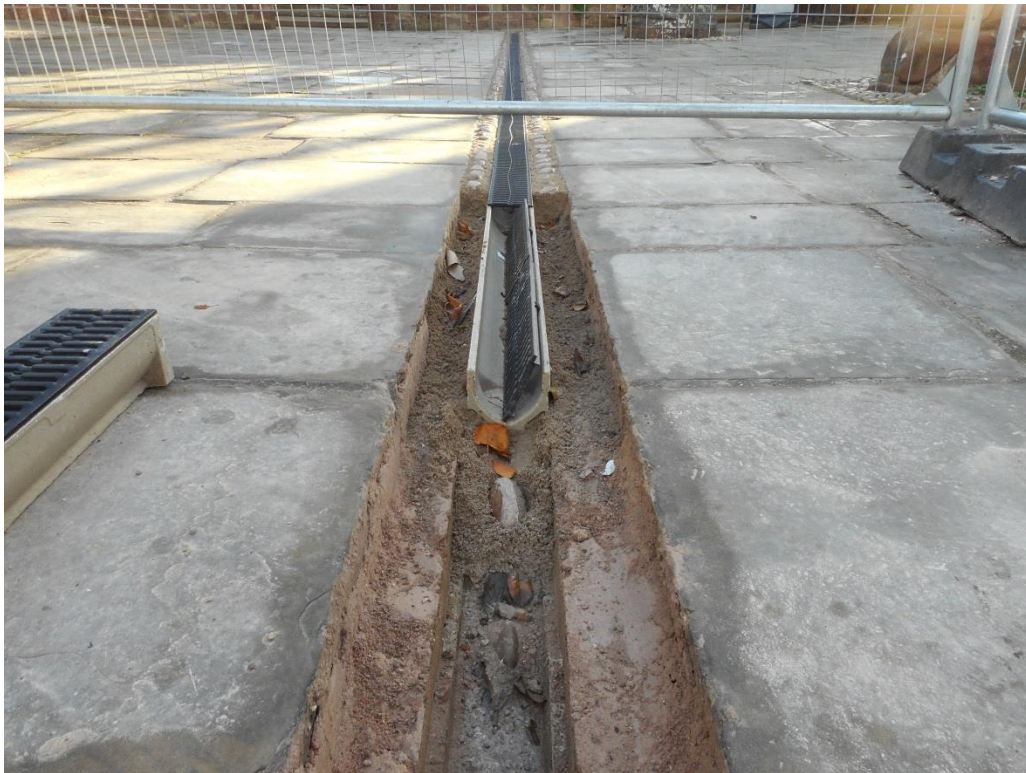
3: Detail of new drain, sitting over old drain channel
