31 The Crescent Brinklow Warwickshire

ARCHAEOLOGICAL INVESTIGATION

Archaeology Warwickshire Report No 1686

SEPTEMBER 2016

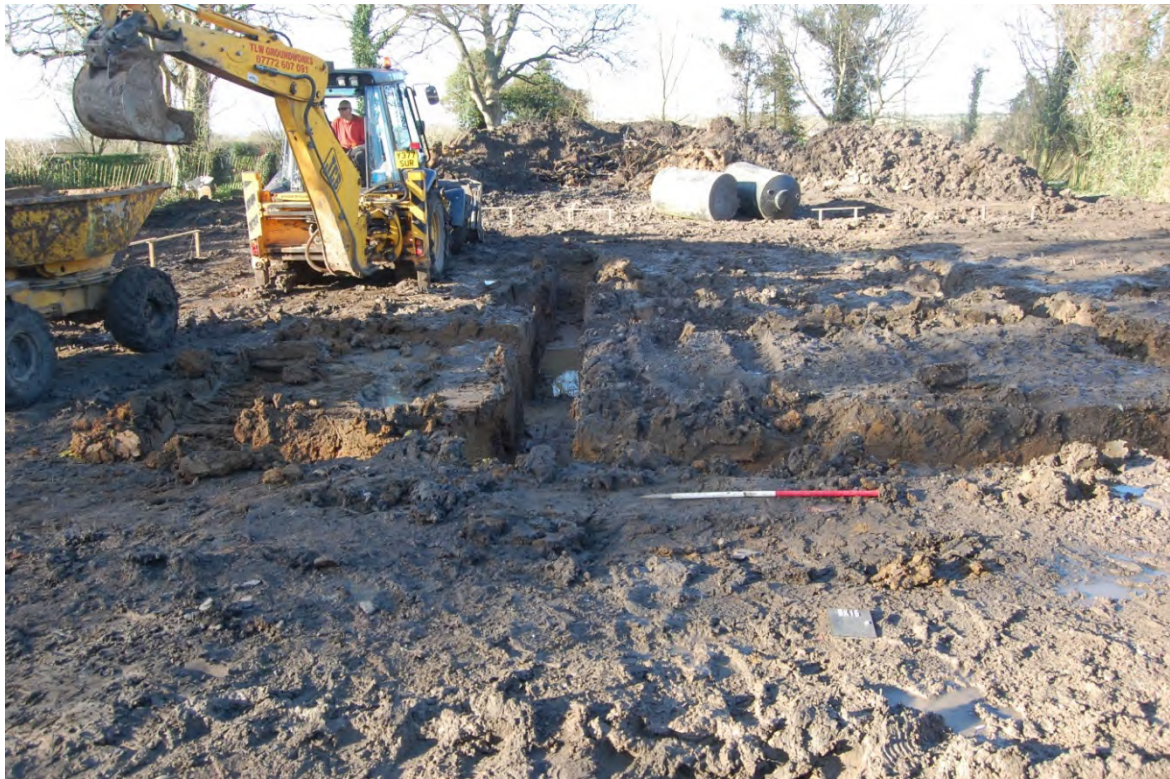
1. General shot of the site

- 5.1 All groundworks were observed; such works included the removal of trees, foundation and service trenches and stripping for a new driveway and garden. The removal of the topsoil was also observed across the site prior to the excavation of the foundation trenches. Following this, a period of inclement weather meant that the site was flooded for several weeks. Once trenching began it was clear that the soft ground caused construction vehicles to sink into the soil and that any shallow archaeological features were likely to have been disturbed by this (Photographs 1 and 2).

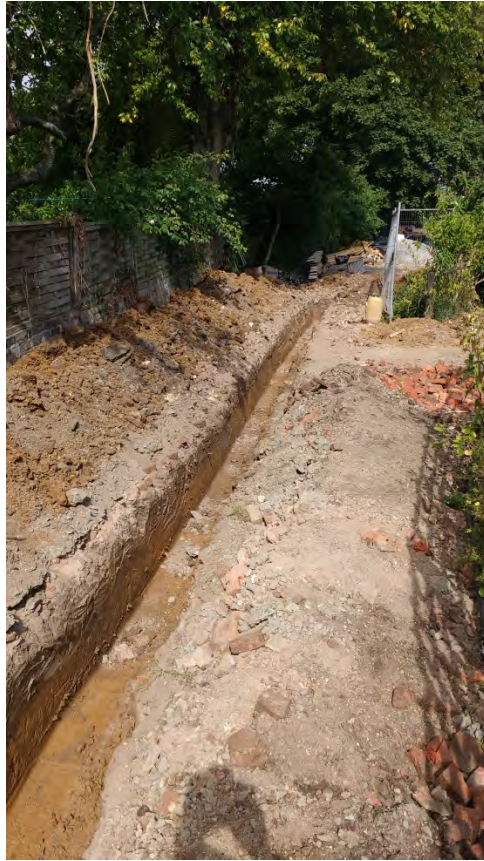
3. Service trench

- 5.2 The geological natural consisted of yellow brown clay mixed with reddish brown clay (102). This was only recorded in the foundation and service trenches (Photograph 3).
- 5.3 No medieval or earlier features were encountered. If present, the features may have been shallow like those found in the evaluation trenches and may therefore have been compromised by the soft ground.
