Archaeological Recording at Pool Meadow

Car Park, Fairfax Street,

Coventry

Report 0230
August 2002

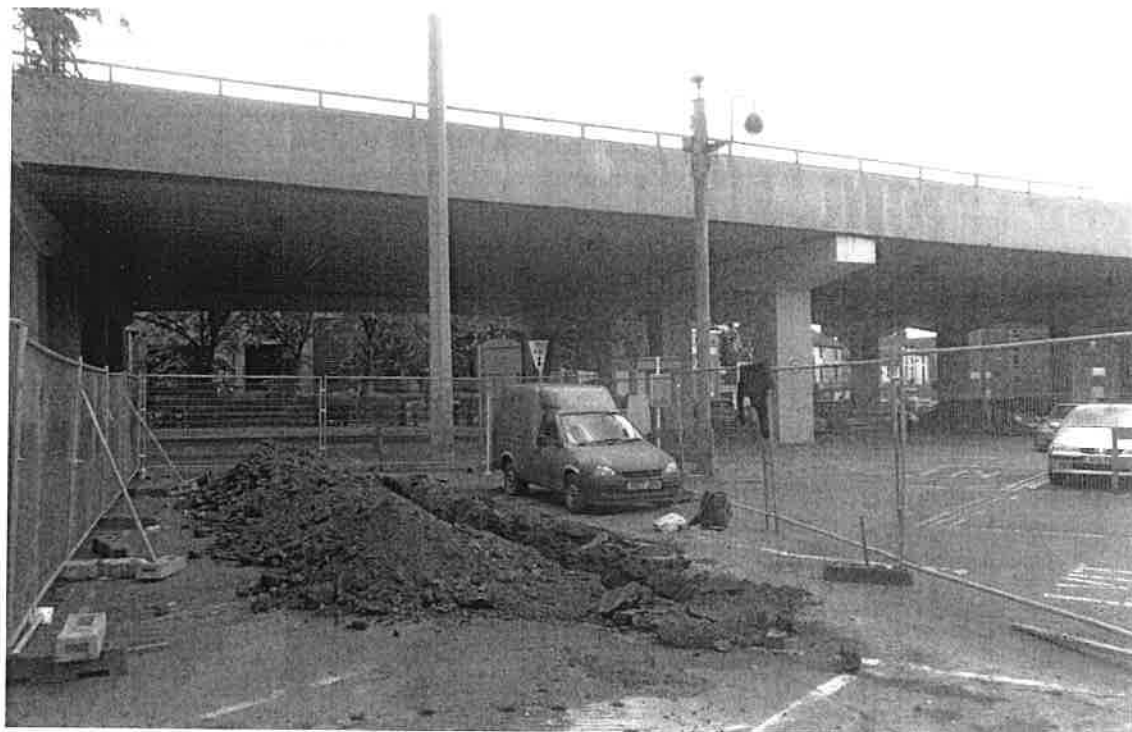
Fig. 3: Excavated trench in relation to existing ring road

5.6 The levelling layers were overlain by an earth layer containing quantities of rubble (102). This is likely to represent a period of abandonment prior to the creation of the car park. Layer 102 was overlain by the grit surface (100, 101) of what was probably a former car park. This was in turn overlain by the tarmac surface (111) of the existing car park (Fig. 3).

6.2 The currently accepted alignment of the town wall would indicate it was likely to be located at the northern end of the trench or at the north-eastern limit of the site. If so then any surviving evidence would almost certainly have been affected during the construction of the ring road in the 1960s (Fig. 3).

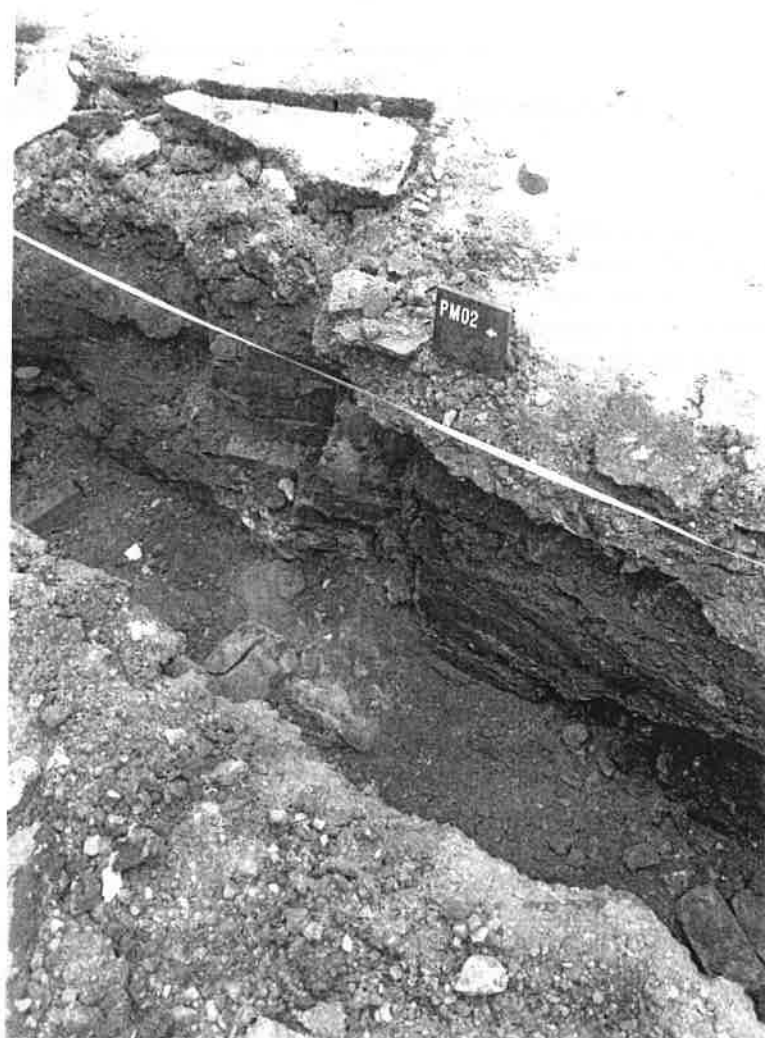
Fig. 4: Wall foundation 114 and adjacent levelling deposits

5.4 At the southern end of the trench none of the layers described above survived owing to what appears to have been modern disturbance. A mortared brick wall (114) forming the corner of a building aligned north-west to south-east was recorded across the width of the trench (Fig. 4). The trial trench was excavated to the apparent base of the foundation (119) of this wall 1.15m below the existing ground surface. Fragments of stone (115) included in the wall foundation may have originated from the medieval town wall, but there is no evidence for this. The bricks were of the large factory made variety and probably dated to the later 19th or 20th century. The wall is likely to have belonged to one of the buildings shown on maps of the early 20th century (Ordnance Survey 1923, Ordnance Survey 1937).

5.5 It was not clear what layer the wall foundation was cut into but it was overlain by a number of modern deposits of varying nature (107, 112, 116, 117, 120) including concrete blocks (113) and lumps of tarmac (118). These would appear to be levelling layers and may have been associated with the demolition of previous structures in the area. The modern levelling layers also extended over the north of the trench (103, 104, 105, 110) where they overlay the buried soil 106.
