ARCHAEOLOGICAL EVALUATION

Archaeology Warwickshire Report No 1706

Project: 3 The Crescent, Brinklow, Warwickshire
Commissioned by: Louise Thornhill
Project Report No. 1706
Site Code: BK16
Planning Reference: R13/1731
Planning Authority: Rugby Borough Council
Planning Archaeologist: John Robinson, Warwickshire
National Grid Reference: SP 4357 7963
Team:
Project Manager: Stuart C Palmer MCIfA
Fieldwork: Bryn Gethin BA, Rob Jones
Author: Bryn Gethin BA
Illustrations: Candy Stevens
Report checked by: Stuart Palmer MCIfA
Date: January 2017
Report reference: Gethin, B, 2016 *3, The Crescent, Brinklow, Warwickshire, Archaeological Evaluation, Archaeology Warwickshire Report 1706*

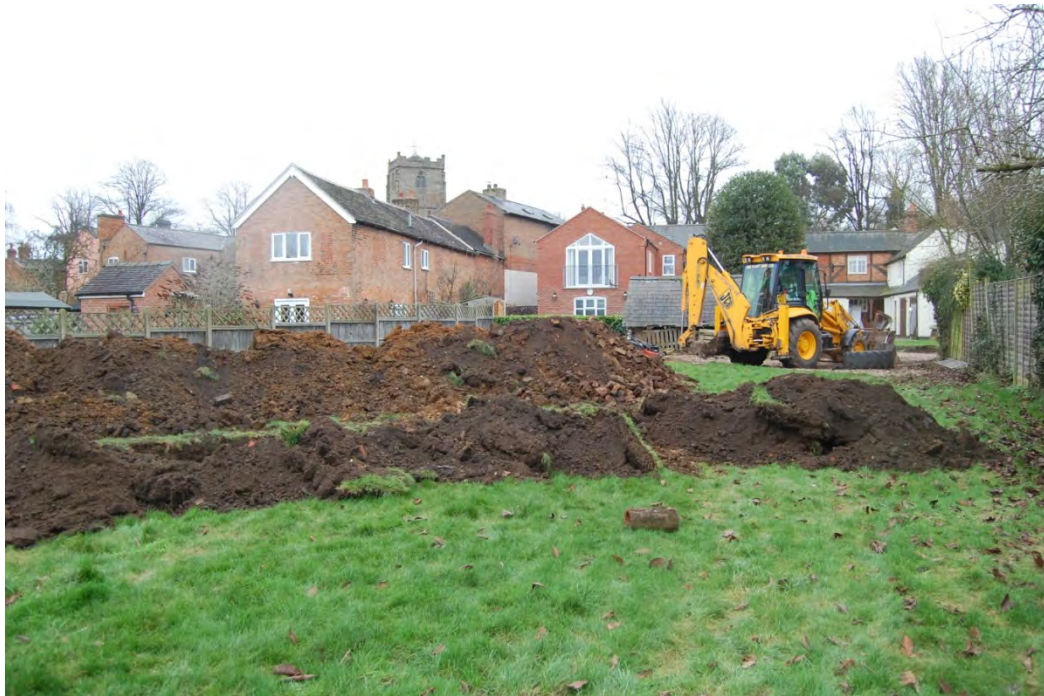
1. Evaluation in relation to medieval church

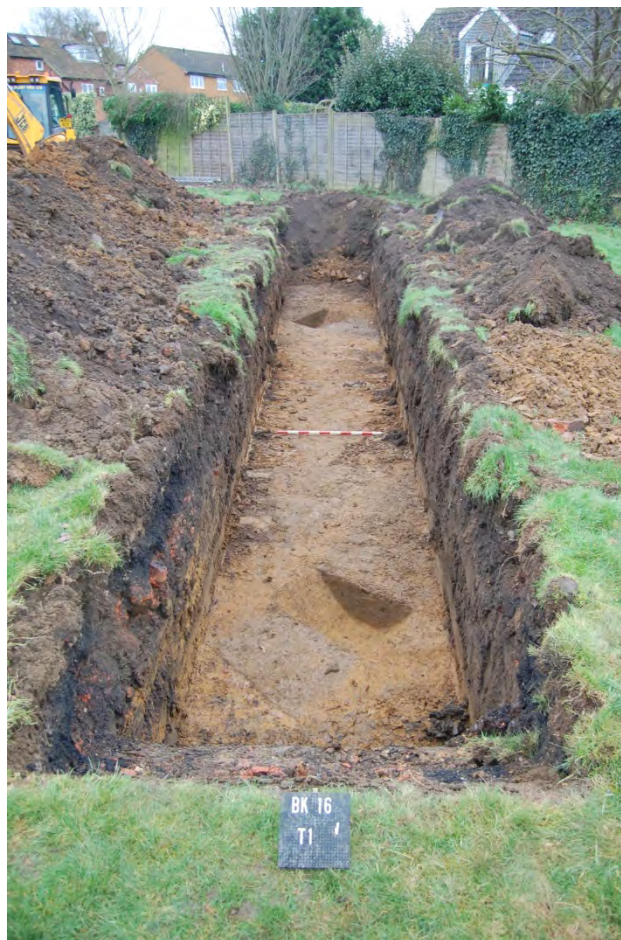
2. Trench 1

- 5.1 The geological natural consisted of brownish yellow clay (104) and was encountered at between 92.01m and 92.39m above Ordnance Datum, over 1.20m below the existing ground level.

- 5.3 The natural was cut by two medieval ditches. Ditch 109 was aligned NNE/SSW and ditch 107 was aligned at right angles. Both features were filled with greyish brown silty clay soil (108 and 110) which yielded sherds of 13th to 14th century pottery.

- 5.4 Overlying the ditches was a 0.50m layer of yellowish brown clay loam (103). No finds were recovered from this layer but its general homogeneity is suggestive of agricultural or horticultural build-up.

- 5.5 Layer 103 was overlain by a mixed yellow brown clay layer (102) that contained brick fragments and likely associated with a fragment of brick foundation (106). It was in turn overlain by a layer of black ash with bricks and plastic (101) and modern topsoil (100). At the northern end of the trench was a large modern pit containing bricks (111). This was cut through layer 103 and was deeper than the base of the trench and clearly extended to the north. It was filled by re-deposited brownish yellow clay (112) which contained fragments of 19th century brick.

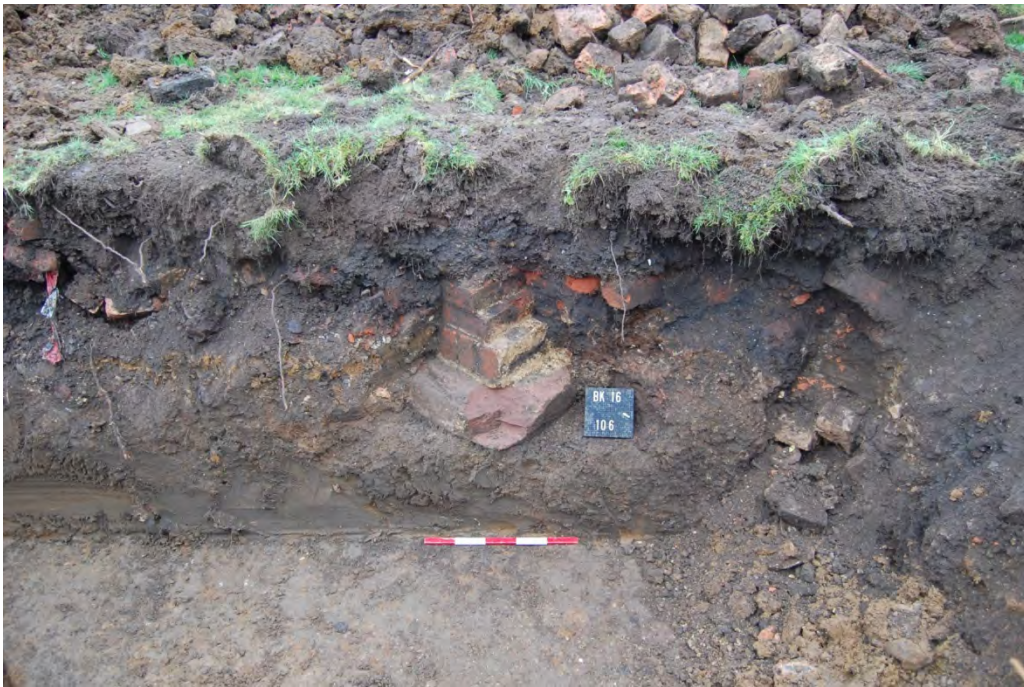
3. Brick foundation 106

- 6.4 The brick foundation in Trench 1 aligns with a building depicted on the 1st Edition Ordnance Survey map of 1887. This would have formed part of a yard attached to the west side of larger complex of buildings, probably associated with a candle factory (information supplied by owners). The main complex of these buildings is depicted on a map of 1838 when the building in Trench 1 is not depicted. A further brick and stone foundation exposed in Trench 2 also matches the position of a building shown on the 1887 map and on the 1838 map and is therefore probably somewhat earlier than the wall in Trench 1.

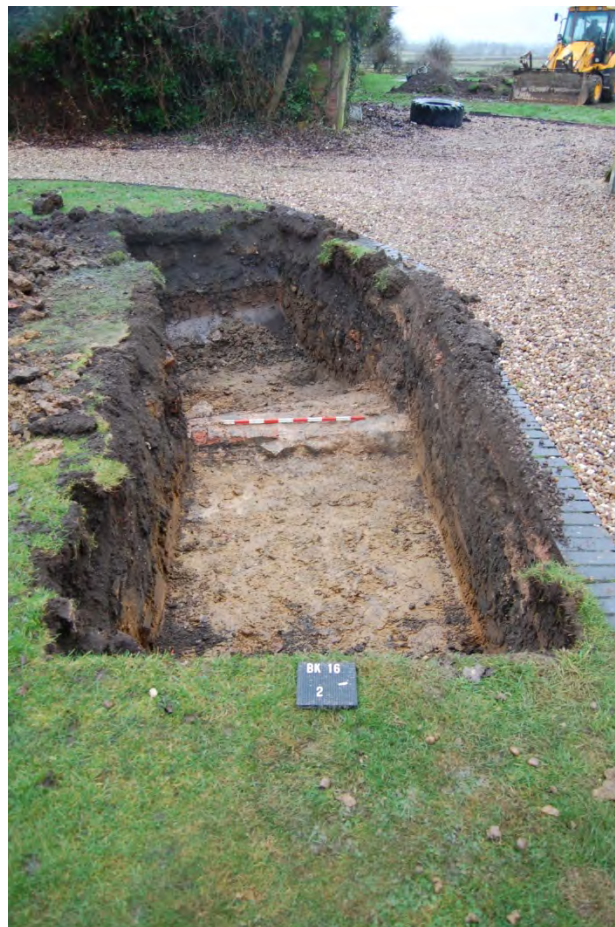
4. Trench 2

- 5.6 The geological natural consisted of yellow clay (205) which was encountered at 92.87m above Ordnance Datum, some 1.1m below the current ground level.
- 5.7 At the west end of the trench was a large pit (208) which contained grey clay. Animal bone was recovered and it is thought likely that this is a medieval feature. A small pit cut (210) to the east yielded a sherd of medieval pottery.
- 5.8 Both medieval pits were cut by the construction trench, 206, for brick wall foundation 207. This foundation was up to 0.46m wide and included fragments of Lias limestone. The wall cut through, or was butted by, two different layers of soil. To its east was a red clay layer (203) and to its west was a mixed brown and yellowish

brown silty clay with occasional small to medium limestone frags (204). These were overlaid by a thick deposit of very dark greyish brown silty clay with large amount of ash and occasional brick fragments (202).

- 5.9 Brownish yellow silty clay containing occasional small pebbles and brick fragments (201) was covered by up to 0.25m of topsoil (200).
