Packwood House, Fibre Optic Cable Trench Lapworth Warwickshire

ARCHAEOLOGICAL OBSERVATION AND RECORDING

Archaeology Warwickshire Report No 1811
FEBRUARY 2018

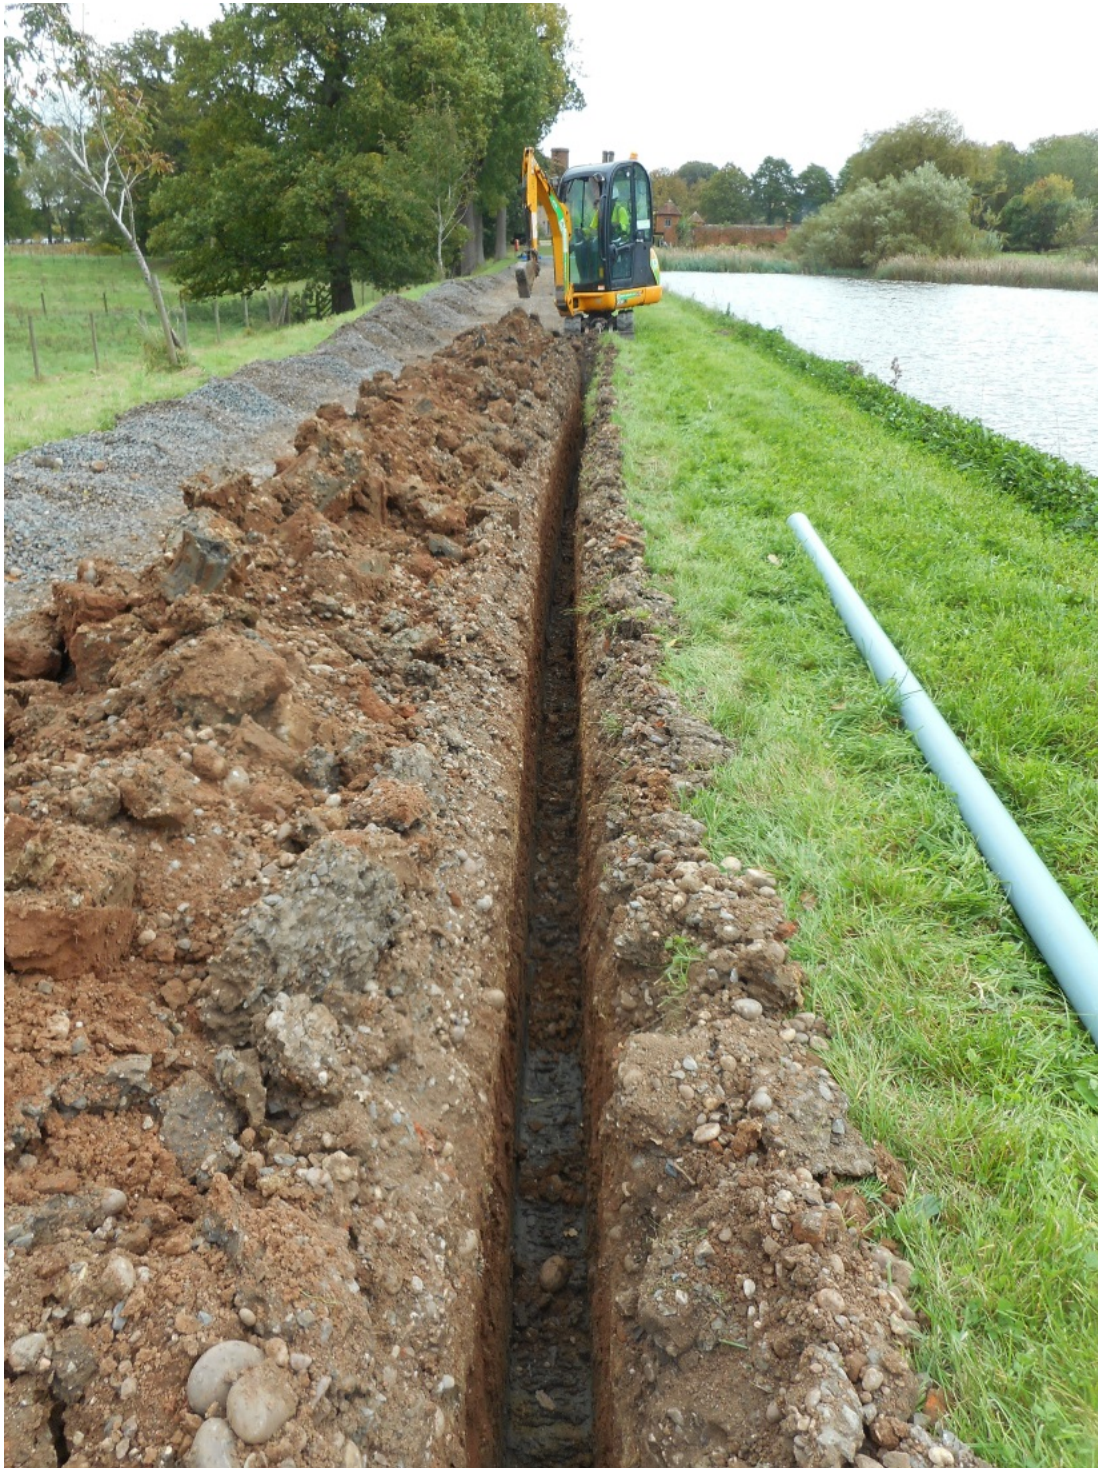
1. View of service trench alongside lake, looking north-east towards Packwood House

- 5.1 The ground disturbance associated with the development was undertaken in several stages. Trenching was undertaken over a period of three weeks with the trench being excavated by mini-excavator to a depth of 0.45-0.65m deep and up to 0.23m wide, with a narrow toothless bucket. Observation proper began when the contractors reached the area by the lake. A small trench was excavated for a service box measuring 0.60m x 0.80m prior to the main run of fibre optic cabling by the lake and across the causeway.

- 5.2 A very simple sequence of deposits was recorded during the observations. Along the south-west side of the lake the trench cut only into a mixed topsoil layer (1), here 0.45m deep. Along the causeway the lowest part of the trench cut c.0.20m into a layer of compact, dark brown silty clay (5), overlain by c.0.20 of red silty clay (4), itself overlain by 0.08-0.20m of yellowish brown sandy clay (3) with overlying topsoil. The path makeup was a thin, 40mm layer of modern pea gravel (2) overlying the topsoil layer. The topsoil contained fragments of brick and is likely to be the source of the other unstratified finds.

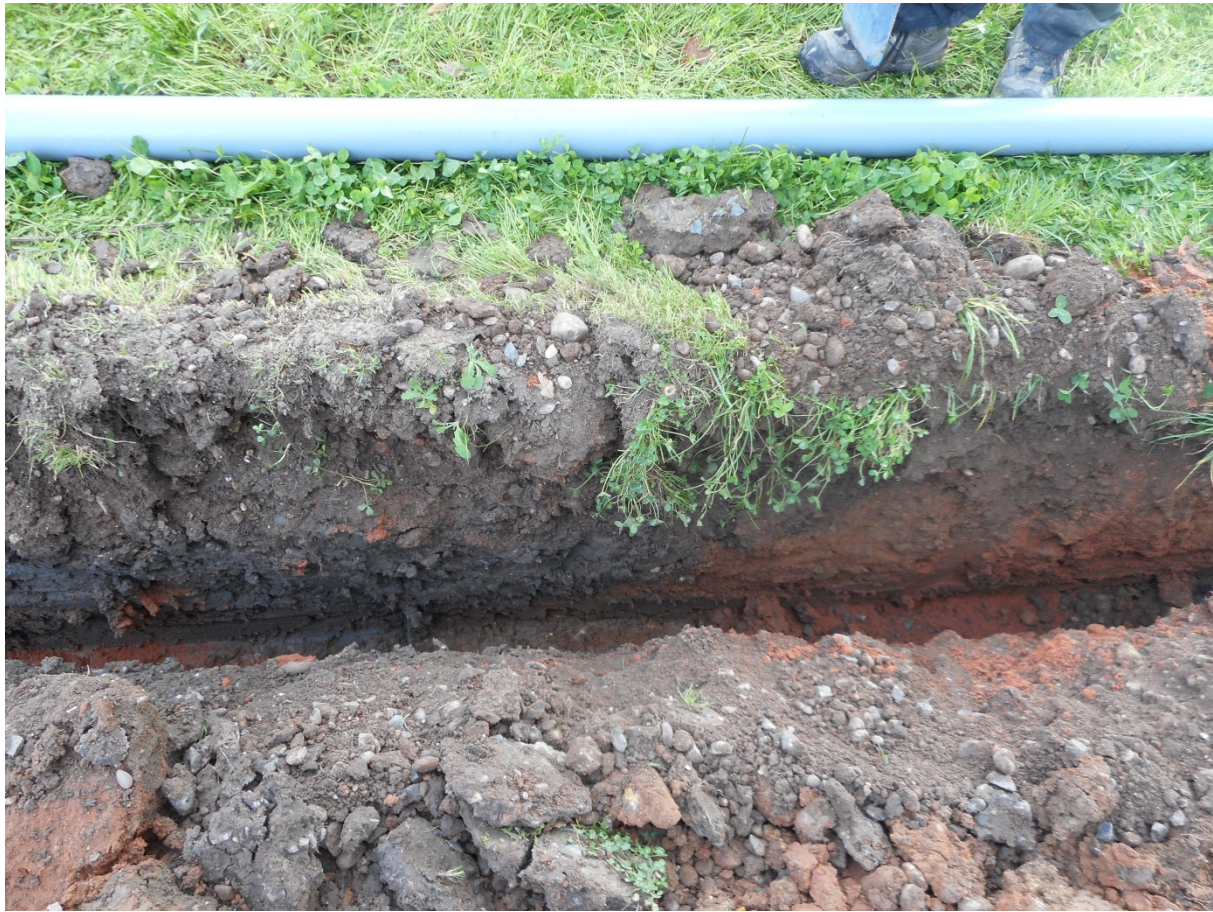
2. South-facing section of ditch 6 and fill 7

- 5.3 The excavation on the causeway revealed the remains of ditch (6) cutting into the red clay (4), filled with a layer of dark brown silty clay (7), sloping towards the lake. This is likely to represent a relict drainage ditch, possibly associated with a field boundary to the north-west. No artefacts were found in the fill. Also noted were two land drains near the north-west corner of the lake.

- 6.1 The causeway on the north-west side of the lake is raised above the level of the field to its north-west, suggesting that lies above a dam created to allow the road to run in a direct line from the house, along the avenue, to the road to the south-west. The two lower levels of clay are likely to have been materials brought in to create the upper part of this dam. The cut of a possible drainage ditch was recorded which may have been associated with a field boundary on the north-west side of the causeway and was post-medieval in date.
