Cedarwood, Coughton, Warwickshire

ARCHAEOLOGICAL OBSERVATION AND RECORDING

Archaeology Warwickshire Report No 1699

Project: Cedarwood, Coughton,
high voltage cable trench

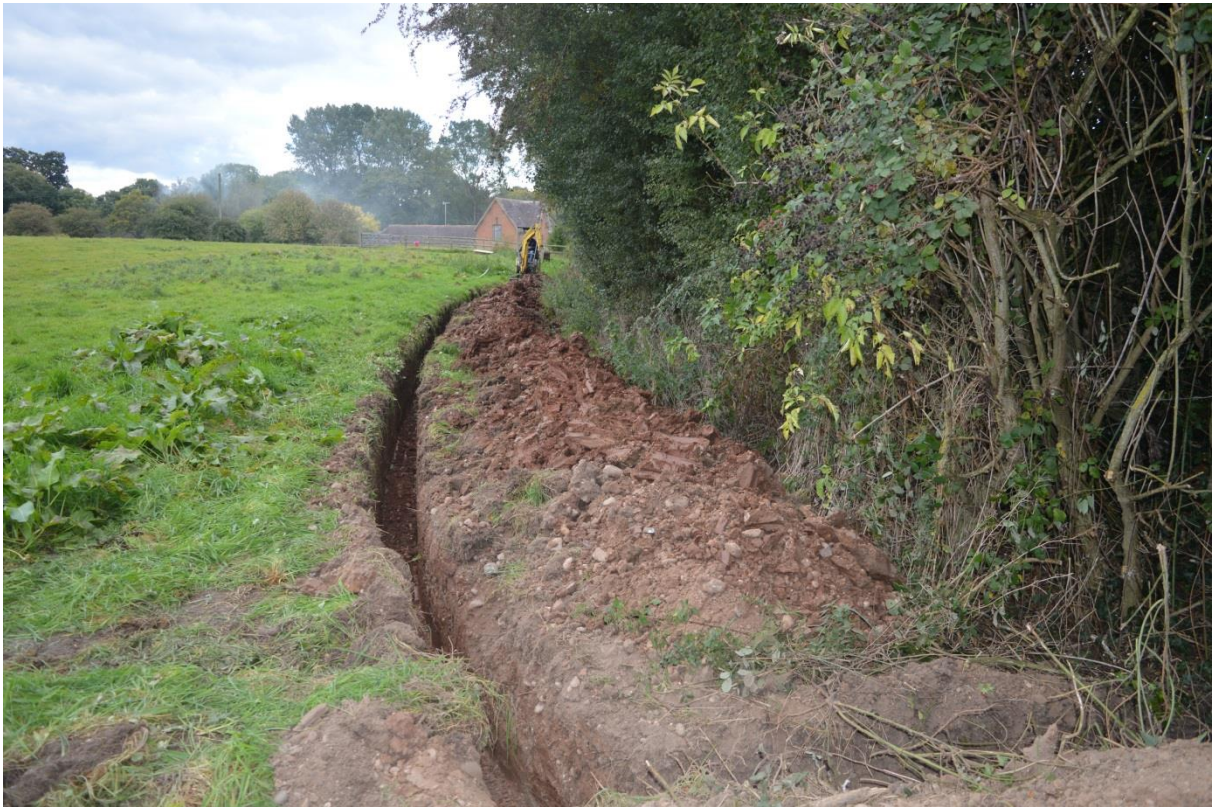
5.1 The trench was excavated using a mini excavator with a toothed bucket to a depth of between 0.60m and 1.00m and was 0.35m wide. The underlying geology was an intractable red brown clay with areas of grey pebbles overlying it and it was reached at a depth of between 0.35m and 0.50m below ground level (3).

1. Excavation of trench in main field

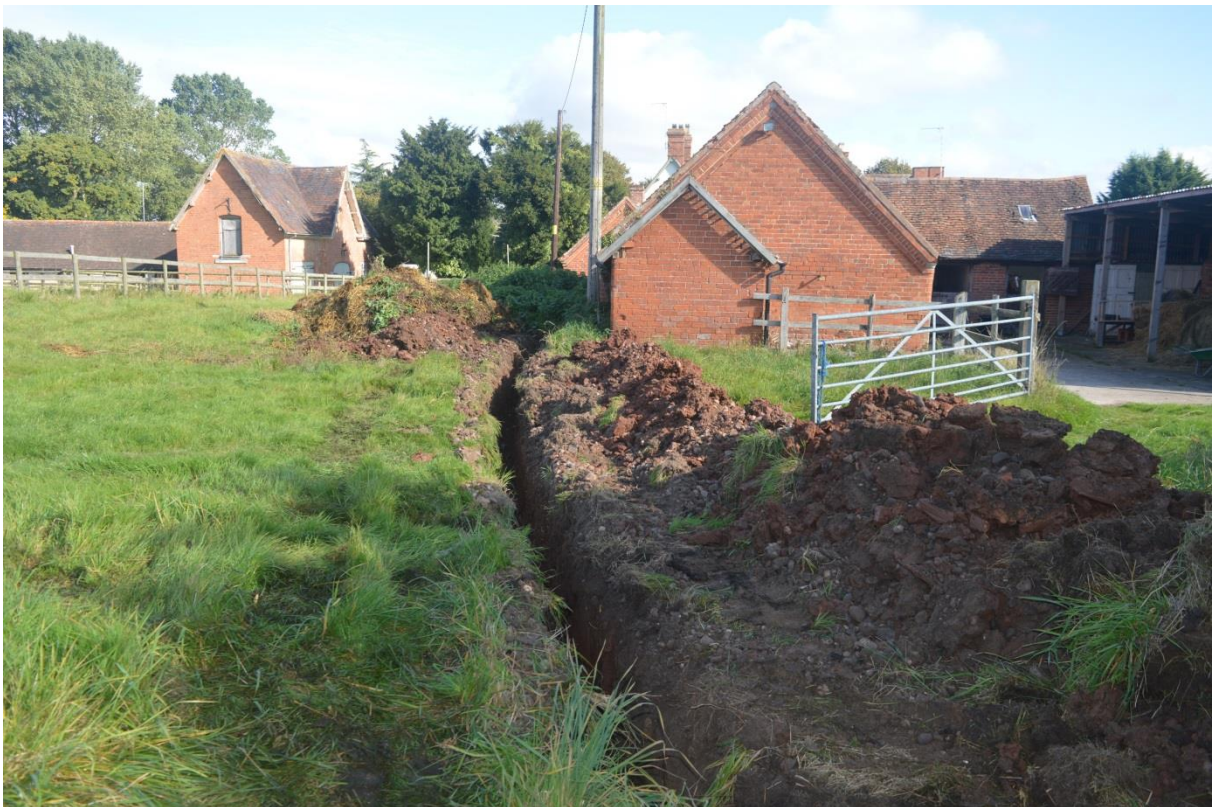
5.2 Following the excavation of the long stretch of trench in the main field a further length of trench was excavated from the telegraph pole back to the fence, in the farmyard area. Here the geological natural was directly overlain by a 0.40m thick layer of gravelly topsoil which contained fragments of roof tile near the farm buildings (6). A single land drain was recorded just west of the westernmost outbuilding at a depth of 0.50m (7). The area between the two field gates was more noticeably stony from metalling of the track (8).

2. Trench excavated adjacent to farm buildings
