Hawkstone Hall, Marchamley, Shropshire

ARCHAEOLOGICAL EVALUATION

Archaeology Warwickshire Report No 1865

AUGUST 2018

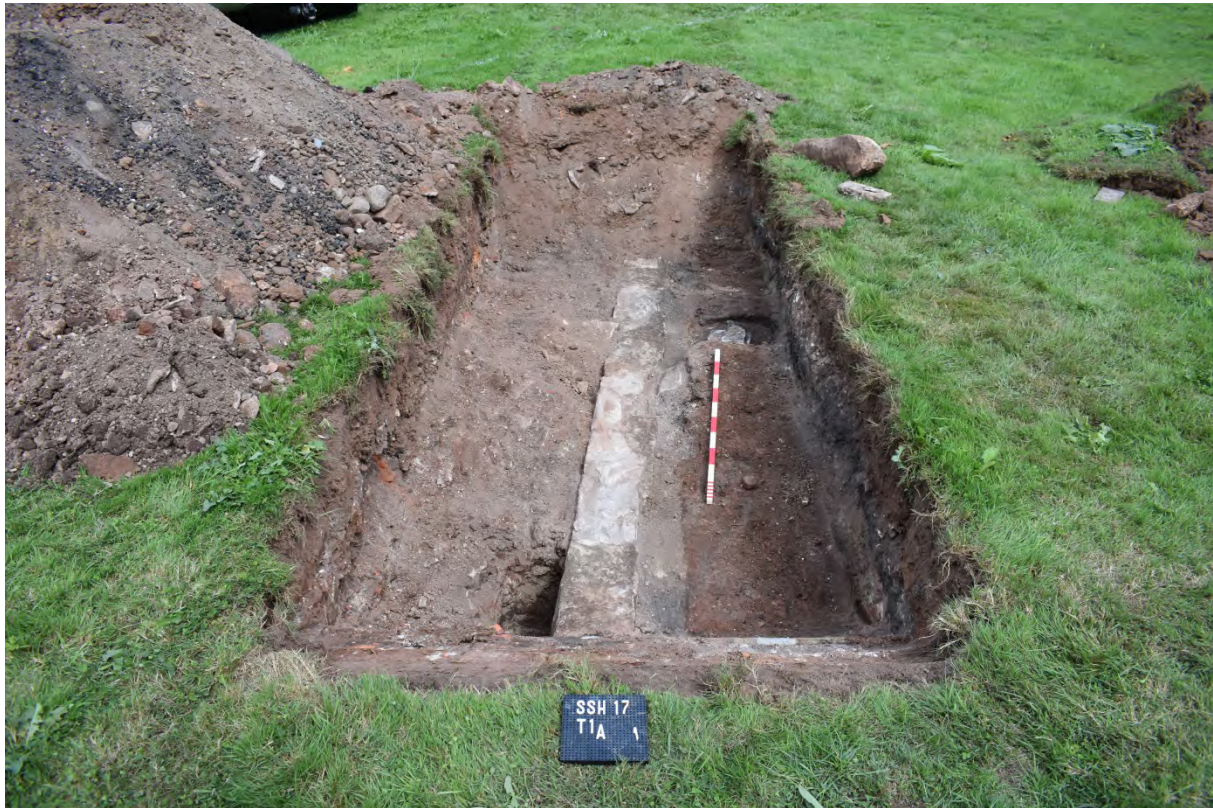
1: Trench 1 'A', looking north, with wall 8 clearly visible

- 5.3 Trench 1 'A' was excavated to a maximum depth of 1.02m below the current ground surface (126.70 above Ordnance Datum, a.O.D). The earliest layer exposed was a reddish brown clay layer (5), which was not a geological natural deposit, but possibly part of a make-up layer across this part of the site. This was cut by a construction trench (6) for a sandstone wall (8). The construction trench only visible on the eastern side of the wall, was a maximum of 0.16m wide and was filled by a very dark grey sandy loam with frequent small mortar flecks (7). The wall (8) consisted of at least two courses of neatly cut pale grey sandstone blocks, up to 0.70m long by 0.19m deep and 0.25m wide.

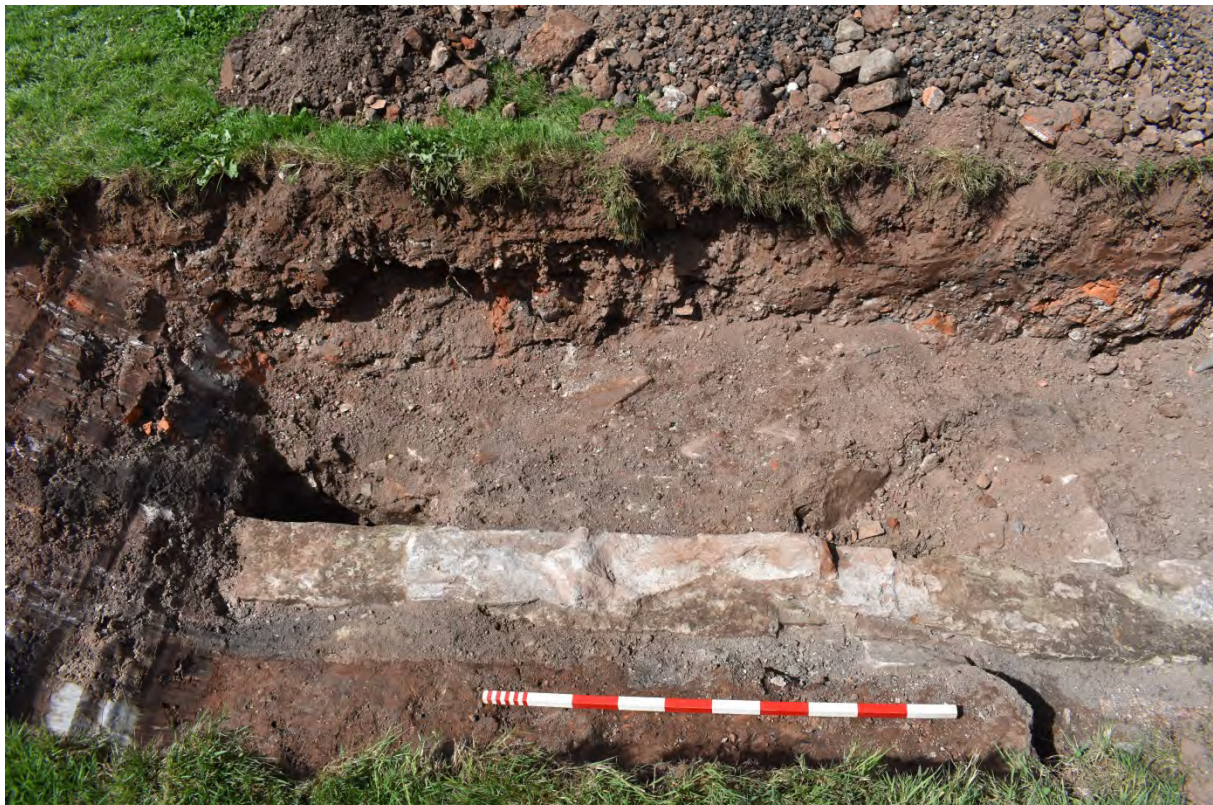
2: Trench 1 'A', wall 8, looking west, with foundation trench (6) on east side and rubble layer (9) butting up against the wall on the west side

- 5.4 On the east side of the wall a small area of mortared welsh slate and fragments of sandstone (11) had been cut down, or pressed, into clay layer 5 and appeared to have been cut by construction trench (6), suggesting it had may have been associated with earlier garden features or outbuildings.

- 5.5 The east and west sections of the trench showed different stratigraphy. A layer of dark brown silty loam, up to 0.16m thick (10), butted up against the west side of wall 8. This was overlain by a layer of demolition rubble, 0.70m (9). On the eastern side of the trench the clay layer 5 was overlaid by a layer of crushed sandstone, 0.13m thick (4), which was in turn overlain by a layer, 0.12m thick, of black ash and charcoal (3). This was overlain a layer, 0.15 thick, of reddish brown clay containing very frequent flecks of off-white mortar (2).

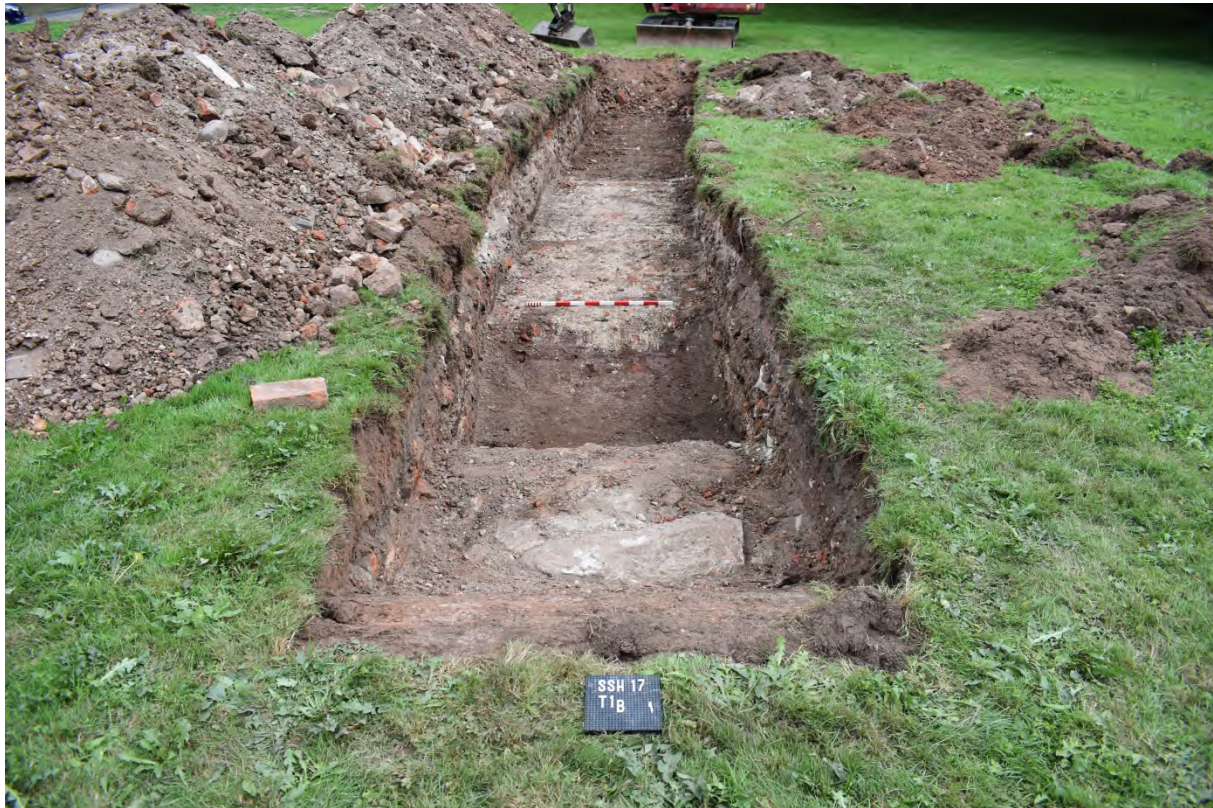
3: Trench 1 'B', looking north, with demolition rubble layer (14) in foreground and floor layer (16) in the background with camera scale

- 5.4 Trench 1 'B' contained different features and deposits to Trench 1 'A'. The trench was excavated down to the top of two surfaces (16 and 17), both at a depth of c.0.78m below the current ground surface (c.126.8m a.O.D). A test hole towards the southern end of this trench revealed the earliest deposit, a layer greyish brown silty sand (18), containing very occasional brick, tile, welsh slate and a few fragments of late 18th/early 19th century pottery, which was excavated to a depth of 0.33m but its full thickness was not determined. Overlying layer 18 was a layer, 0.09m thick, of firm mortar and crushed brick (16), which may have been the remains of a former floor. Its northern side butted against a layer of firm greyish brown sandy clay containing frequent small to medium pebbles and very occasional greyish sandstone fragments (17), which had the appearance of an external yard surface or trackway. Although there was a clear difference between surfaces 16 and 17, there was no evidence for a wall or formal boundary between them, which makes the interpretation of surface 16 as a floor uncertain.

- 5.5 Overlying both surfaces was a layer of firm greyish brown sandy loam, 0.09m thick (15). This was covered by a 0.4m, layer of greyish brown clay loam (14) which contained much crushed mortar, frequent bricks, occasional medium to large sandstone fragments along with some metal items such as copper cable and plastic coated wire. This layer clearly represented demolition rubble and was similar to layer 9 and trench 1 'A'. Layer 14 was overlain by a layer of dark grey sandy loam, 0.17m thick (13).

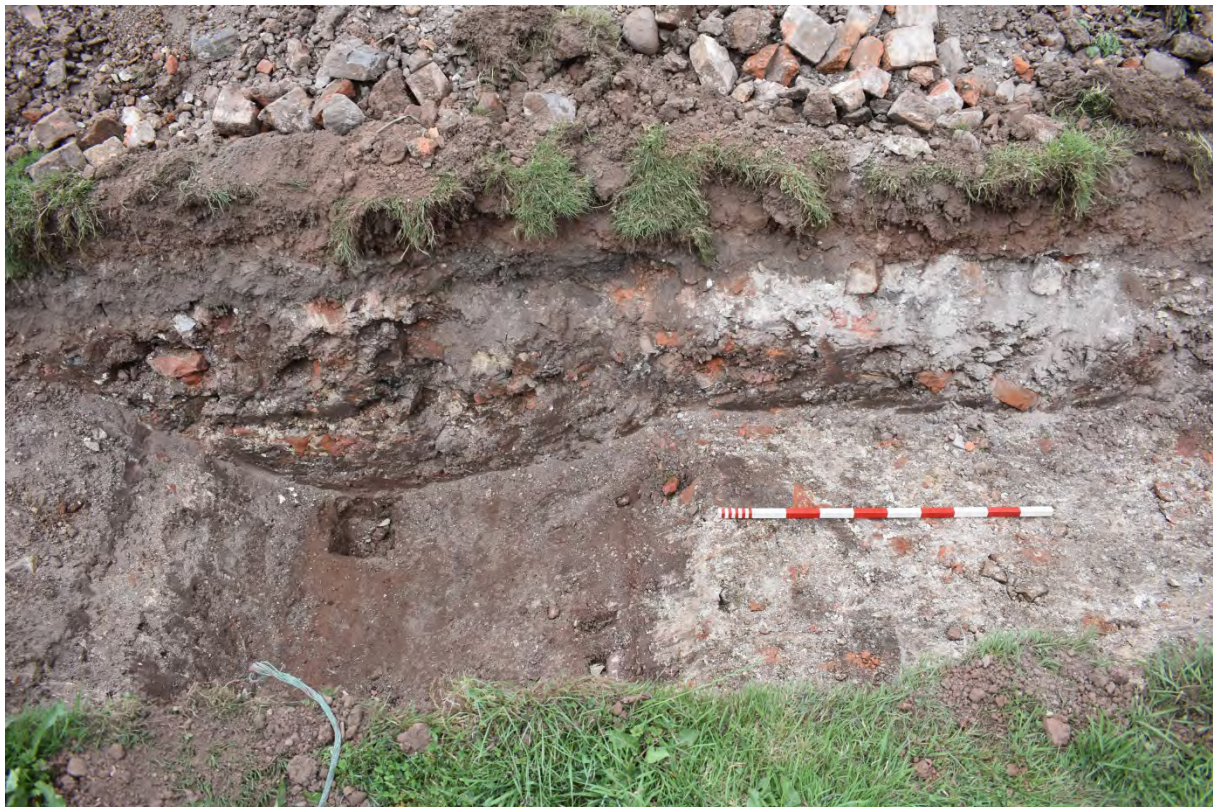
4: Trench 1 'B' showing layer (18) beneath floor layer (16, under scale)

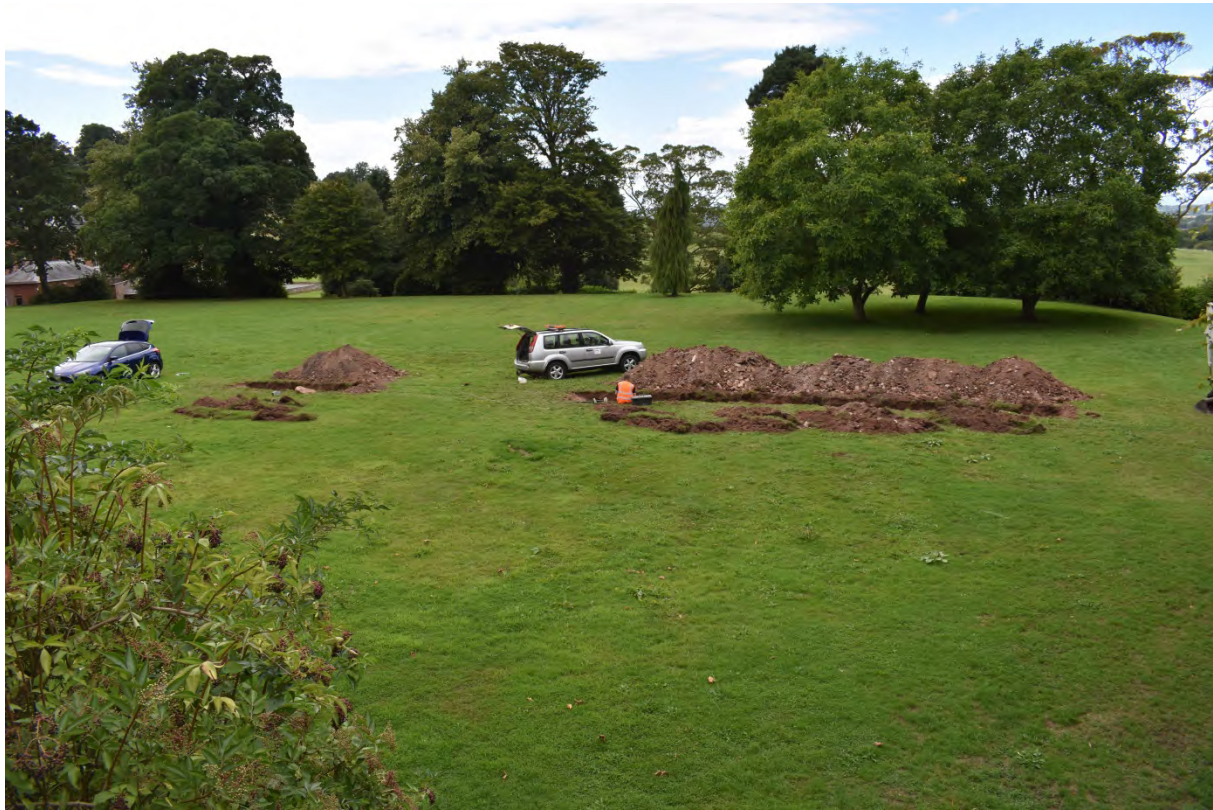
5: Trench looking west across the lawn formerly occupied by outbuildings
