# Barby Pools Marina, Barby Northamptonshire

## ARCHAEOLOGICAL EVALUATION

Archaeology Warwickshire Report No 15106

APRIL 2015

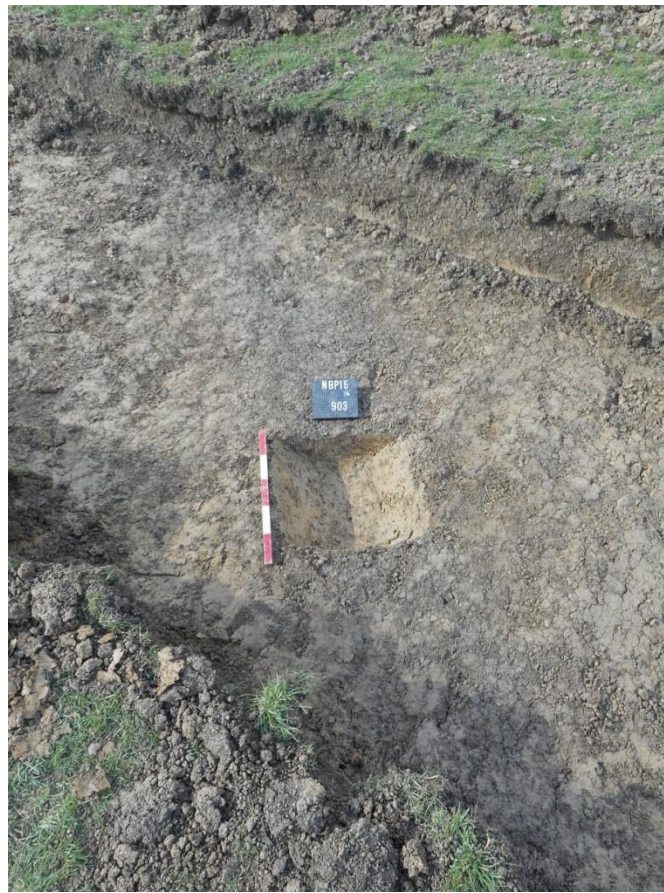
5.2 A narrow linear gully, perhaps a drainage feature, containing a fragment of post-medieval brick or tile, was recorded in Trench 29 (Fig 2).

Photograph 1. Gully 2903, Trench 29

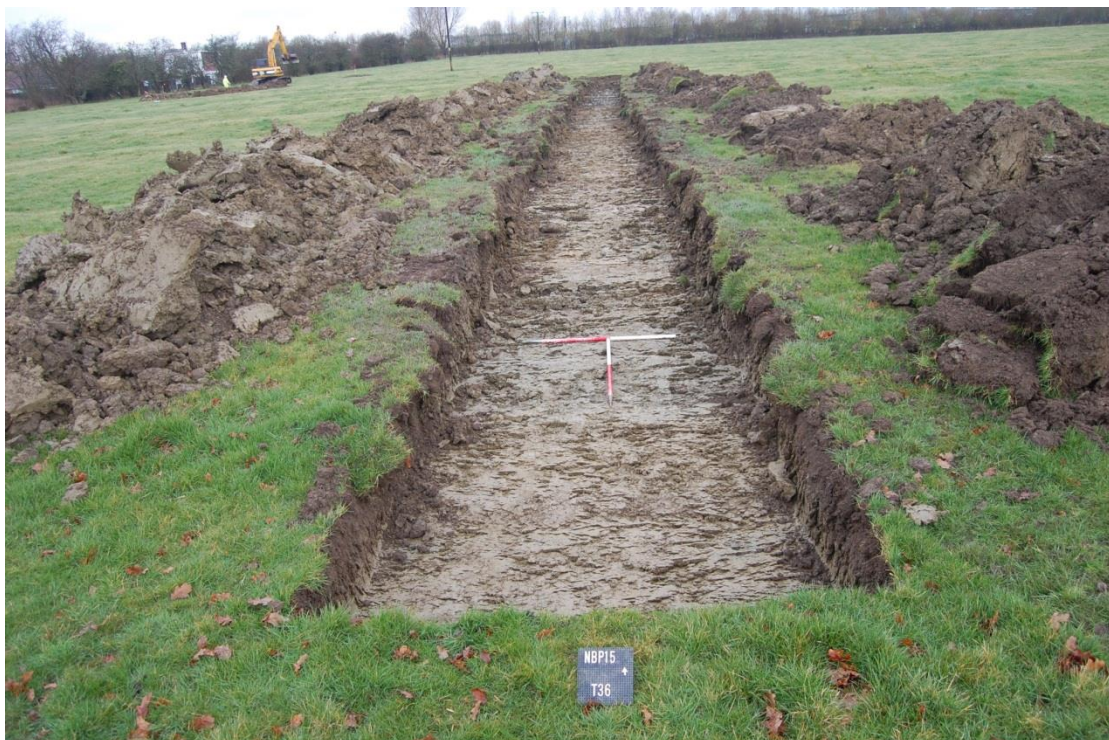
Photograph 2. Trench 36

5.4 The ridge and furrow visible as well-preserved earthworks in this field was in two blocks separated by a low headland. At the west part of the field the ridge and furrow was E-W aligned and at the east part of the field the ridge and furrow was NW-SE aligned. The ridges in both blocks of ridge and furrow were 9-10m apart and up to 0.50m in height. Trench 35 was excavated as in two parts to avoid electricity cables for safety reasons.

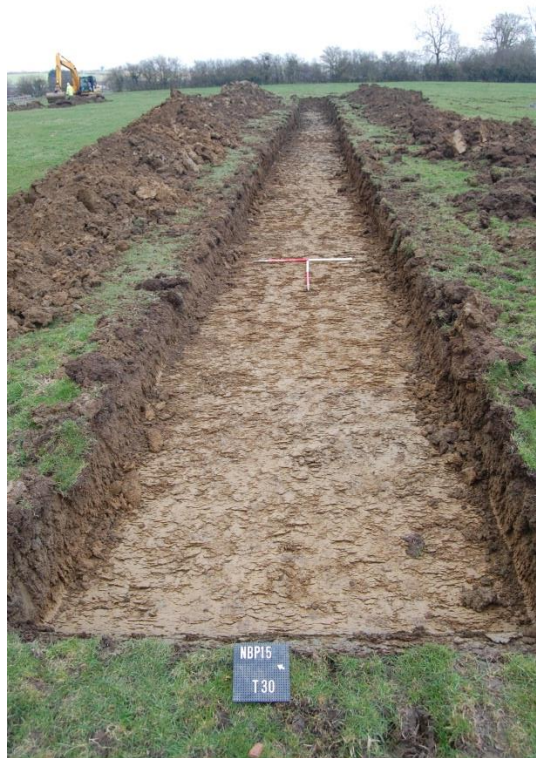
Photograph 3. Trench 30

5.5 A deep silty clay layer recorded in Trench 30 may be associated with an infilled pond or a natural paleochannel.

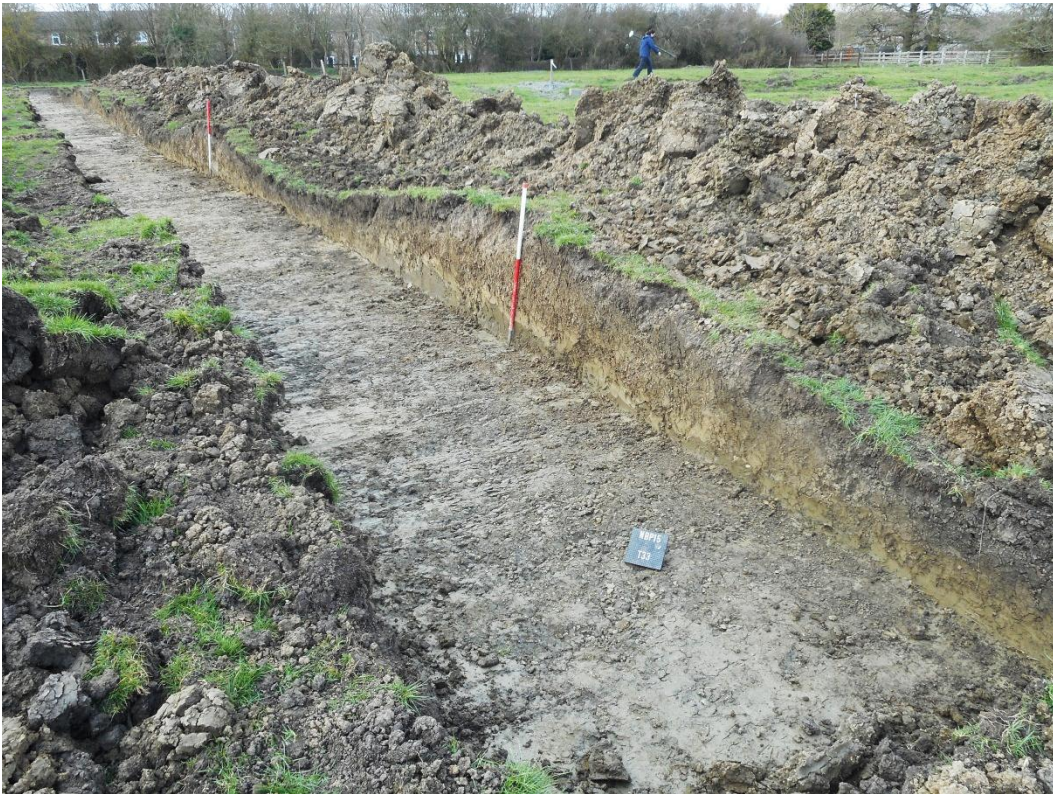
5.3 Ridge and furrow in this field was on a N-S alignment and still visible as well-preserved earthworks. The ridge and furrow was recorded in Trenches 33 (Fig 3, Trench 33) and 34, 8-9m apart with ridges surviving up to 0.50m high.

Photograph 5. Trench 33 from west

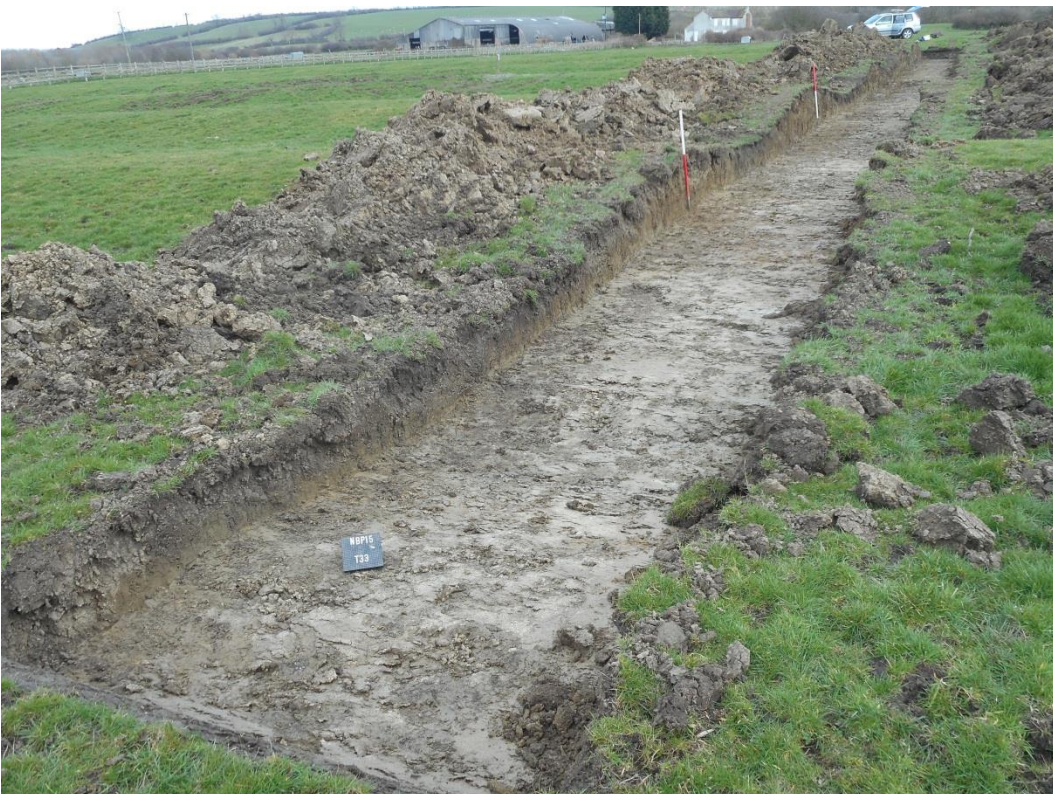
Photograph 6. Trench 33 from east
