Smiths Butchers, High Street Chipping Campden Gloucestershire

ARCHAEOLOGICAL WATCHING BRIEF

Archaeology Warwickshire Report No 1905
JANUARY 2019

Project: Watching Brief Smiths Butchers, High Street,
Chipping Campden, Gloucestershire

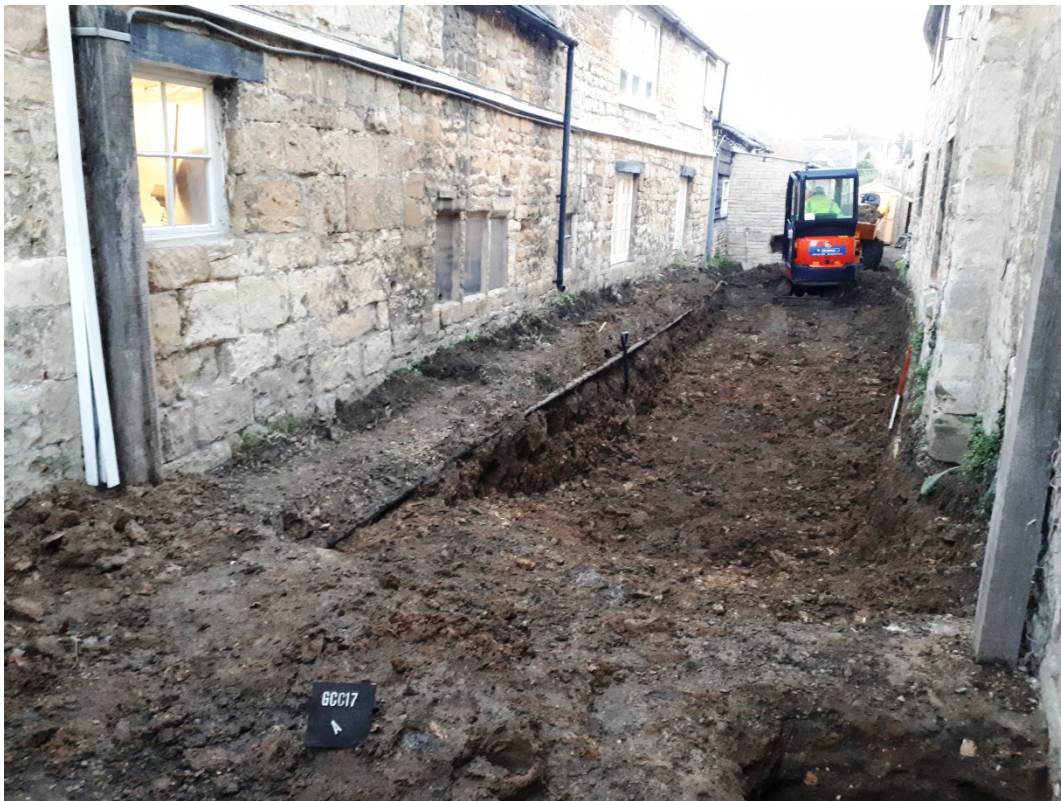
1: Excavation of the new access ramp between the buildings

- 5.1 Groundworks consisted of the reduction of ground for the access ramp along the NW/SE oriented passage between Smith's Butchers and the neighbouring 'Drinkwaters fruit and veg' store fronting High Street to the south-east. This was excavated by machine using a toothless bucket. The reduced area for the ramp was c.3m wide and c.20m long and it sloped from the NW and SE ends to a maximum depth of 1.2m at the centre (Fig 3; Photo 1). A test-pit was also excavated against the wall of the building.

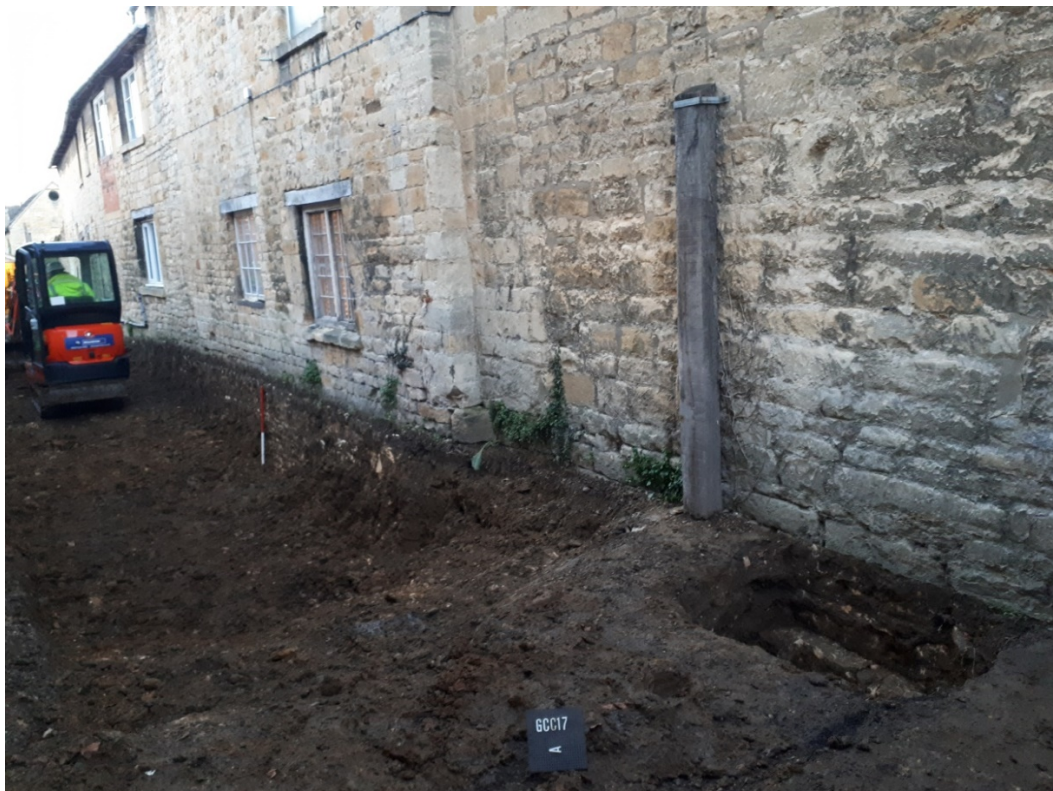
2: Location of test-pit against neighbouring building

- 5.3 A test-pit was excavated against the north-east wall face of Drinkwaters in order to determine if the excavation would undermine its footings. The sondage was located 3m back from High Street extending 1m along the wall. It was hand-excavated to a depth of 1.5m which revealed the full depth of the building footing at this point. The footing was constructed in two different styles between the lower and upper halves.

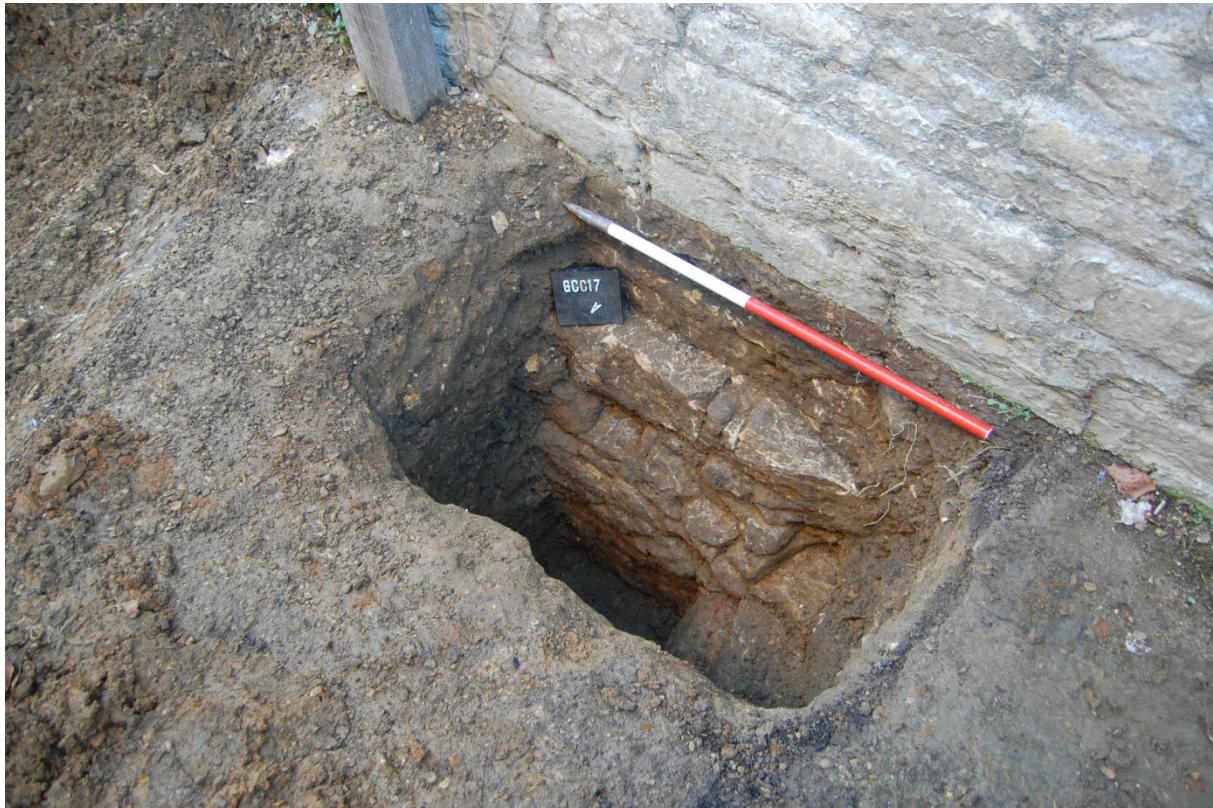
3: Remains of offset stone walling (3 and 4) below neighbouring building

- 5.4 The lower part (3) was cruder than the upper and projected c.0.18m out from the standing wall face. It was comprised of irregular-shaped blocks of limestone and sandstone which were roughly laid and bonded with a mix of silty clay and lime mortar. The wall foundation cut into the geological natural clay (2). A further section of wall footing (8), 0.46m high, projected out from the wall line in the north-western side of the sondage. This projecting part was a single course incorporating a large limestone block c.0.4m wide, but otherwise of the same rough construction as footing 3. Its full width was not visible, however, it is presumed to have formed part of a wall across the present passage. The upper portion was truncated and overlaid by formation deposit (1), likely brought in to create a level passageway.

- 5.5 The upper course (4) of footings was constructed in a similar manner to the walling above, with regular sub-square limestone coursed blocks between 0.2 and 0.5m wide and bonded with a lime mortar. The lower course formed a plinth that was offset by 80mm from the standing walling. This difference between the construction style of the wall and upper offset footing and the material and bonding of the walling below suggests two possible scenarios. The existing building may have been built on the remains of an earlier, largely demolished, building which was much cruder in construction. Alternately, it may be that the 17th-century building's footings, which would never been visible above ground, were simply constricted in a much rougher manner than the walling above. The significant difference in the styles and bonding materials used suggests it may be more likely that the lower part of the wall belonged to an earlier structure, possibly supporting the plinth of a timber-framed building.

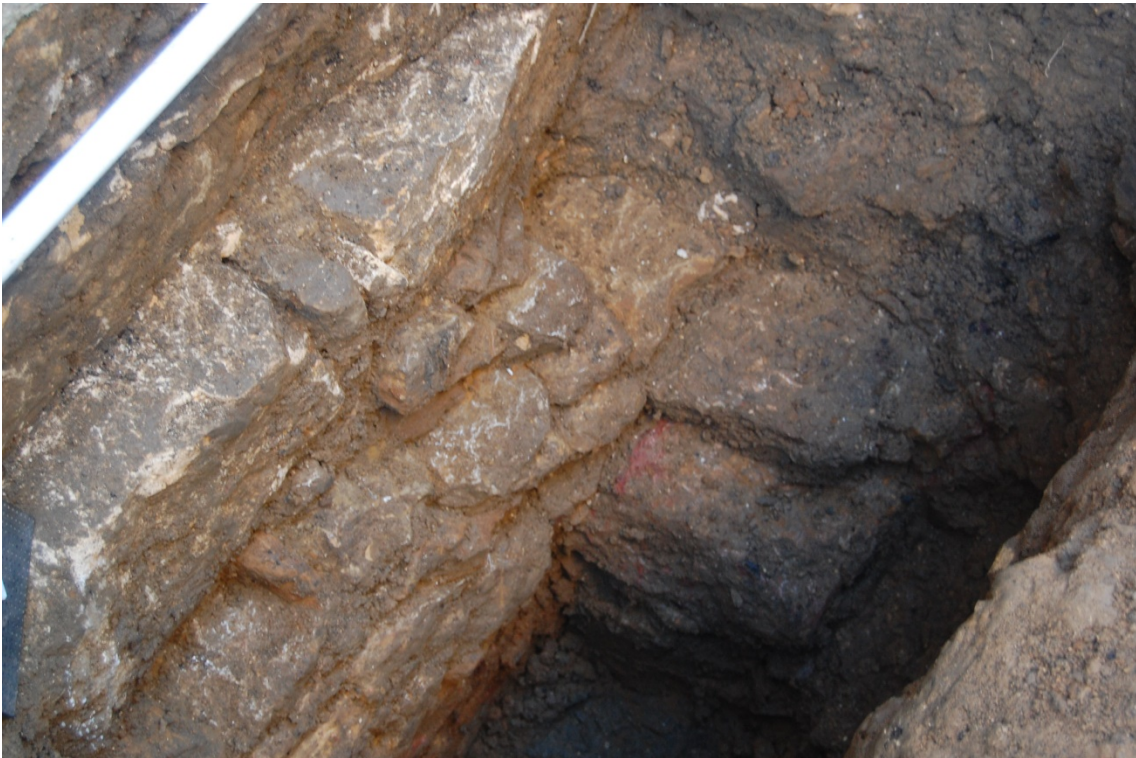
4: Remains of projecting stone walling (8)

- 6.2 The identification of a possible earlier building below Drinkwaters, including a section that extended across the passageway is significant, although no structures are shown on any maps of the town. The centre of Chipping Campden is almost entirely made up of buildings from the 14th century to the 17th century. Drinkwaters dates to the later part of this period, indicating the putative earlier building pre-dates this. Many of the early buildings in the town are timber-framed, on a stone plinth, and this may well have been the remains of such a structure.

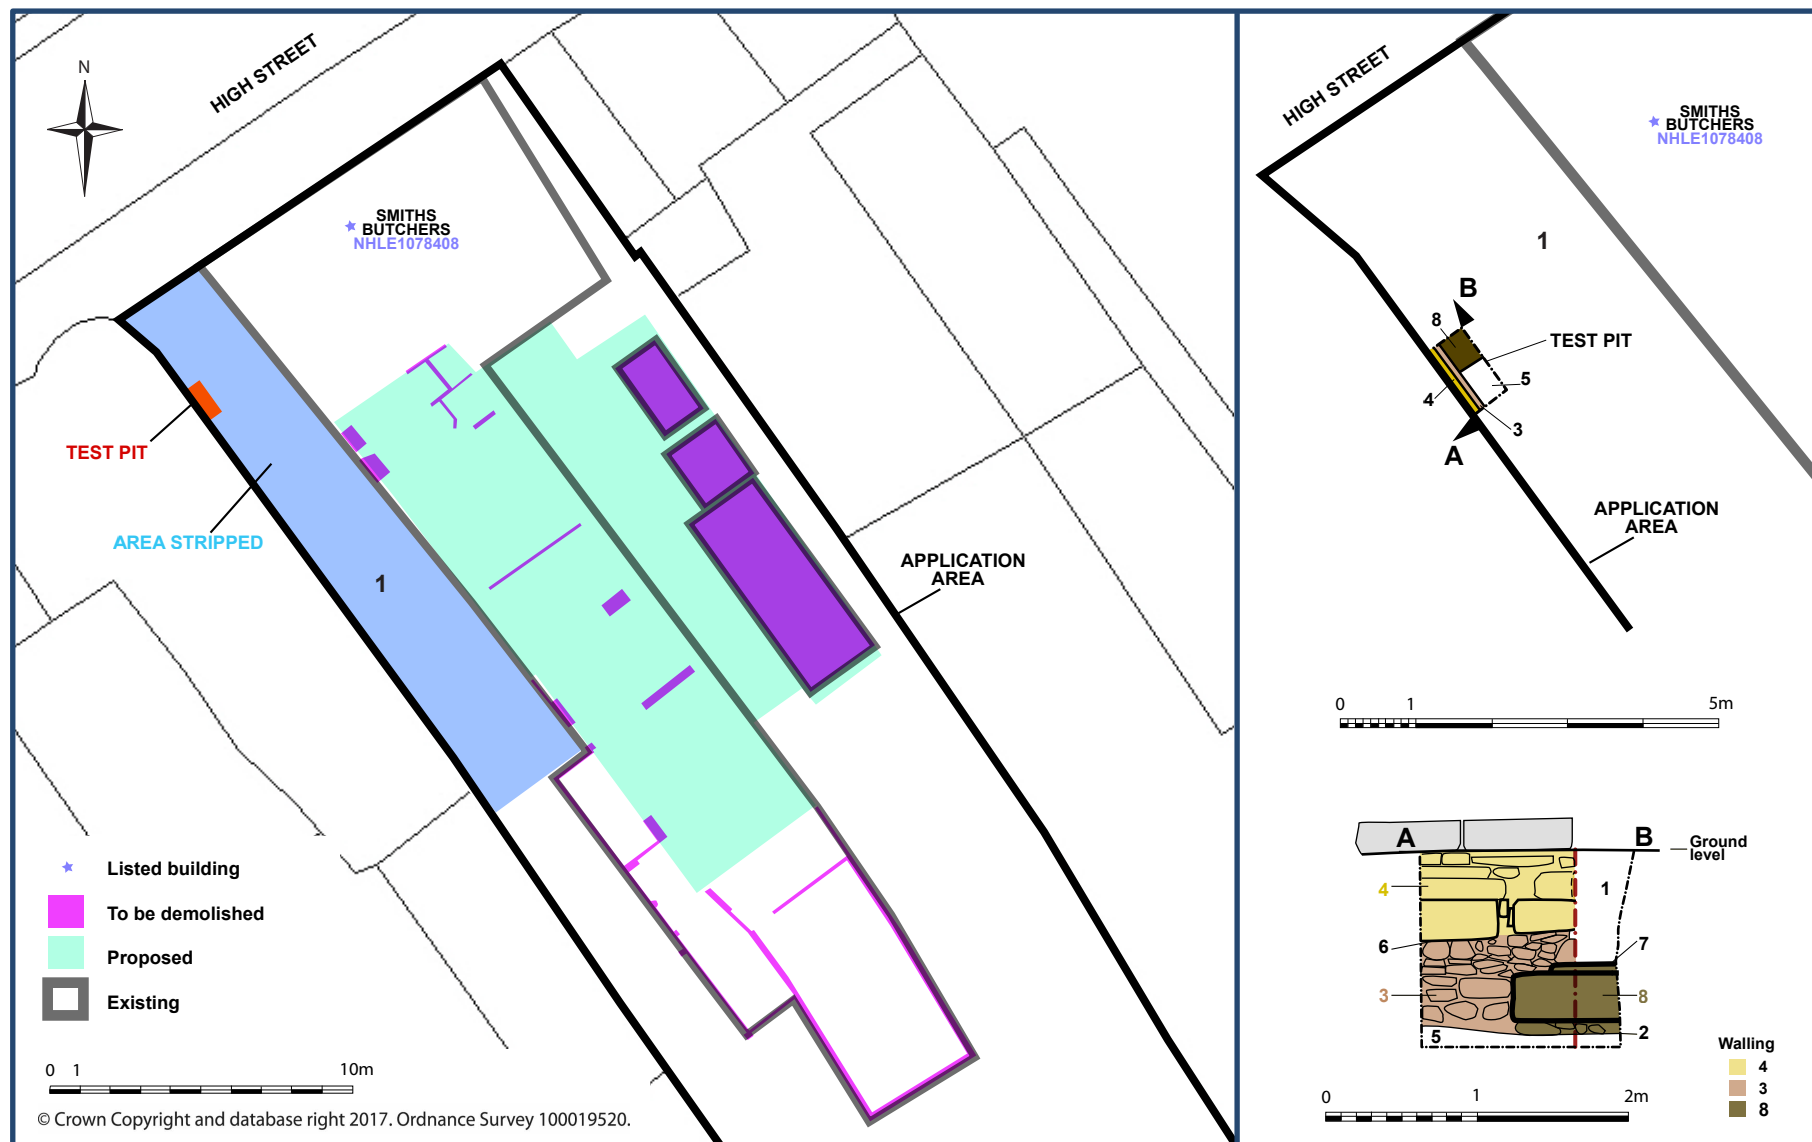
Fig 2: Location of area excavated, with detail and section
