Harefield House, High Street, Fenny Compton Warwickshire

ARCHAEOLOGICAL WATCHING BRIEF

Archaeology Warwickshire Report No 19112
SEPTEMBER 2019

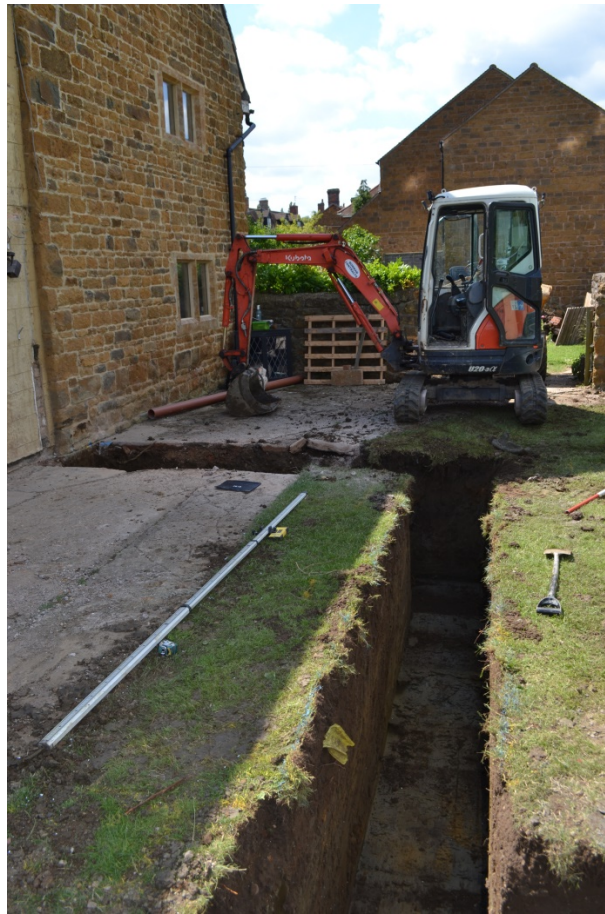
1: Observed trenches and gable end of the house

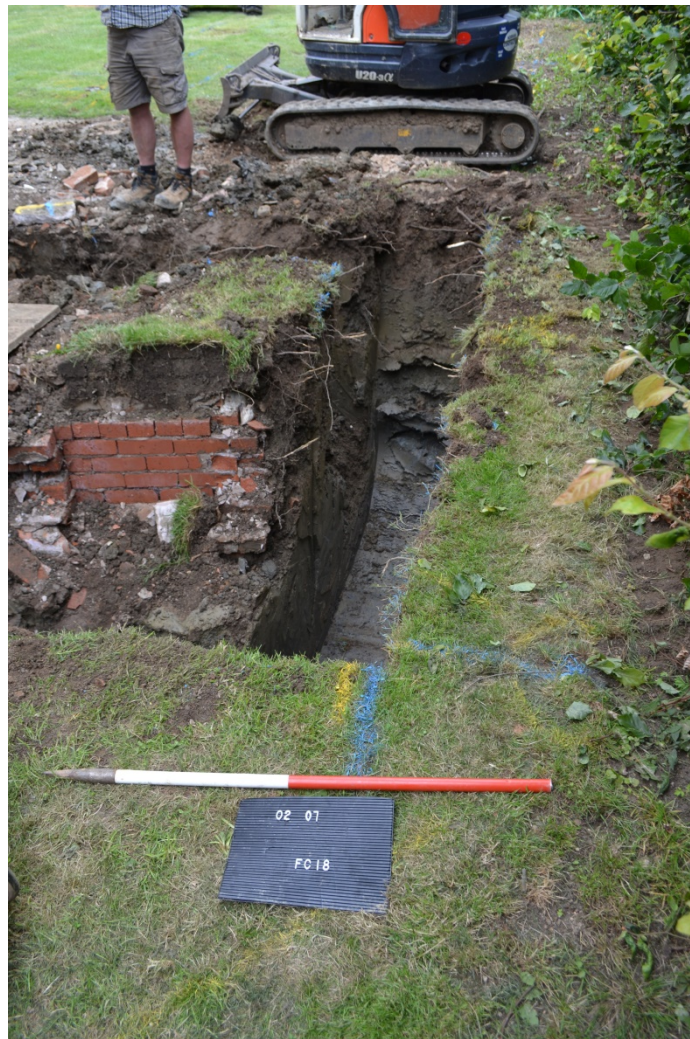
3: Observed trenches to north of the house showing pre-existing services

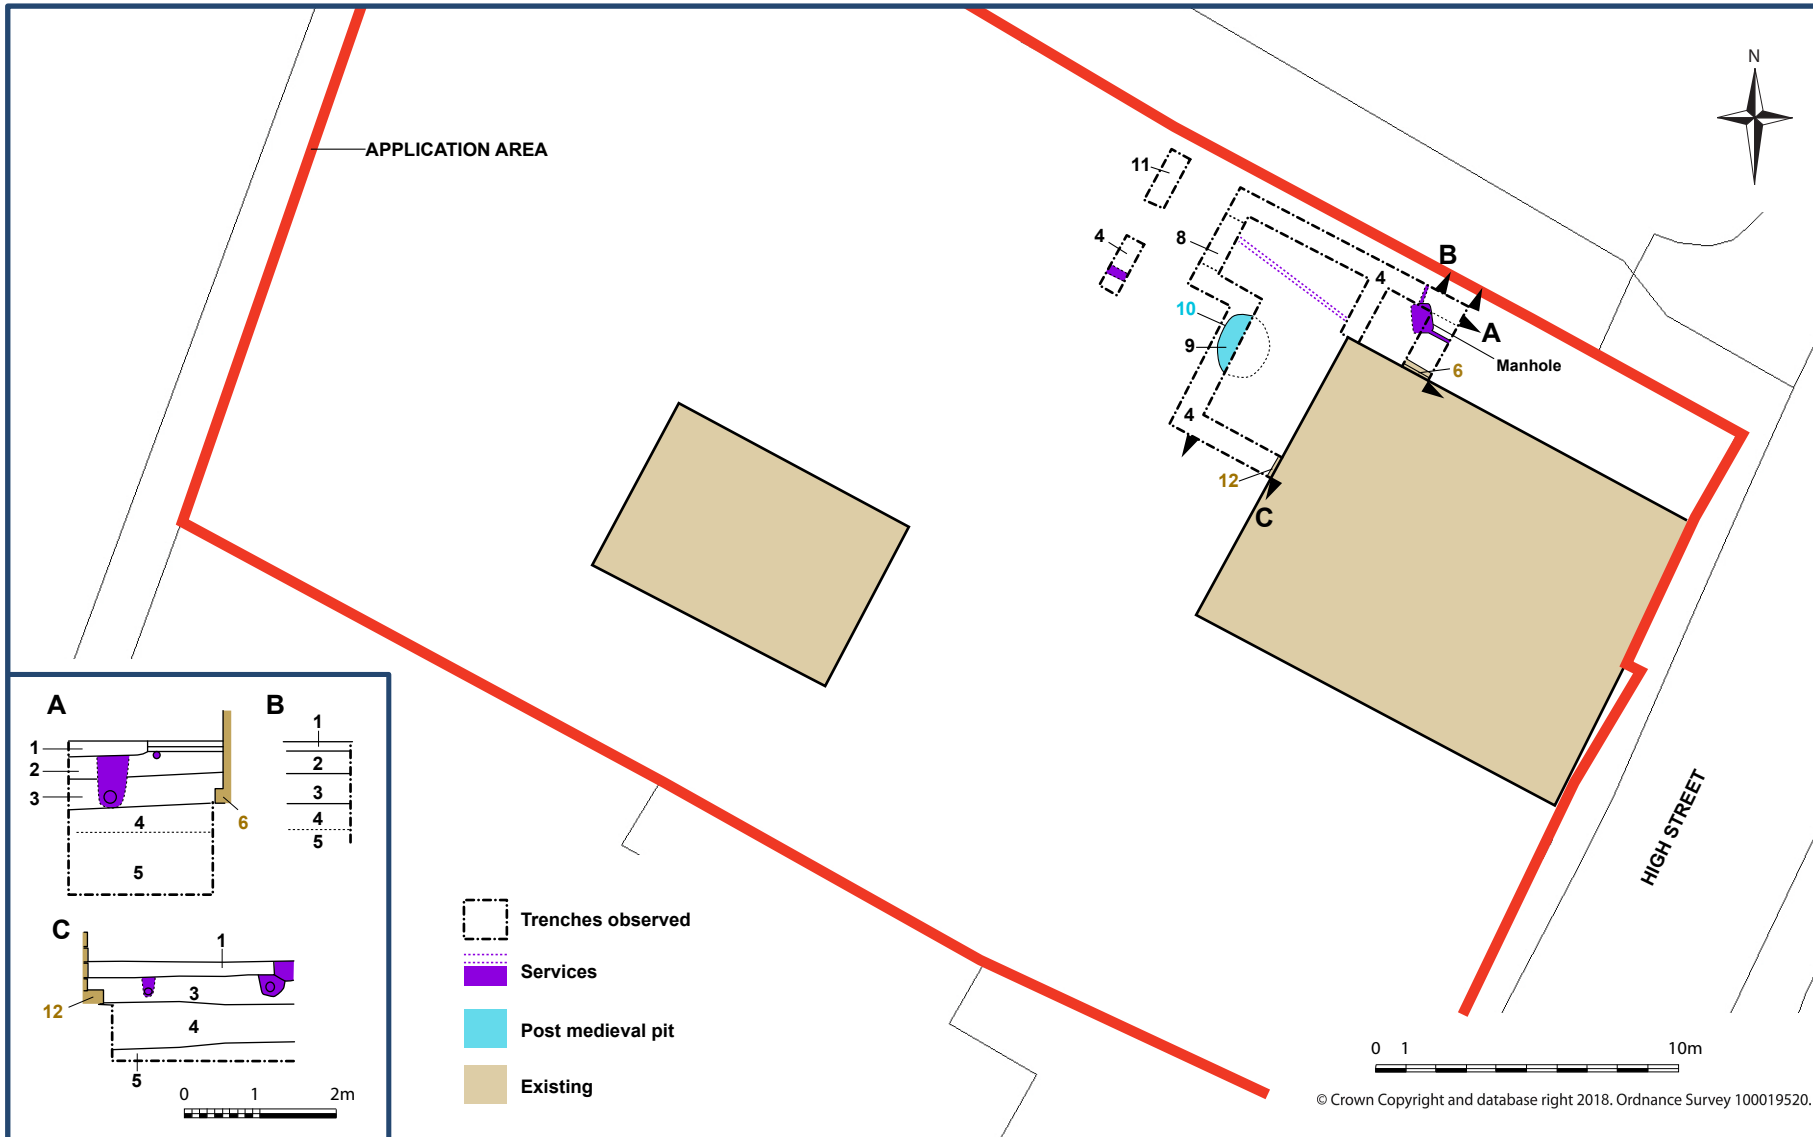
- 4.3 The foundation trenches for the new extensions were excavated by a machine using a toothless bucket. The trenches were up to 0.70m wide and excavated to a depth of 2m.

Fig 3: Location of trenches observed and sections A to C
